Project Status Memorandum		
To:	Mr. Shane Cunningham CalFire PO Box 994246 Sacramento, CA 94244-2460	Subject: Status to date Re: Investigation of Valley Fire, Lake Co 8015 High Valley Rd, Kelseyville, CA Incident # CALNU 008670 Request # O-351 DOL 9/12/2015 Contract # 7CA02326
From:	Jim Nolt, P.E.	Date: September 30, 2015

CALFIRE - INCIDENT # CALNU 008670, REQUEST # 0-351

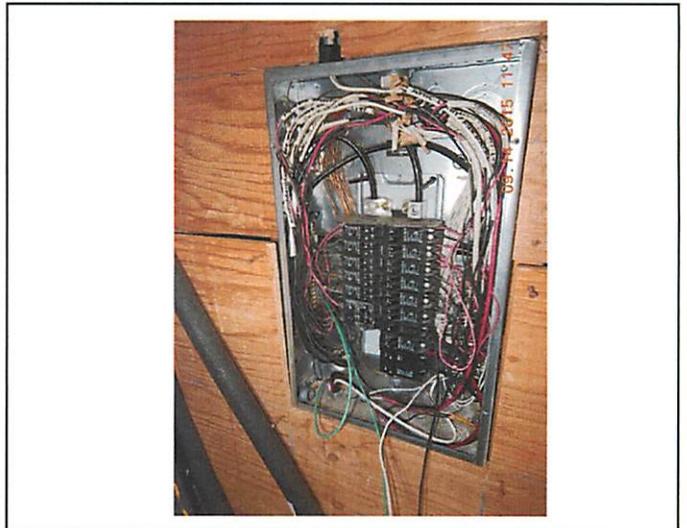
Photo 4

- 3.03 This splice was one of two splices made in the branch circuit conductors providing power from a 2-pole 40-amp circuit breaker (see photos 4 & 17 as typical) to an operating spa/hot-tub (see photos 9 & 10 as typical).

- 3.04 The splice closest to the power source (line) can be seen in photos 5 thru 8. The splice closest to the spa (load) can be seen in photo 9.
- 3.05 Power to the hot tub was provided by a 2-pole 40-amp circuit breaker. See photos 4, 17 and 18 as typical. This circuit breaker was found in the tripped position.

- 3.06 Branch conductors for this circuit ran from the circuit breaker inside a sub-panel (see photo 4 as typical) through an exterior wall to an exterior single-gang junction box near the area of interest. See photos 25 through 27 as typical. These individual branch conductors were in white PVC conduit that was installed about 1 inch below finished grade. (Table 300.5 of the National Electrical Code specifies that nonmetallic conduit, for circuits less than 600V but more than 120V, be installed 18 inches below finished grade.) Photo 26 shows much of the white conduit and some gray water piping (run in parallel) after it had been pulled up to the surface by hand.

- 7.02.02 examine as necessary conductor splice from nearest to the spa. See photo 9 as typical.
- 7.03 Conduct a multi-party evidence examination of the collected Eaton 2 pole, 40 amp molded case circuit breaker as necessary. See photos 4, 17 - 18 & 24 as typical.

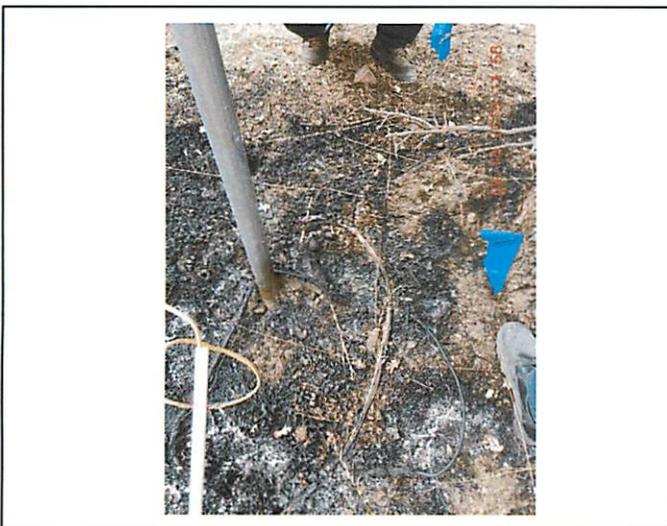
Photo 5

- 3.01 I was asked by CalFire to assist with the examination of the subject fire scene.
- 3.02 When I completed my initial site survey (see photos 2 through 4 as typical) my attention was directed at the remains of an electrical conductor splice (see photos 5 & 6 as typical).

- 3.08 The splice of interest is shown in the photo 25 near the yellow-number-one tag. It is also shown in more detail in photos 5 through 8 as typical. The orange wire ties are there to indicate the area of interest as found.

- 7.02 Conduct a multi-party evidence examination of the collected conductor evidence in a lab with binocular microscope and/or x-rays as necessary.
 - 7.02.01 examine as necessary conductors, wire nuts and wire nut splices from area of interest. See photos 5 thru 8 as typical.

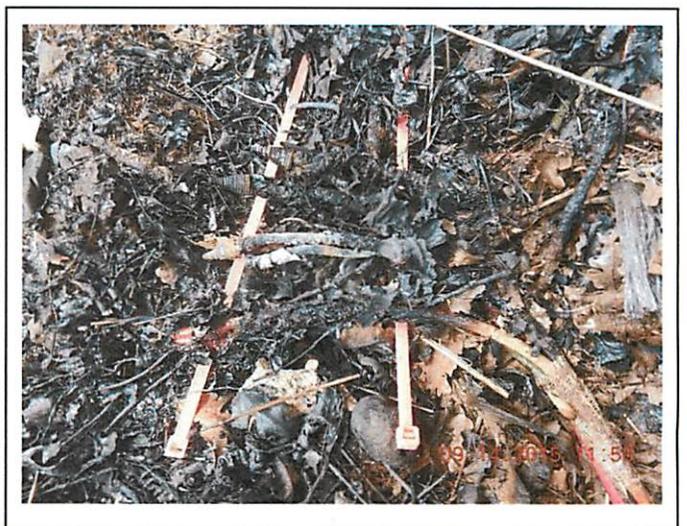
Photo 6

- 3.16 Observe in photo 8 the clear evidence of both copper melting and arcing. Copper melts at 1981°F. I was told that the vegetative debris likely to have been in that area before ignition would not by its combustion create that temperature. See photo 6 as typical. Therefore, the most likely failure mode would have been thermal-resistance heating at the wire nut because of a poor electrical connection. The conditions of this connection would have been exacerbated by the relatively high current required by the operation of the hot tub heater and pumps.

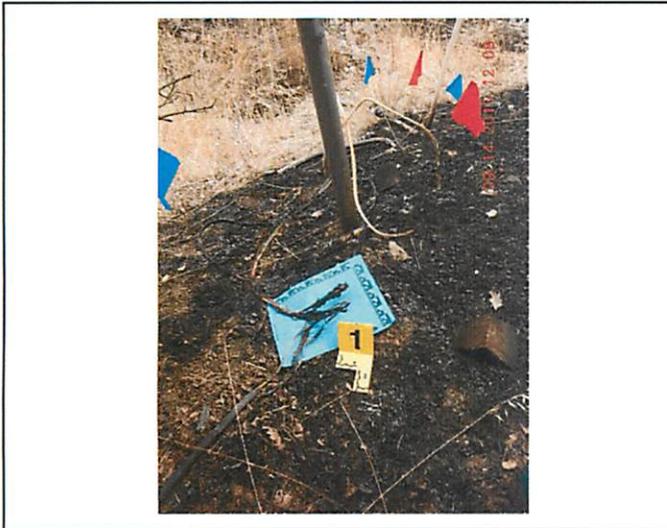
Photo 7

- conductors to a large jacketed extension cord that was run along the ground surface and the deck surface to the hot tub. See photos 7 and 9 as typical.

- 4.01 There are three fuses on the printed circuit board that provided controls for the hot tub. None of those fuses were blown. See photo 15 as typical.
- 4.02 The junction box shown in photos 25, 27 and 28 was originally 18 to 24 inches above finished grade. It was not secured structurally with the support required by the National Electrical Code (NEC), section 314.23B, Supports. At my examination, it appeared to have been held in place only by the conduit.
- 4.03 None of the holes in metal or wood panels through which conductors were installed had the code-required insulating bushings installed that are intended to protect the conductor insulation from the sharp edge of the hole or fitting. See photos 4, 12, 14, 22 and 23 as typical.
- 4.04 Neither of the splices seen in photos 7 and 9 were installed within the code-required junction box. See Article 314 of the NEC.

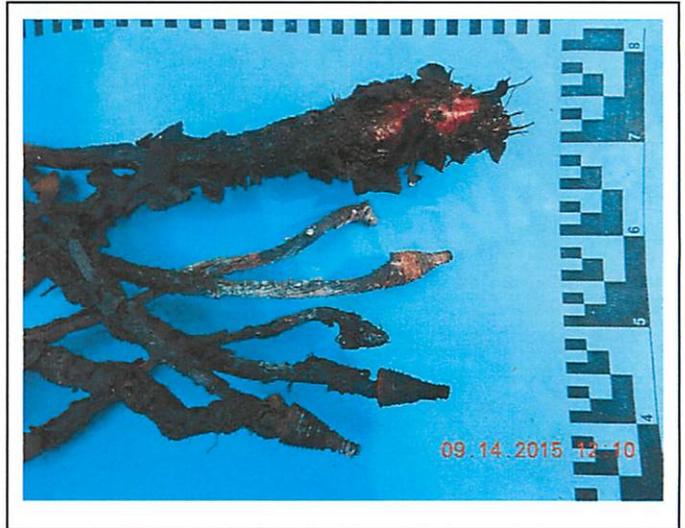
Photo 8

- 3.15 Observe in photo 20 the resistance between the steel spring of the wire nut and the circuit breaker is about 2100 ohms instead of less than 2 ohms. That same measurement made directly to the conductor (see photo 21 as typical), thereby circumventing the damaged wire nut resulted in 1.2 ohms, as expected. Thus, there appeared to be significant electrical resistance at the wire nut to conductor interface that is also exhibiting the most thermal damage. See photo 8 as typical.

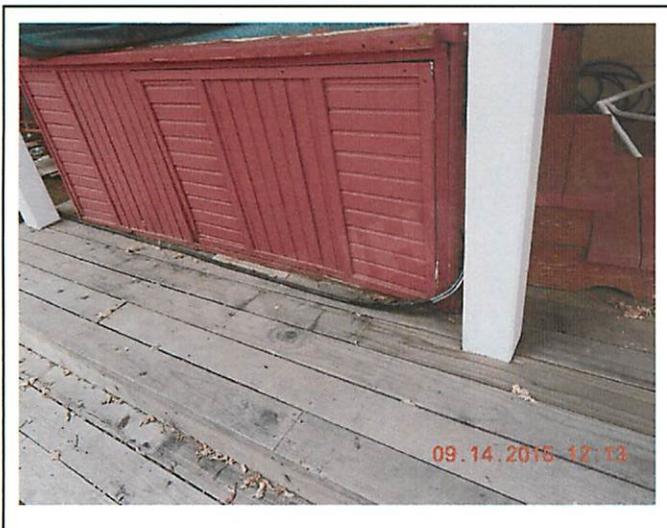
Photo 9

- 3.10 Near the hot tub the jacketed conductors were again spliced to other unjacketed conductors (see photo 9 as typical) that were terminated onto an electrical terminal strip inside the hot tub control enclosure. See the conductors labeled "R" & "B" depicted in photo 22 as typical. Photo 23 shows the same terminations after the conductors had been removed for collection.

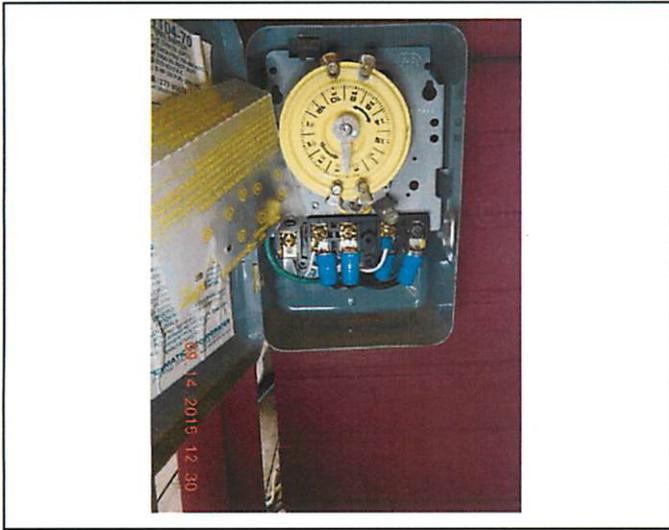
Photo 13

- 3.13 A time clock was also used to control power to the hot tub. This time clock allowed the heater and related water circulation pumps to operate twice daily, each time for about two hours. At the time of my examination the time clock was in the "on" position and appeared to have stopped operating at about 09:00 hours. See photo 13 as typical.

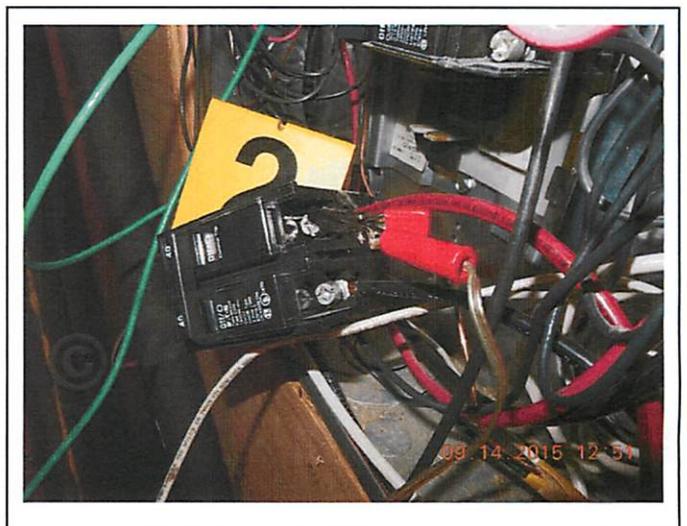
Photo 18

- 3.14 I was able to confirm that conductors at the splice of interest were provided power by the 2-pole 40-amp circuit breaker. See photos 18 through 21 as typical.

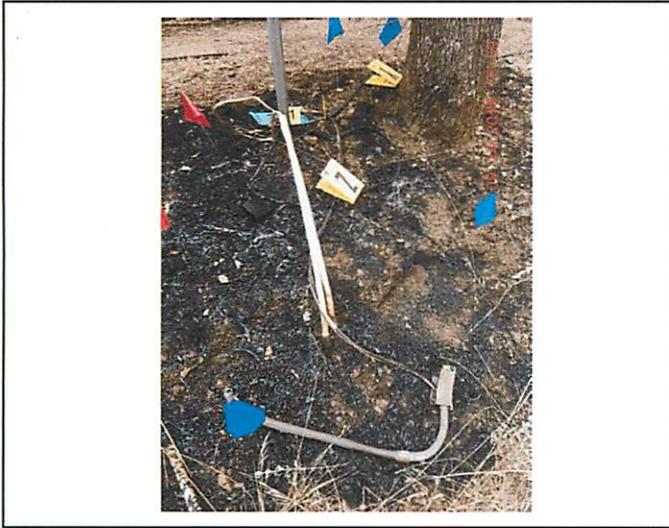
Photo 25

- 3.07 The junction box shown in photos 25, 27 and 28 was originally 18 to 24 inches above finished grade. It was not secured structurally with the support required by the National Electrical Code, section 314.23B, Supports. At my examination, it appeared to have been held in place only by the conduit.

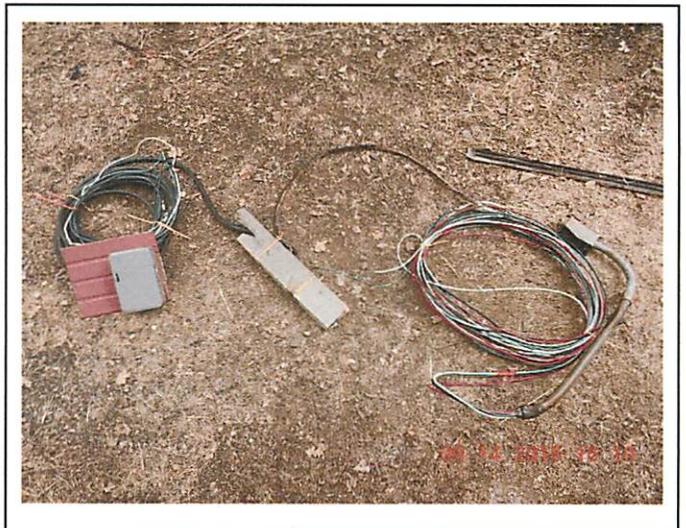
Photo 28

- 3.11 The entire length of branch circuitry including the source circuit breaker, all the conductors, the junction box and some of the conduit, the time clock and the conductors terminated on the terminal strip were taken and secured as evidence by CalFire. See photo 28 as typical.
