# Valley Fire

State Post Fire Watershed Emergency Response Team  
Addendum I

Hazard Site Evaluation

October 2015

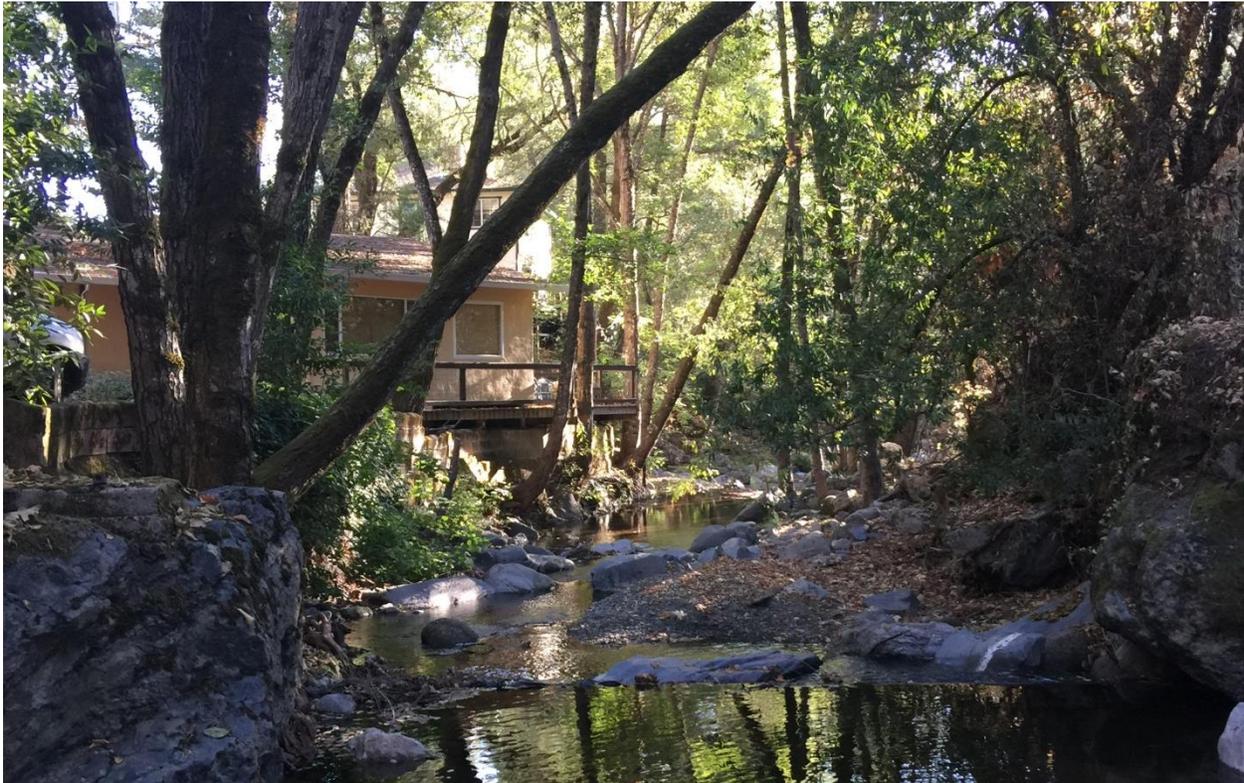
## Site 100

This site is a single family dwelling located on Anderson Springs Road (38.77456' N, 122. 69003' W). The house is located in the Anderson Creek channel. Anderson Creek is a perennial fish bearing stream, in the Putah Creek watershed. Habitat type at this site is mixed-riparian. The home is located very close to the waterway and built on a foundation that will be directly in the main force of flood flows. The threat to existing infrastructure is debris-laden flooding and debris flow down Anderson Creek.

Early warning of flood events and evacuation of home.  
Assess structural integrity of foundation.

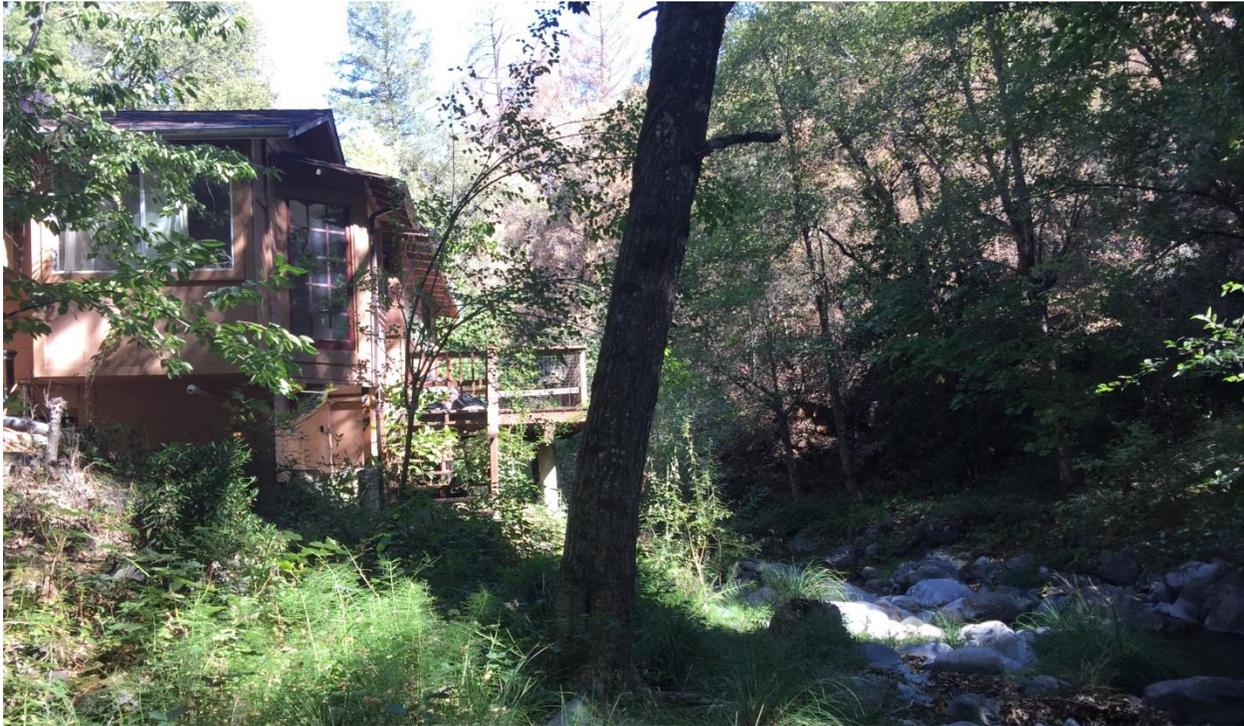
## Site 101

This site is a single family home located on Foard Road (38.77462' N, 122.68904' W). The house is located at the confluence of Anderson Creek and Bear Canyon Creek. Anderson Creek is a perennial fish bearing stream in the Putah Creek watershed. Habitat type at this site is mixed-riparian. The threat to existing infrastructure is debris-laden flooding and debris flow down Anderson Creek rising to an elevation that will impact the home.

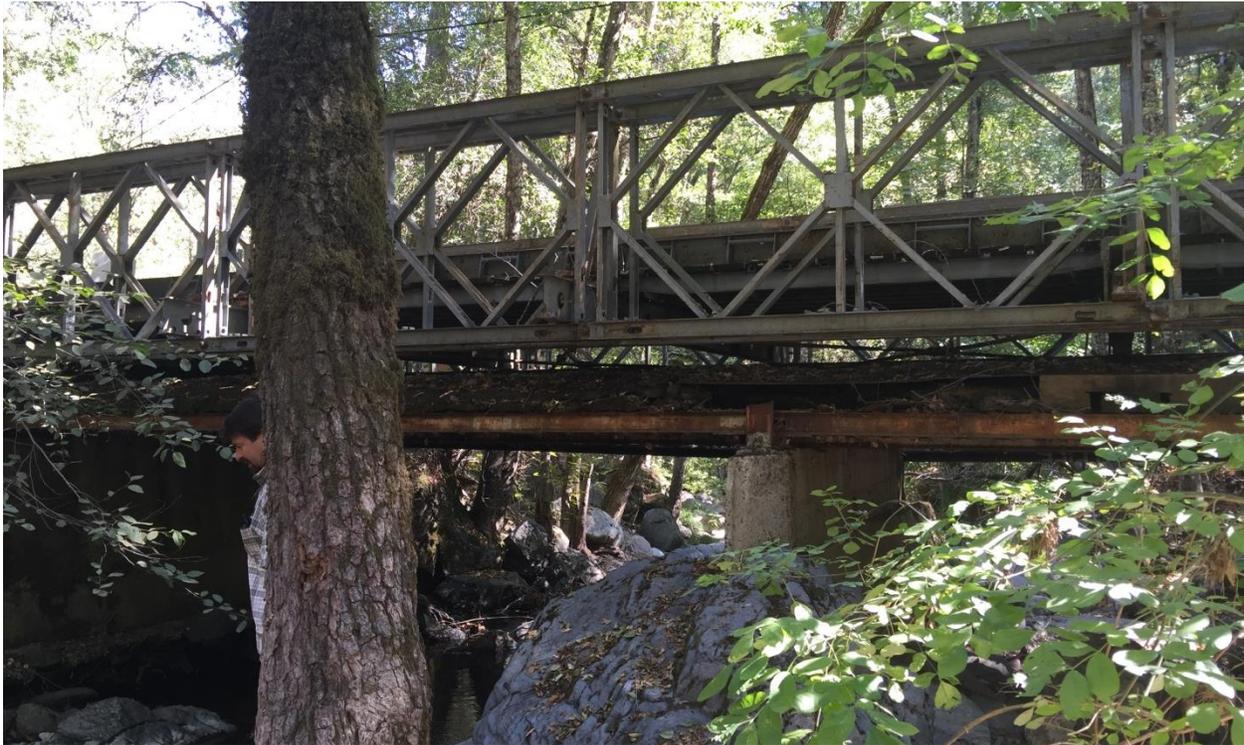
## Site 102

This site is a bridge located at Foard Road (38.77438' N, 122.68942' W). The bridge is located over Anderson Creek. Anderson Creek is a perennial fish bearing stream in the Putah Creek watershed. Habitat type at this site is mixed-riparian. The bridge has a center pier that is located in the center of the channel. The threat to existing infrastructure is debris-laden flow and debris flowing down Anderson Creek, piling on bridge and flooding nearby homes or damaging the bridge.

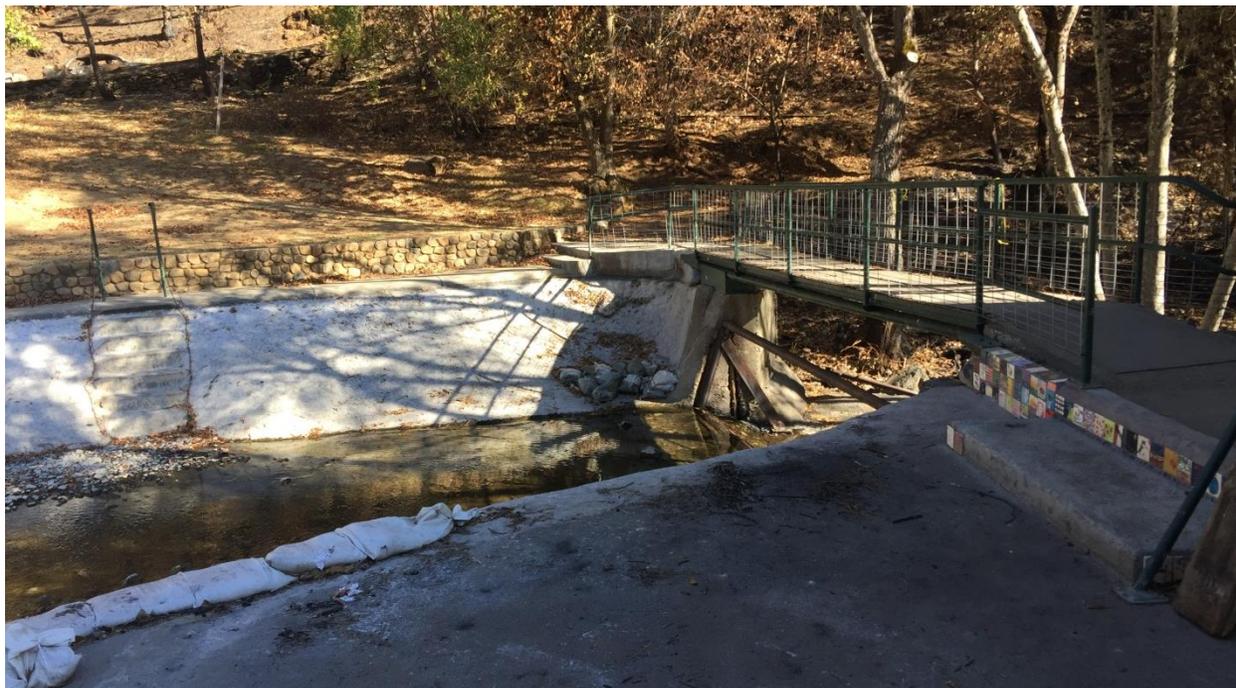
## Site 104

This site is a local recreation facility located on Rose Anderson Road (38.77469' N, 122.69970' W). Property is located along the Anderson Creek channel. Anderson Creek is a perennial fish bearing stream in the Putah Creek watershed. The habitat type at this site is mixed-riparian. The facility includes a roughly four foot high board and concrete dam structure used to create a swimming pond in Anderson Creek. The concrete structures create a roughly four-foot drop downstream, creating a barrier for some fish species. The threat to existing infrastructure is debris flow piling up on dam structures and flooding and damaging nearby facilities.

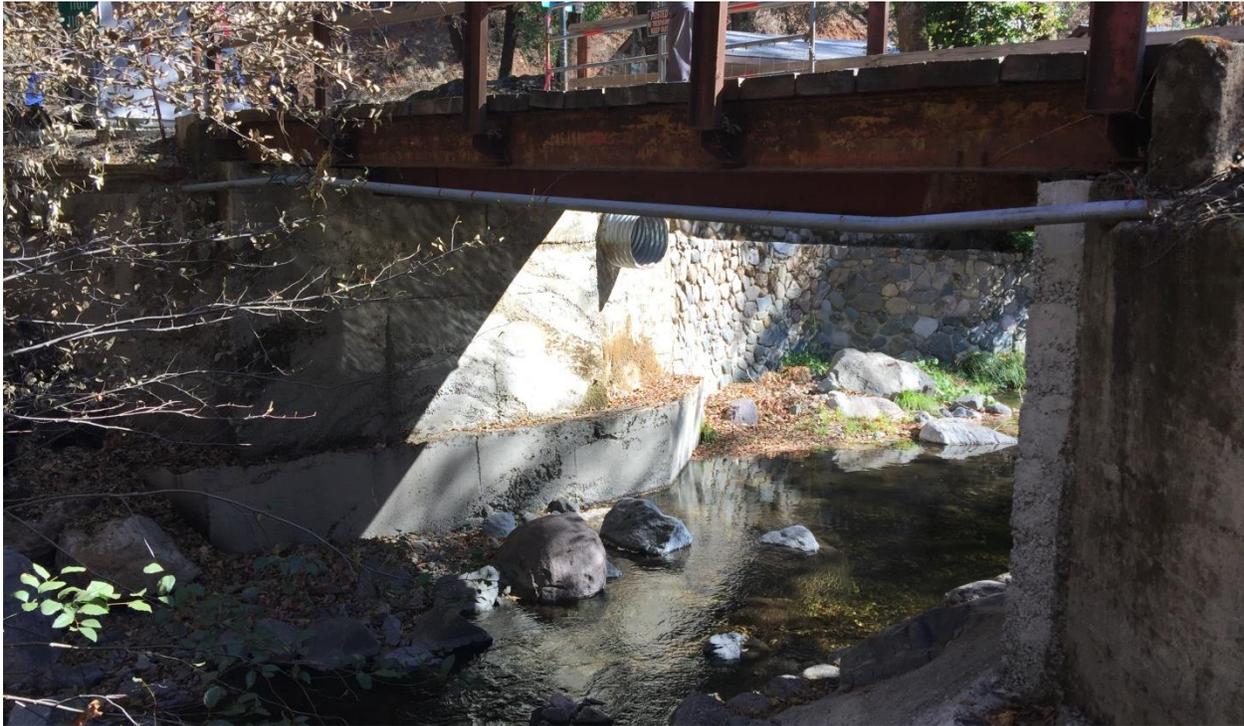
## Site 106

This site is a bridge located at Van Dorn Reservoir Road (38.77623' N, 122.70312' W). The bridge is located over Anderson Creek. Anderson Creek is a perennial fish bearing stream, in the Putah Creek watershed. Habitat type at this site is mixed-riparian. The threat to existing infrastructure is debris-laden flow down Anderson Creek piling up on the bridge, causing damage to the bridge or flooding nearby homes.

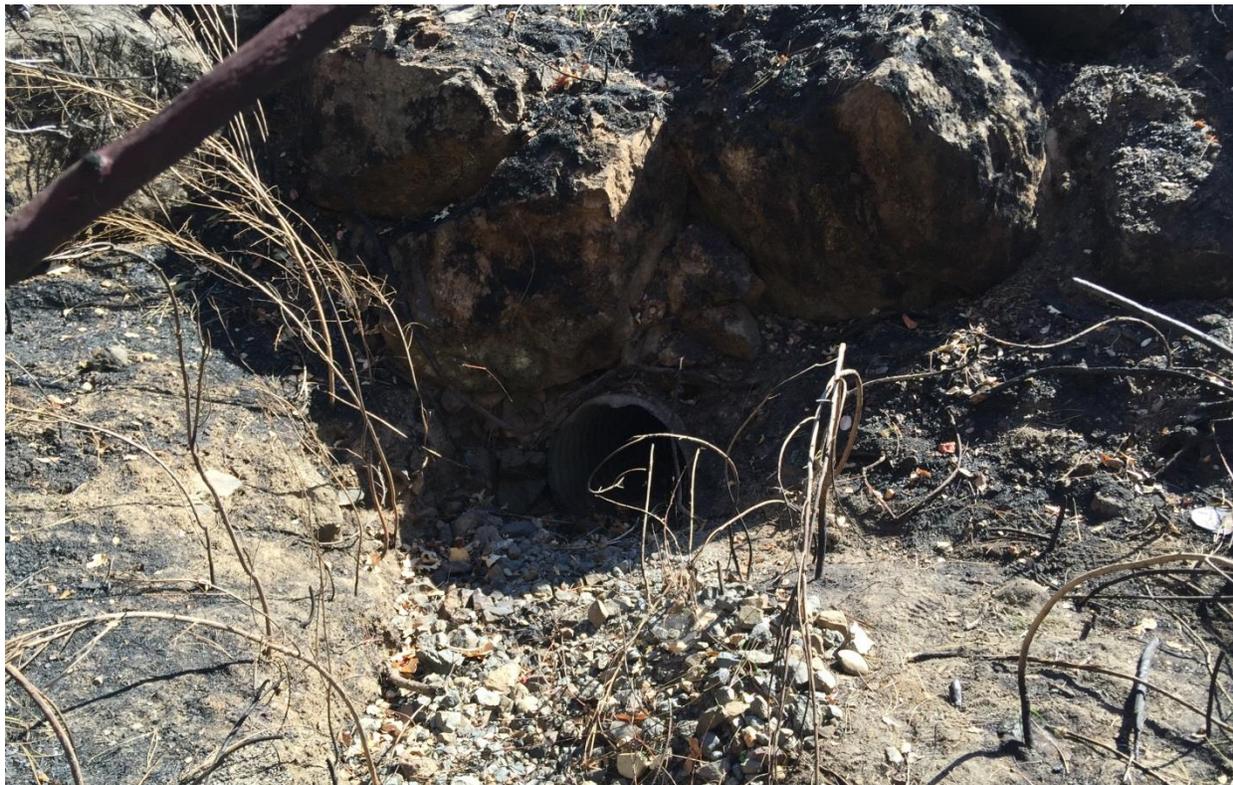
## Site 107

This site is a 24-inch culvert on Anderson Springs Road (38.77684' N, 122.68563' W). The culvert is on a tributary to Anderson Creek. The tributary is a seasonally dry channel while Anderson Creek is a Perennial fish bearing stream, in the Putah Creek watershed. Habitat type at this site is mixed-riparian. The culvert is in a high burn area and looks to be very susceptible to plugging, and the culvert may be undersized for expected high flows. Plugging of this culvert will flood the road, forcing water onto property on opposite side. The threat is debris-laden flow piling up at the culverts and flooding onto road and home.

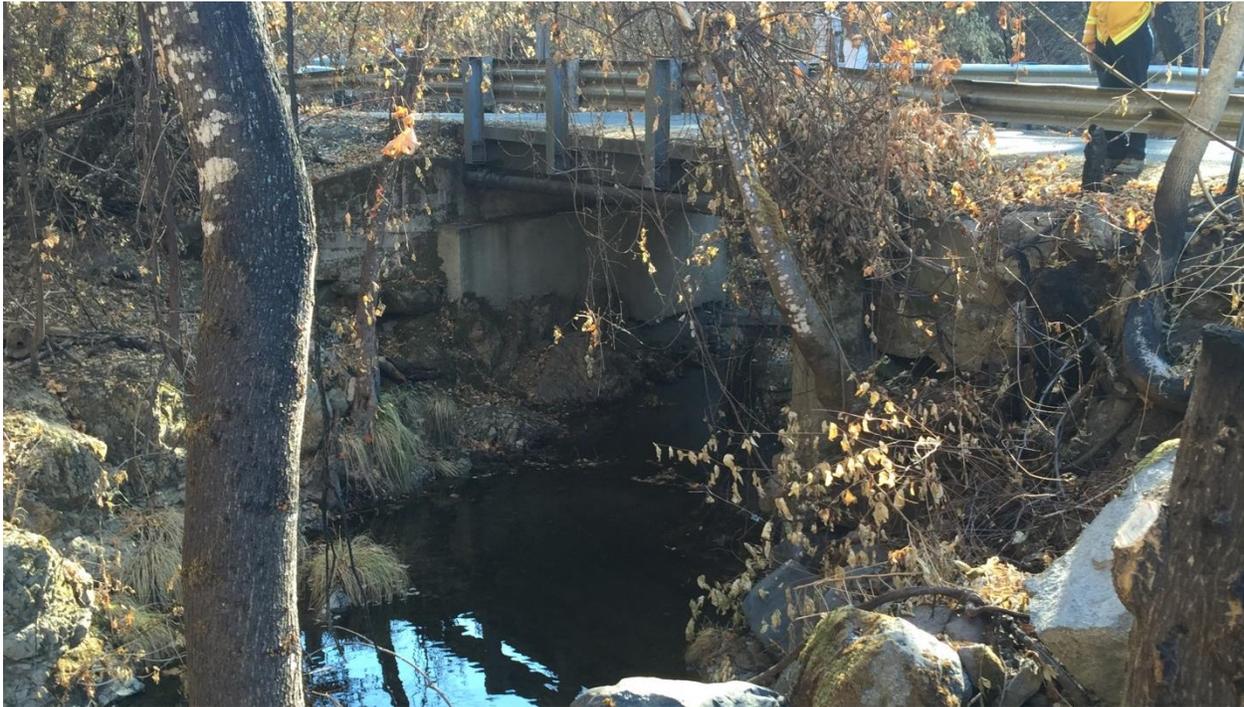
## Site 110

This site is a bridge located at Anderson Springs Road (38.77432' N, 122.69274' W). The bridge is located over the Anderson Creek channel. Anderson Creek is a perennial fish bearing stream in the Putah Creek watershed. Habitat type at this site is mixed-riparian. The threat to existing infrastructure is debris-laden flow down Anderson Creek, causing debris pileup and flooding.

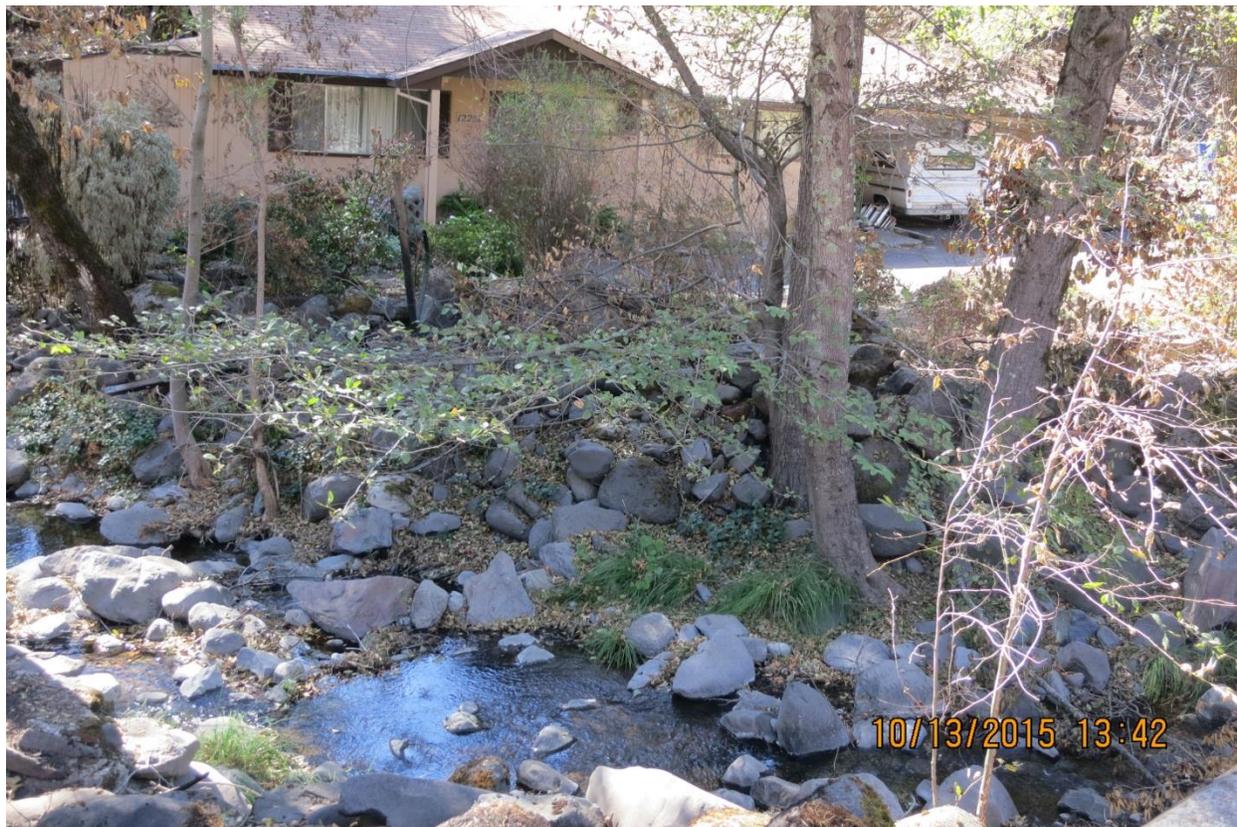
## Site 111

This site is a bridge located upstream of a single family dwelling on Anderson Springs Road (38.77813' N, 122.68079' W). The bridge is located over the Anderson Creek channel. Anderson Creek is a perennial fish bearing stream in the Putah Creek watershed. The habitat type at this work site is mixed-riparian. The threat to existing infrastructure is debris-laden flow down Anderson Creek, causing debris pileup and flooding.

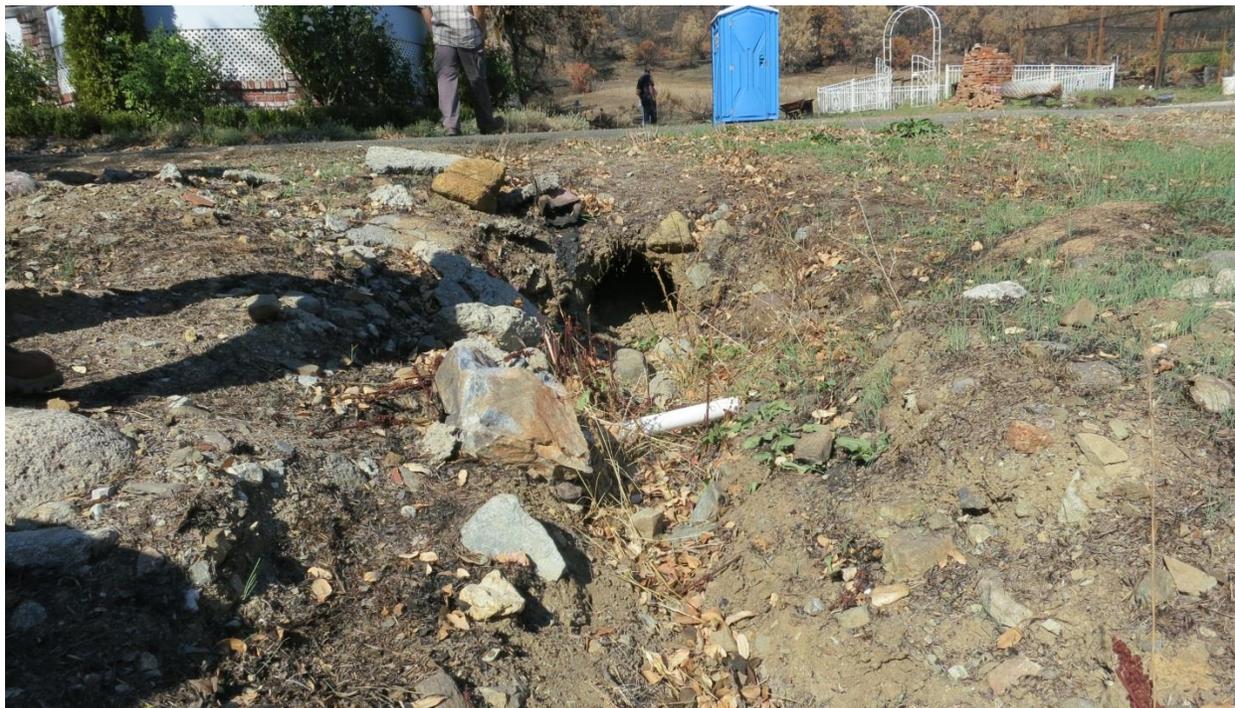
## Site 112

This site is a culvert at a private residence north of Highway 175 (38.77775' N, 122.67647' W). The culvert is located on a swale run-off to Putah Creek. The swale run-off is seasonally dry. The habitat type at this work site is grassland. The plastic culvert melted during the fire event and is no longer functional. The threat is flooding to the home and associated outbuildings.

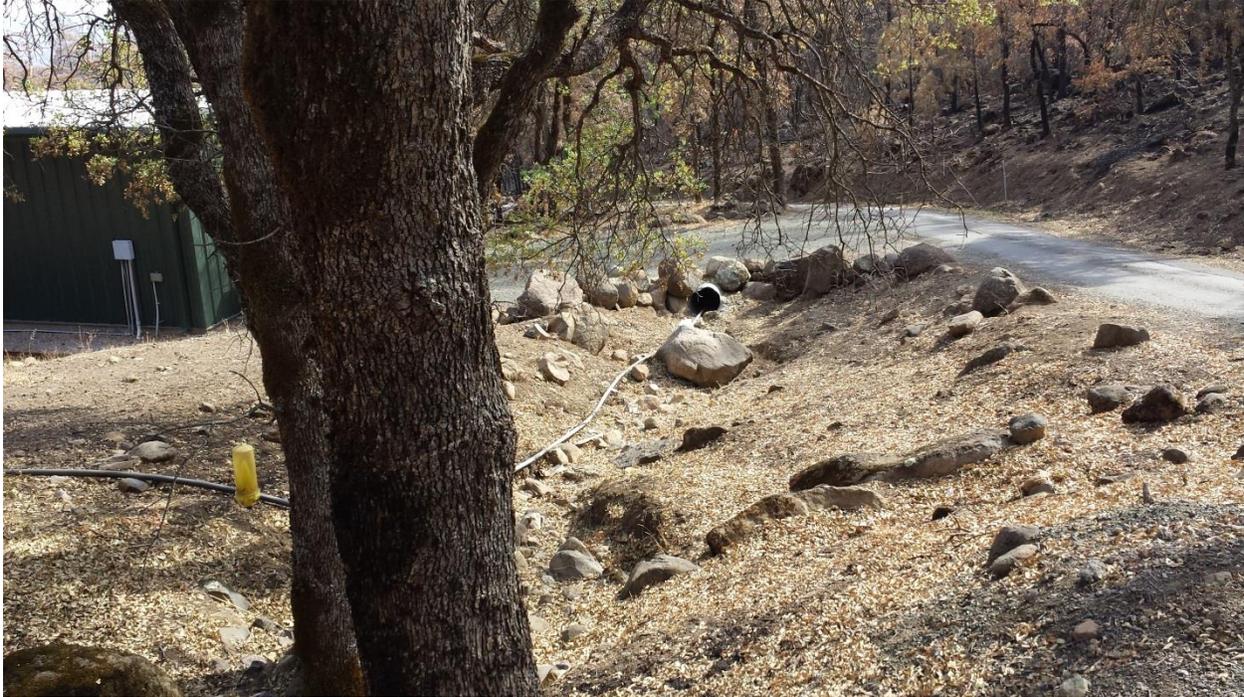
## Site 114

This site is a water tank and water treatment facility located on a private road west of Harbin Springs Road (38.79453' N, 122.66614' W). The water tank and water treatment facility are located next to a swale run-off north of Harbin Creek. The run-off is seasonally dry. The habitat type at this site is oak woodland. The threat to existing infrastructure is debris-laden flooding and debris flow down Harbin Creek.

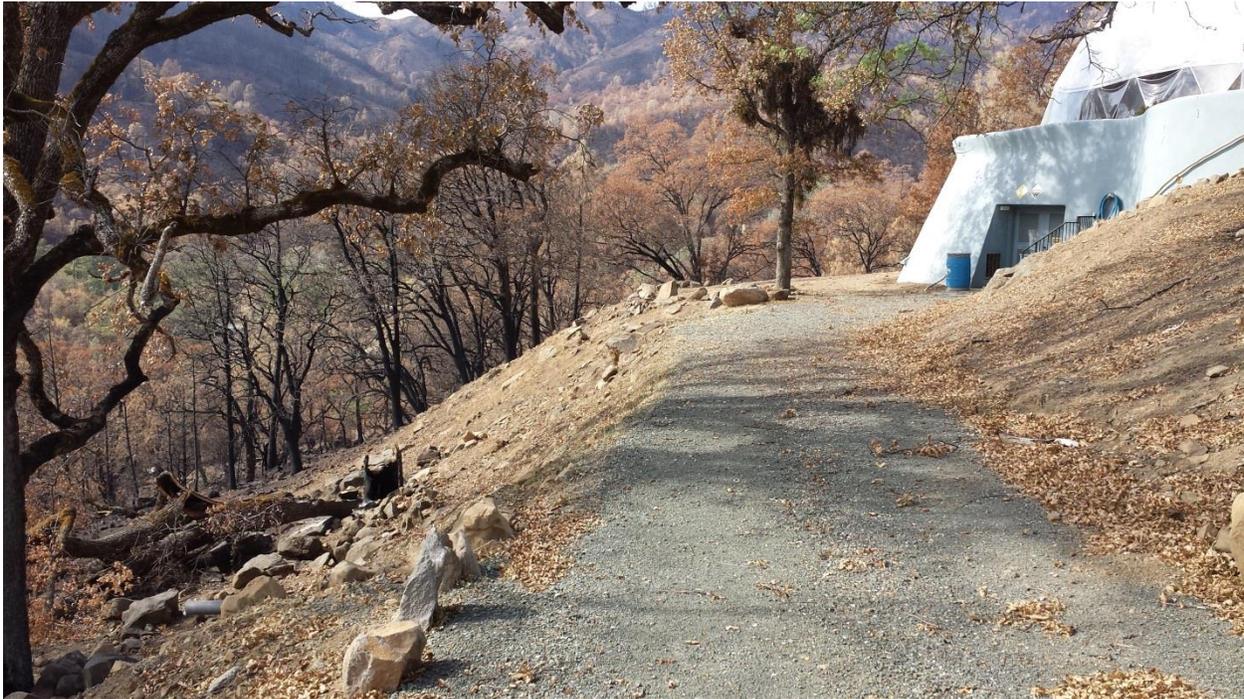
## Site 115

This site is a recreation facility located on a private road east of Harbin Springs Road (38.79110' N, 122.65312' W). The recreation facility is located uphill on the east side of Harbin Creek. Harbin Creek is a seasonally dry channel in the Putah Creek watershed. The habitat type is oak woodland. The threat to existing infrastructure is debris flow and run-off down the hill flooding the facility.

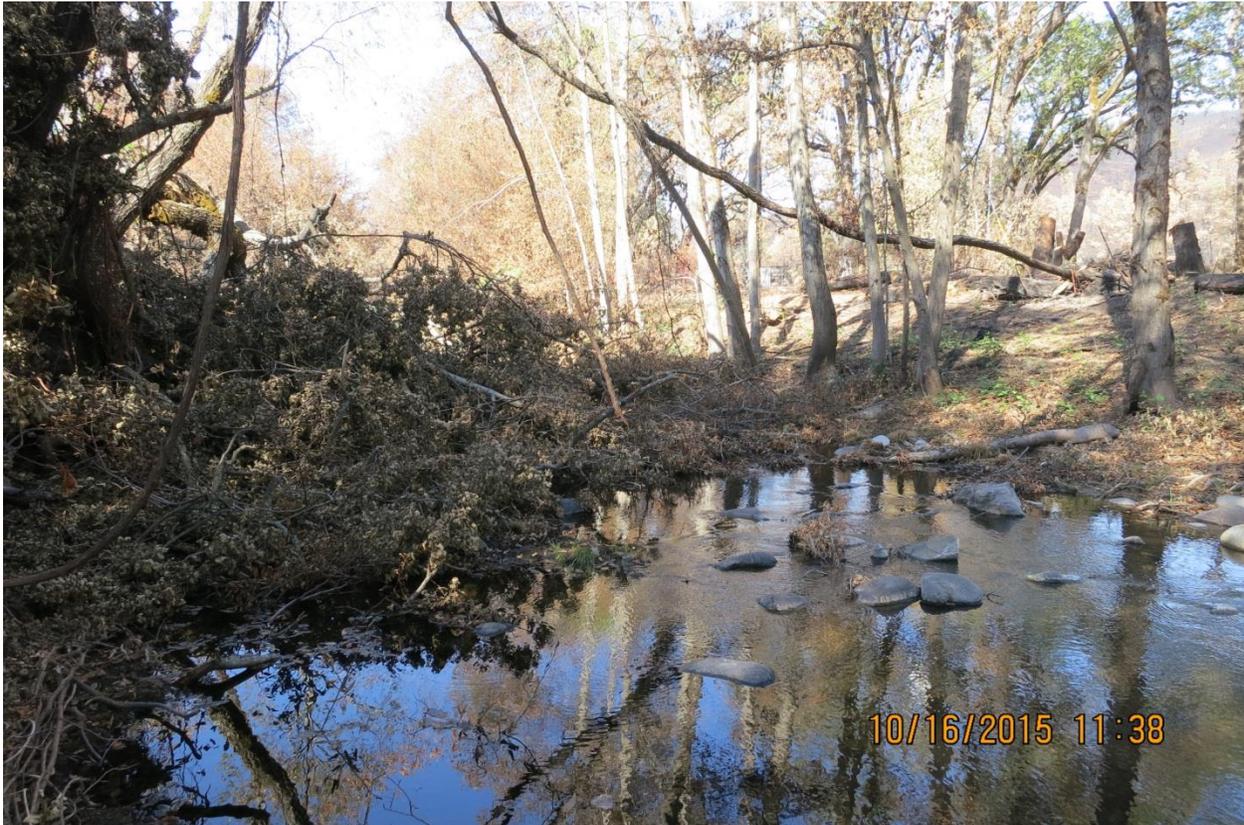
**Site 118**

This site is a bridge located at Highway 175 (38.77223' N, 122.66386' W). The bridge is located over the Putah Creek channel. Putah Creek is a perennial fish bearing stream. The habitat type at this site is oak woodland. There is a large oak tree in the Putah Creek channel downstream of the bridge. The oak tree is located 30 yards northwest of mile post marker 25.06. The threat to existing infrastructure is debris-laden flooding and debris flow down Putah Creek piling on the tree and flooding the road.

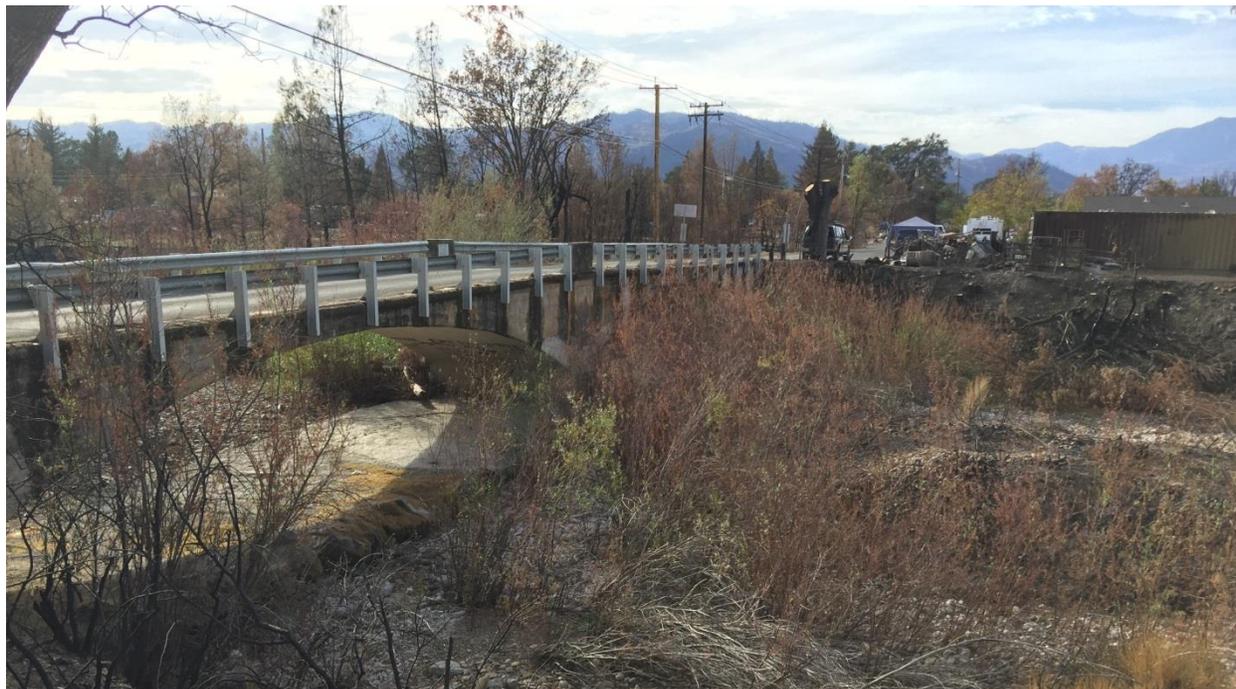
## Site 120

This site is a bridge located at Wardlaw Street in Middletown (38.75372' N, 122.61069' W). The bridge is located over the Saint Helena Creek channel. Saint Helena Creek is a seasonally dry channel, in the Putah Creek watershed. The habitat type is oak woodland. Saint Helena Creek is a seasonally dry channel. The bridge has a center support mid-channel. The threat to existing infrastructure is debris-laden flow down Saint Helena Creek piling up on the bridge support and causing damage to the bridge or flooding of local homes.

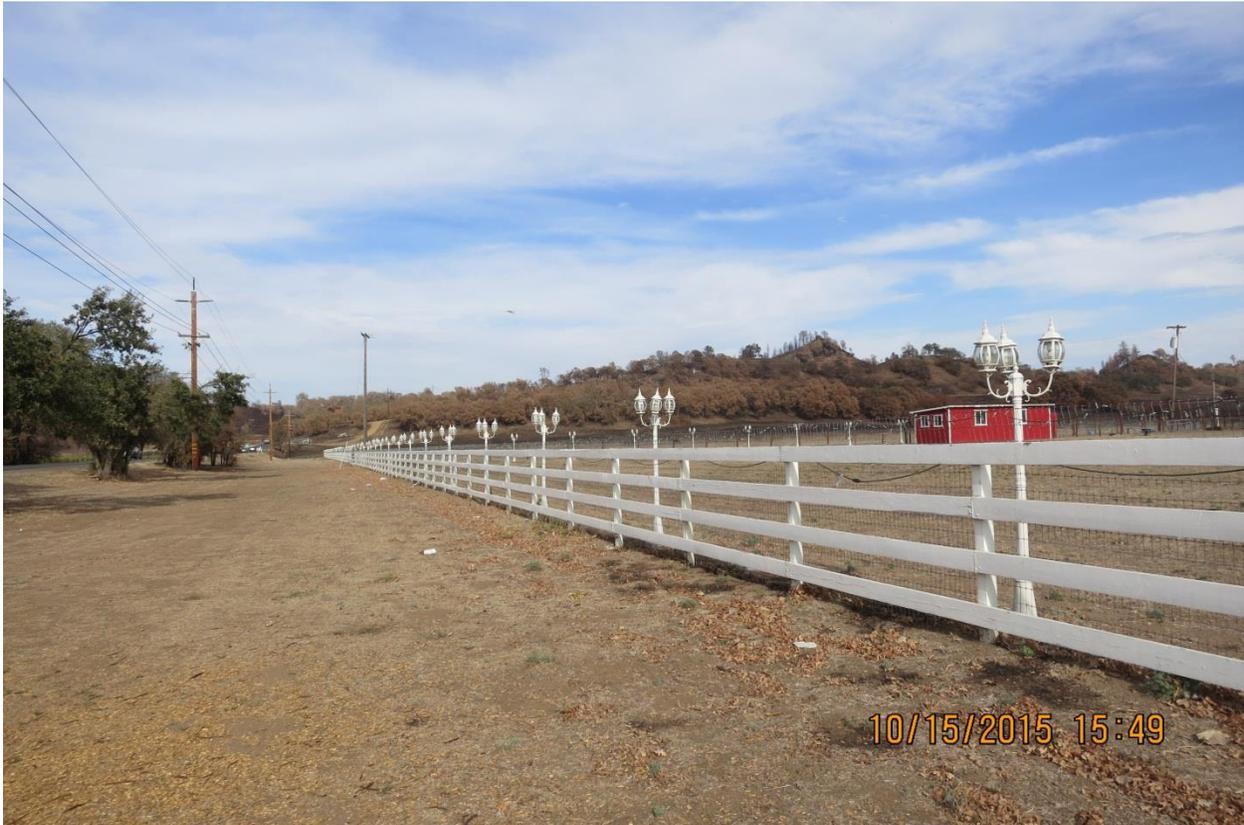
**Site 122**

This site is a single family dwelling located on Highway 29 in Middletown (38.7581' N, 122.60319' W). The house is at the confluence of Putah Creek and Saint Helena Creek. Saint Helena Creek is seasonally dry while Putah Creek is a perennial fish bearing stream. The habitat type at this site is oak woodland. The threat is debris laden flooding to the house.

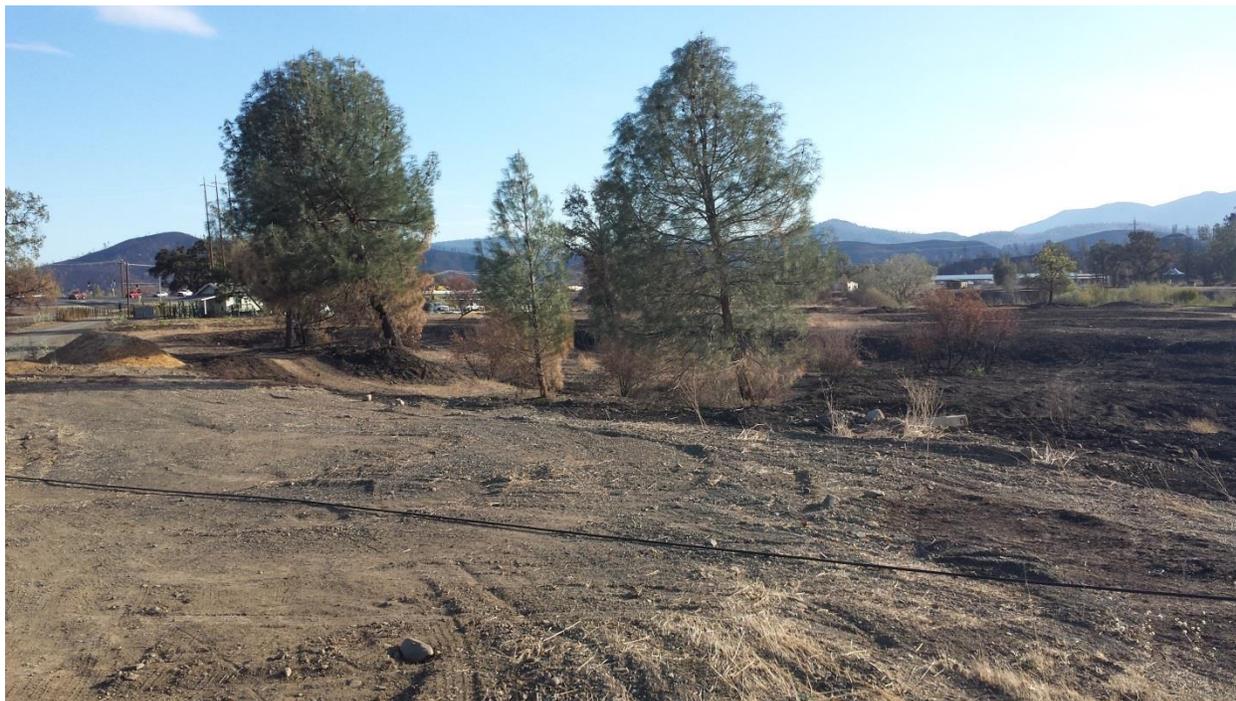
## Site 123

This site is a single family home located on Highway 29 (38.79333' N, 122.56658' W). The house is located at the confluence of an unnamed tributary and Putah Creek. The unnamed tributary is a seasonally dry channel while Putah Creek is a perennial fish bearing stream. Habitat type at this site is predominantly grassland. The threat to existing infrastructure is debris-laden flooding and debris flow down Putah Creek rising to an elevation that will impact the home.

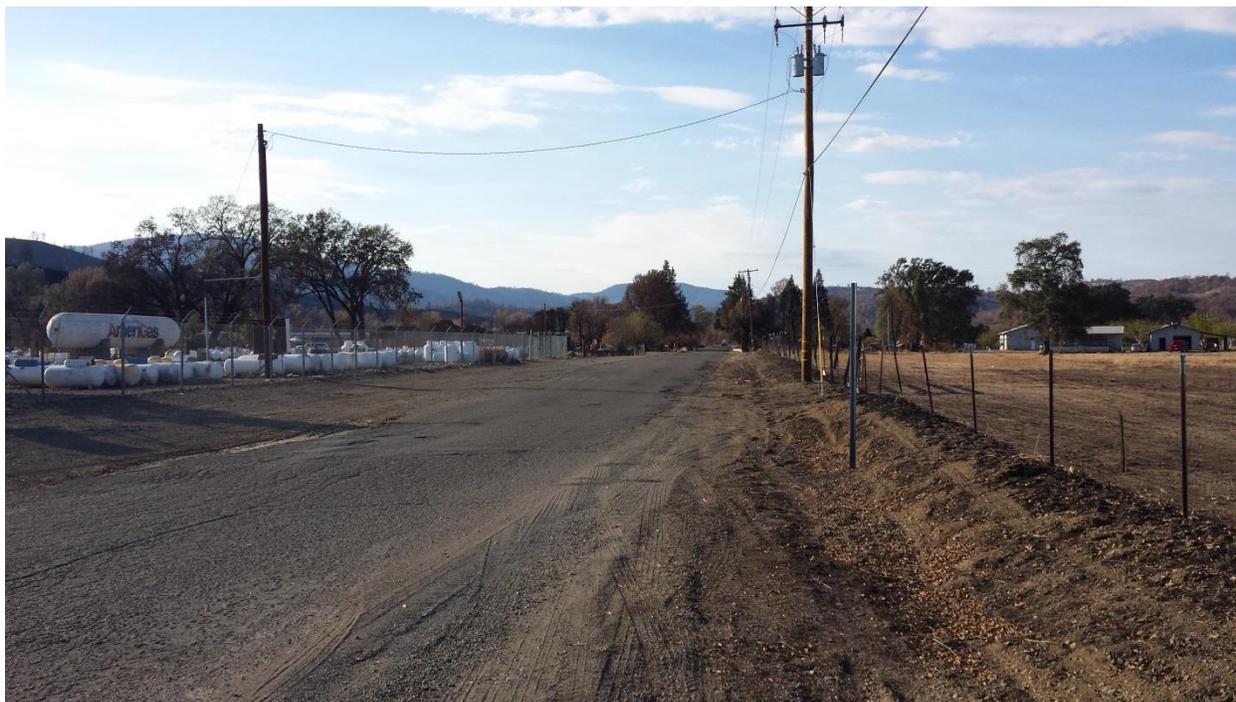
## Site 124

This site is four family homes and three businesses located on Spruce Road between the two way points 38.7985' N, 122.57366' W and 38.79516' N, 122.56831 W. The homes and businesses are located along Putah Creek. Putah Creek is a perennial fish bearing stream. Habitat type at this site is grassland and valley oak woodland. The threat to existing infrastructure is debris-laden flooding and debris flow down Putah Creek rising to an elevation that will impact the homes.

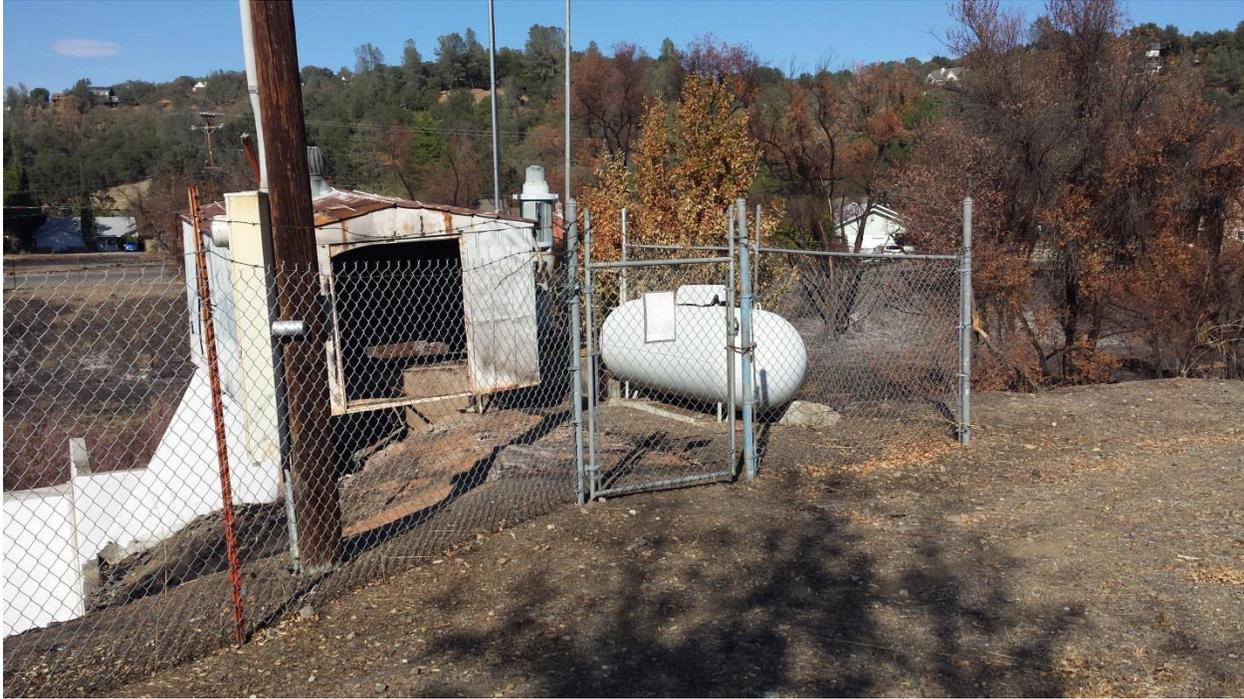
## Site 125

This site is a pump station located on the Putah Creek levee near Gold Flat Court (38.78448' N, 122.54229' W). The pump station is located along the north side of Putah Creek. Putah Creek is a perennial fish bearing stream. Habitat type is grassland and sparse riparian vegetation. The threat to existing infrastructure is debris-laden flooding and debris flow down Putah Creek rising to an elevation that will impact the homes nearby. The pump is used to drain subdivision runoff from behind the levee into Putah Creek. The pump is burned and is inoperable which increases risk of flooding of homes.

Replace Pump.

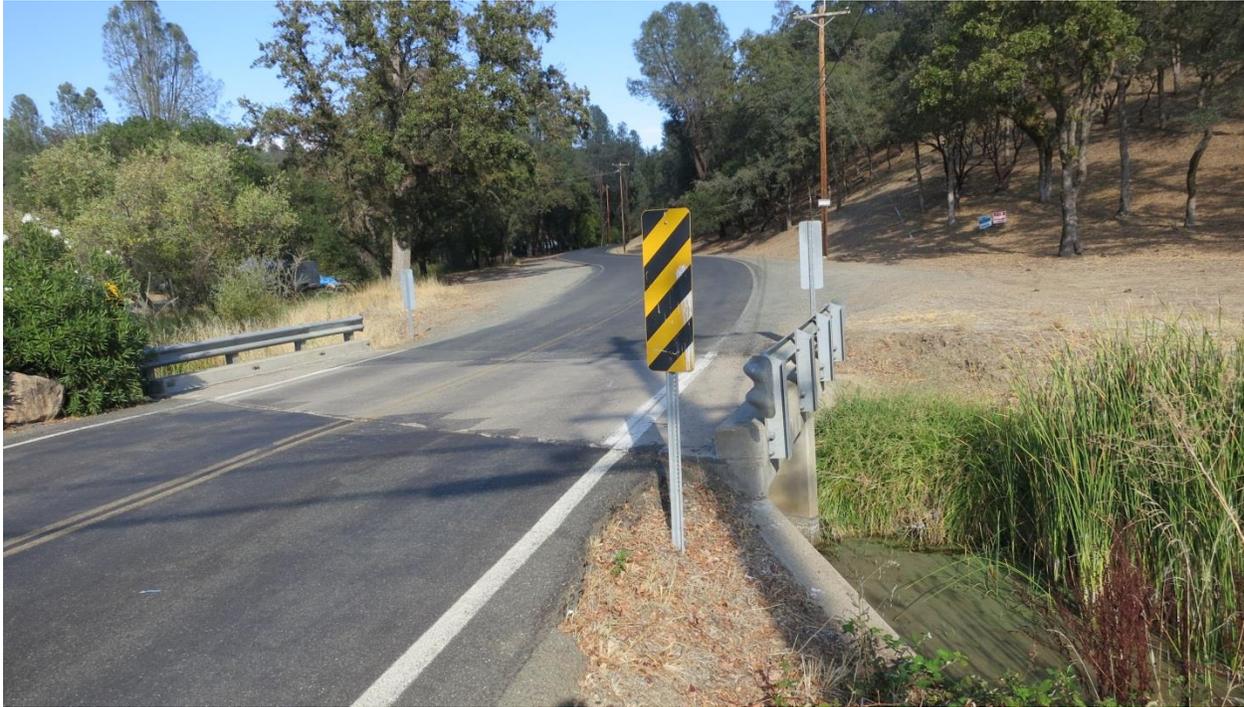
## Site 126

This site is a bridge located on Hartmann Road (38.80014' N, 122.54394' W). The bridge is located southwest of Site 127 on Gallagher Creek, a tributary to Coyote Creek, in the Putah Creek watershed. The habitat type at this site is emergent vegetation (tules and cattail). Pondered water was present at the time of site review. The creek may experience higher than average flow events and debris laden flow. The threat is debris-laden flow piling up at the bridge and on in-channel vegetation flooding the campground, Hartmann Road, and surrounding buildings.

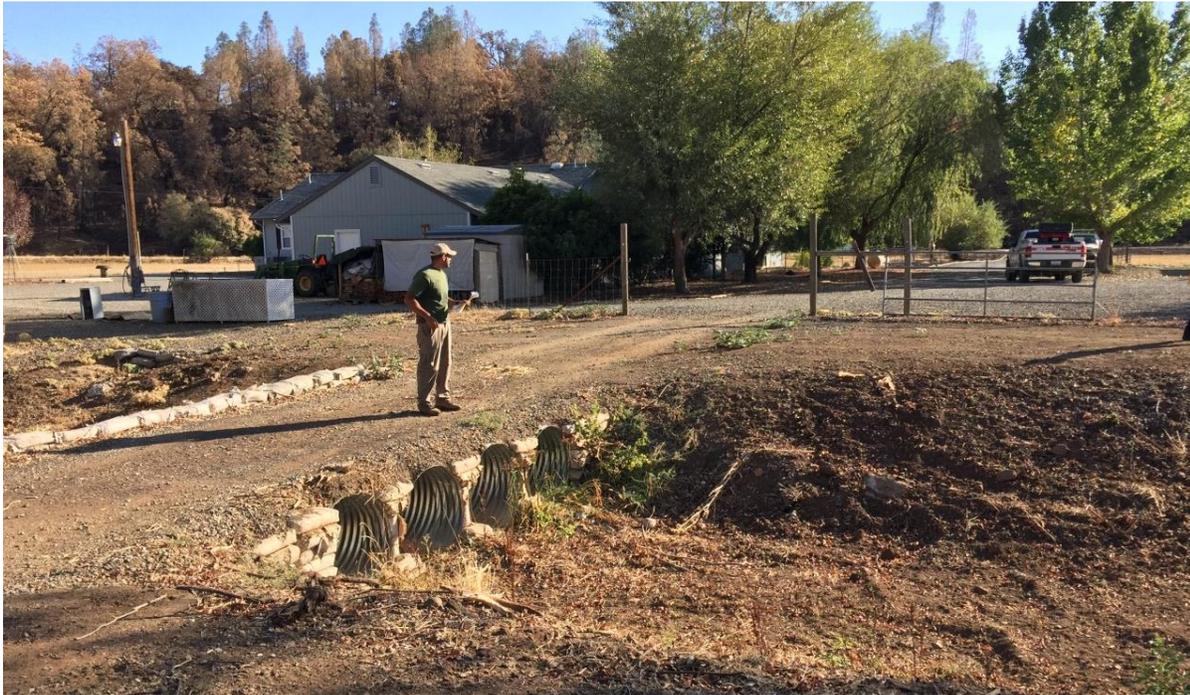
## Site 129

This site is two homes with outbuildings on Hartmann Road (38.80037' N, 122.54012' W). Gallagher Creek transects both properties. Gallagher Creek is a seasonally dry channel in the Putah Creek watershed. The habitat type at this site is oak woodland. There are two private drives with four 36-inch culverts crossing the creek. The threat to existing infrastructure is debris-laden flow piling up on culverts causing flooding and damaging facilities nearby.

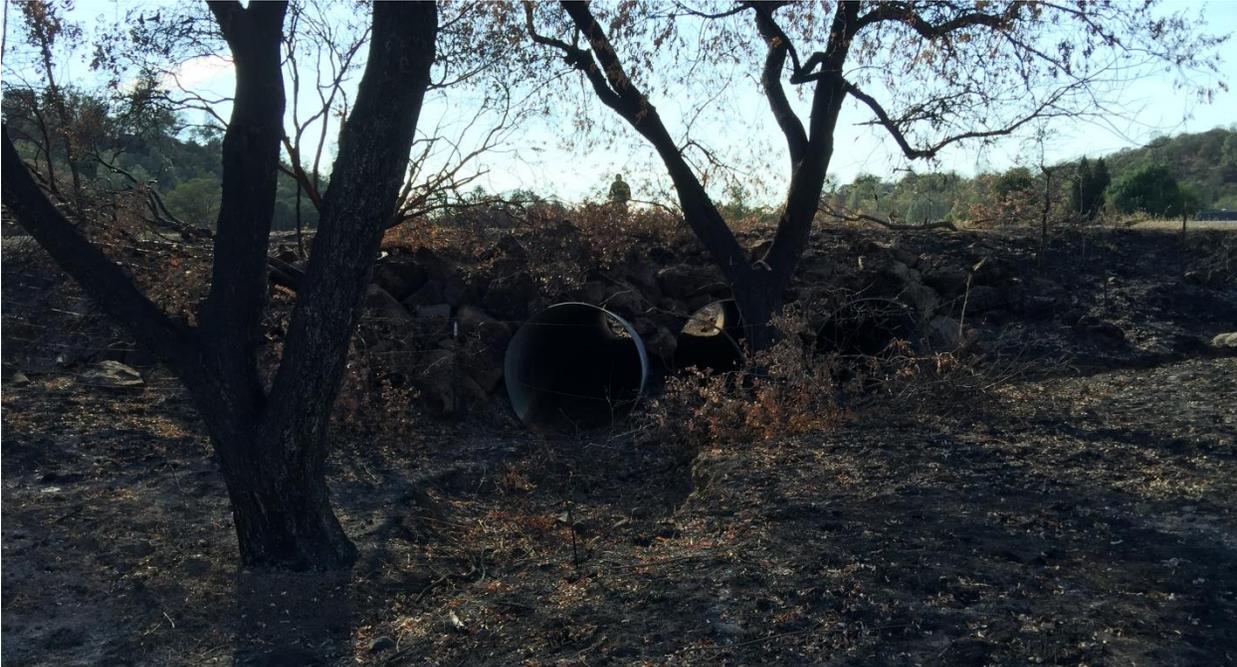
## Site 130

This site has three 60-inch culverts located on Stinson Road (38.80104' N, 122.54195' W). The culverts are located on Gallagher Creek. Gallagher Creek is a seasonally dry channel in the Putah Creek watershed. The habitat type at this site is oak woodland. The channel has several dead trees obstructing the culverts. The threat to existing infrastructure is debris-laden flow down Gallagher Creek piling up on the culverts and causing flooding of road and local homes.

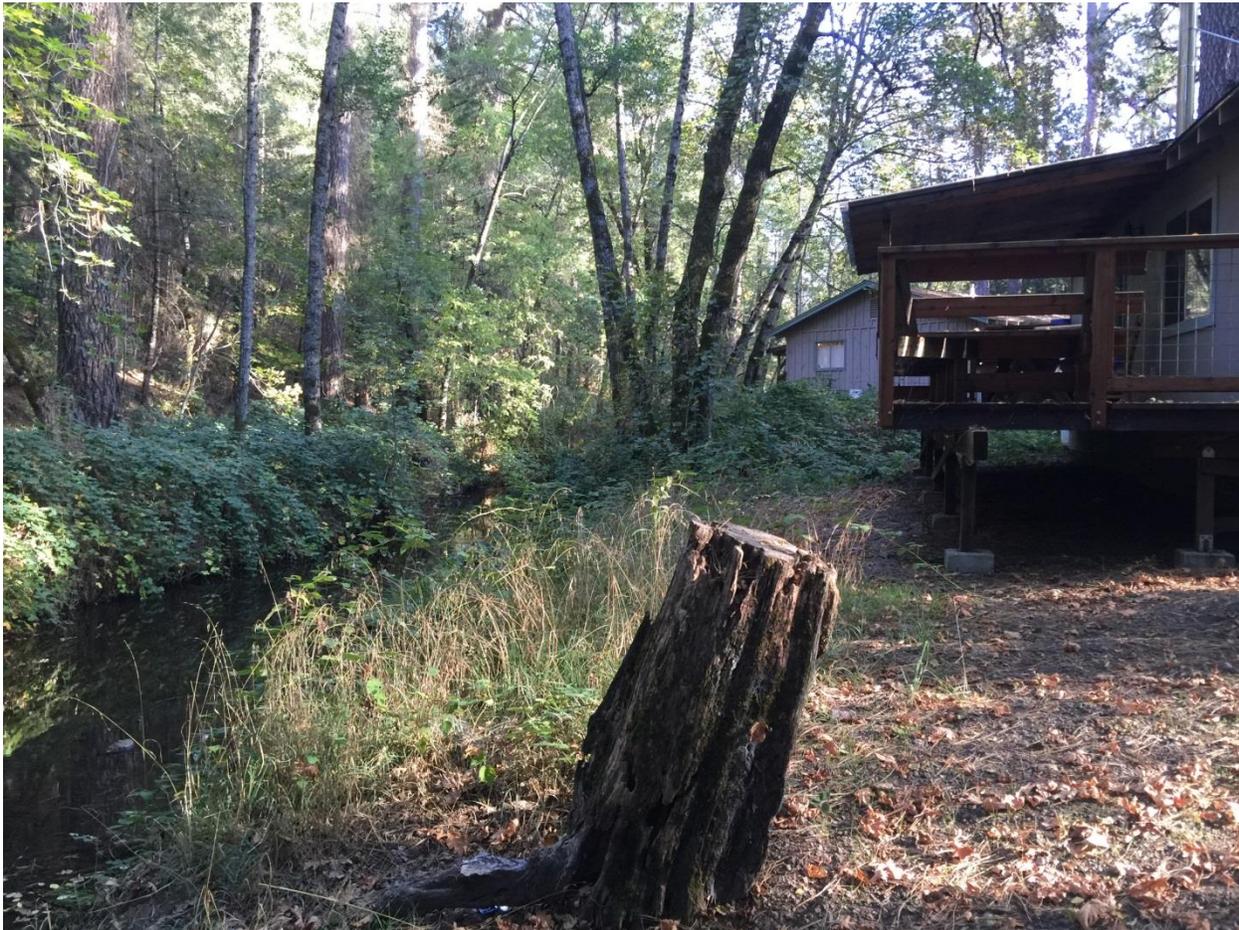
## Site 136

This site includes a campground and cabins on Bottle Rock Road (38.83104' N, 122.72789' W). The campground and cabins are on Kelsey Creek. Kelsey Creek is perennial fish bearing stream. Habitat type at this site is mixed-conifer. The threat is debris-laden flooding and debris flow down Kelsey Creek rising to an elevation that will impact the homes.

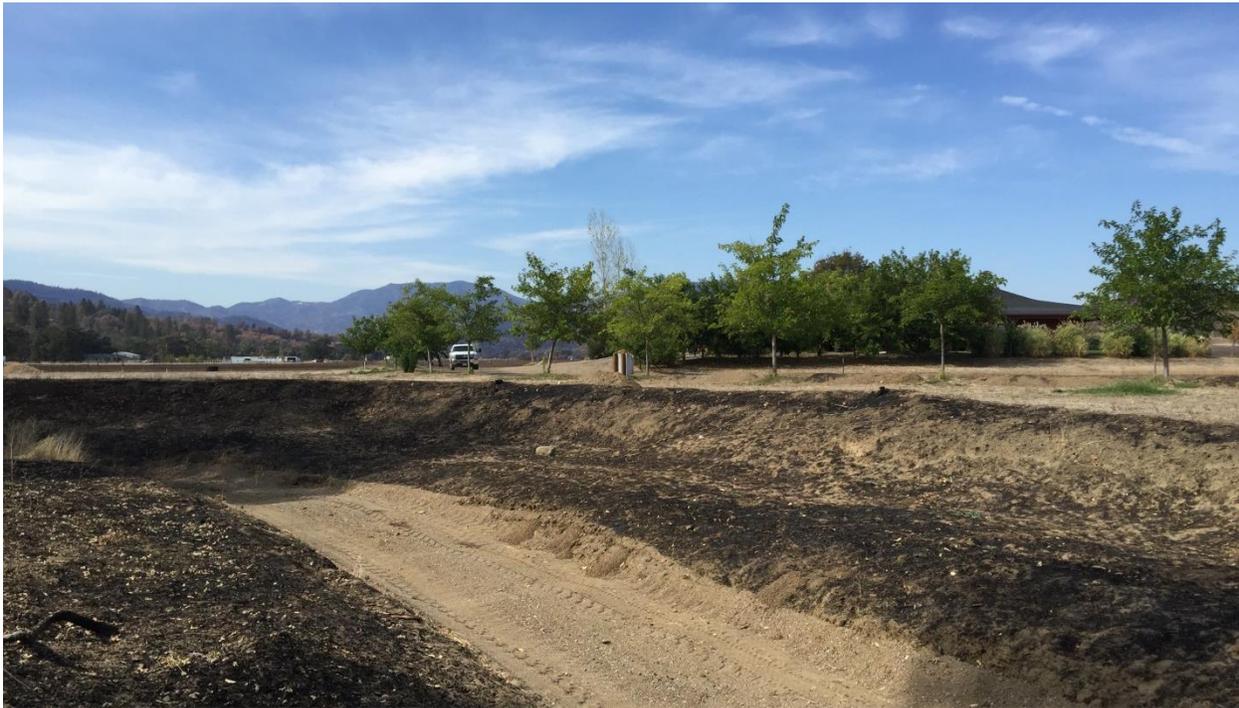
## Site 137

This site includes multiple single-family dwellings in an area on and between Loconomi Road and Eureka Road in the Long Valley area (38.74824' N, 122.57774' W). The homes are located along an unnamed tributary to Putah Creek. The tributary is a seasonally dry channel. Habitat type at this work site is oak woodland. The threat to existing infrastructure is debris-laden flooding and debris flow down the channel rising to an elevation that will impact the homes.
