# Valley Fire

State Post Fire Watershed Emergency Response Team  
Addendum I

Hazard Site Evaluation

October 2015

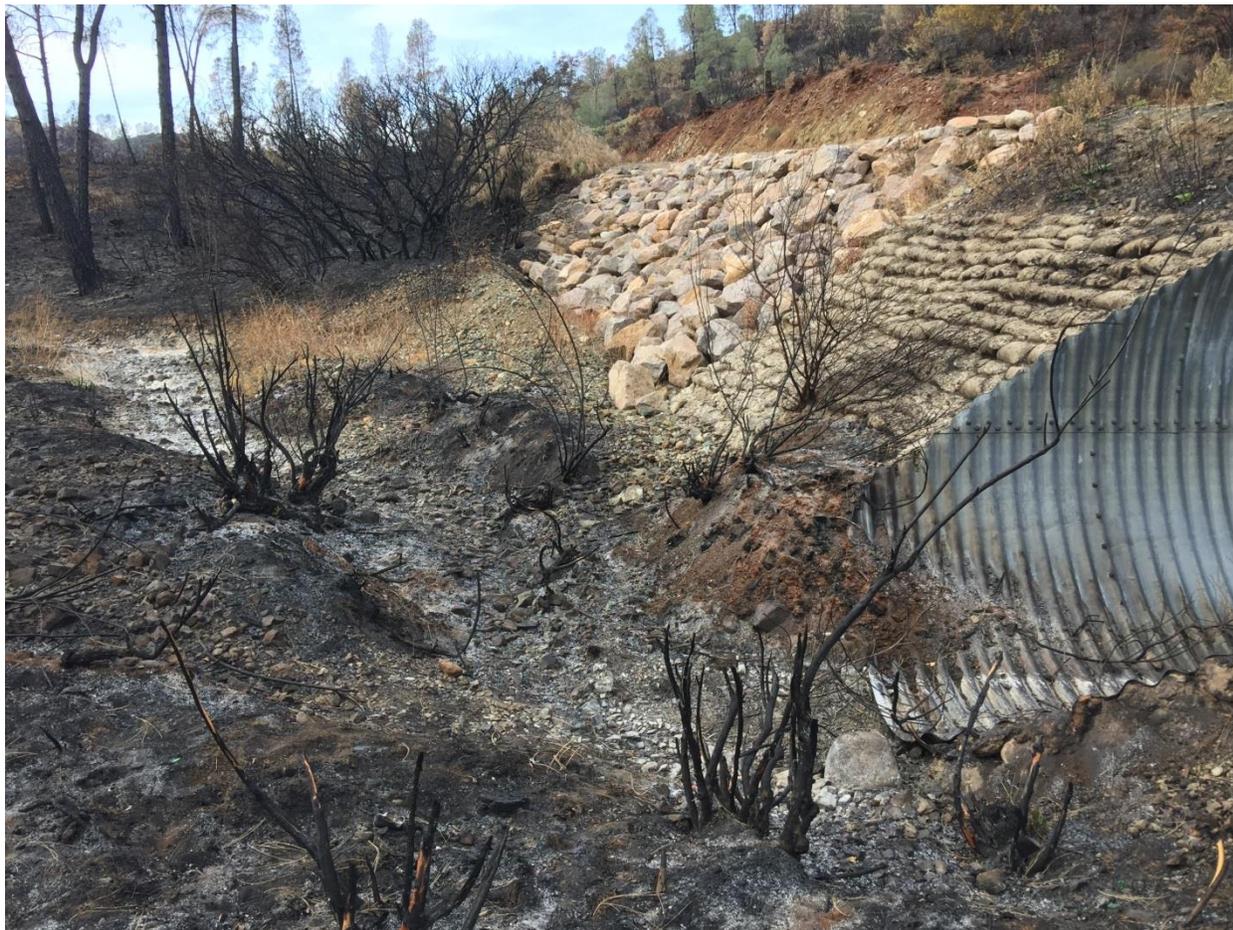
## Site 140

This site is a 12-foot culvert located on Butts Canyon Road (38.71024' N, 122.47591' W). The culvert is located on Butts Creek. Butts Creek is a seasonally dry channel in the Putah Creek watershed. Habitat type at this work site is oak woodland. The culvert is askew to the direction of the channel and is showing about 6-inches of scour below the inlet. The threat to existing infrastructure is debris-laden flooding and debris flow down Butts Creek rising to an elevation that will clog the culvert and the channel and causing flooding of Big Canyon Road.

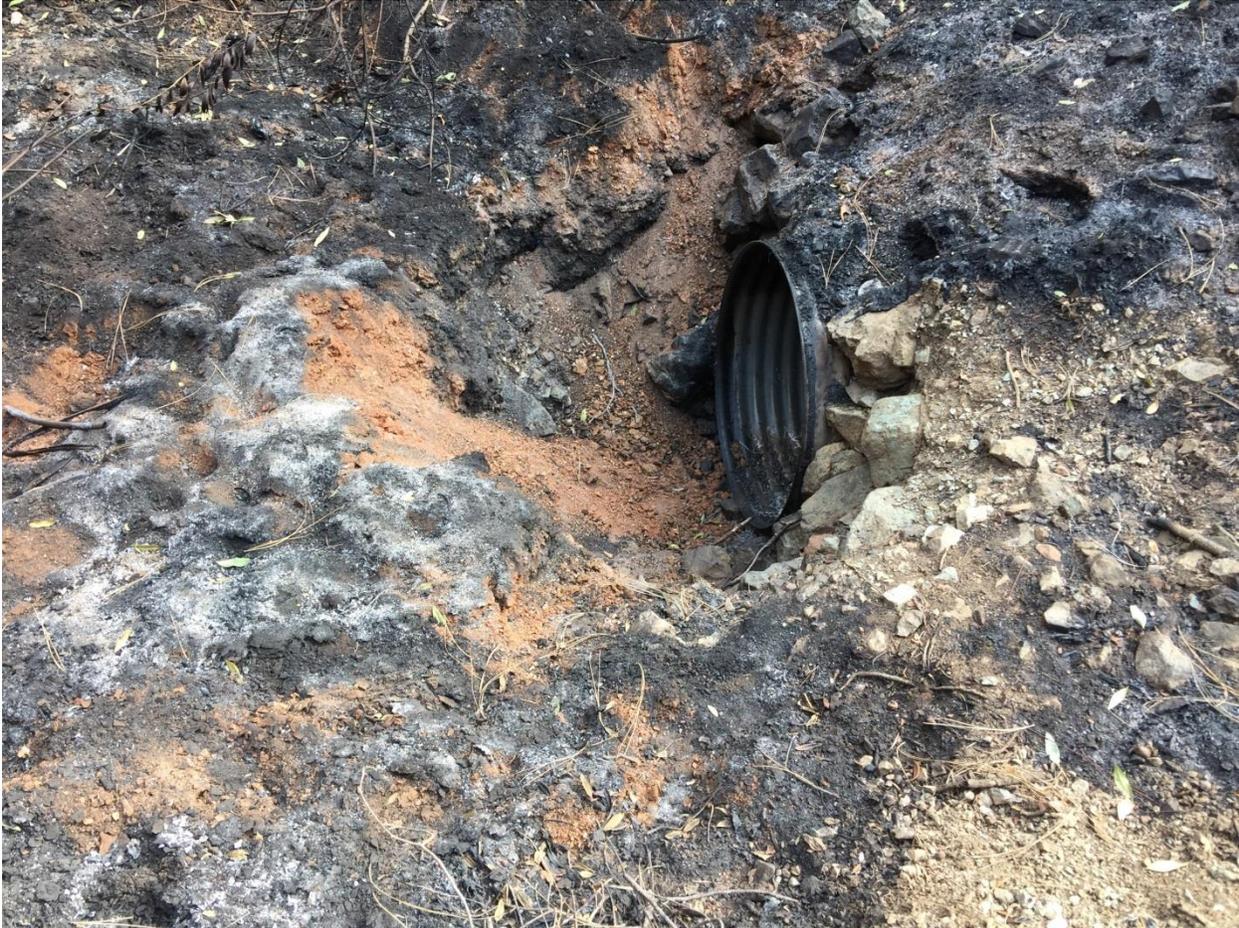
## Site 141

This site is an approximately 30-inch culvert on Butts Canyon Road (38.71401' N, 122.48257' W). The culvert is located in a drainage swale to Butts Creek. The drainage swale is seasonally dry and in the Putah Creek watershed. Habitat type at this site is oak woodland. The culvert is covered with up to 60-feet of fill. Inlet is below watercourse level. There is a high chance of plugging. The threat to existing infrastructure is debris-laden flow down the creek piling up on the culvert and causing flooding of road and nearby area.

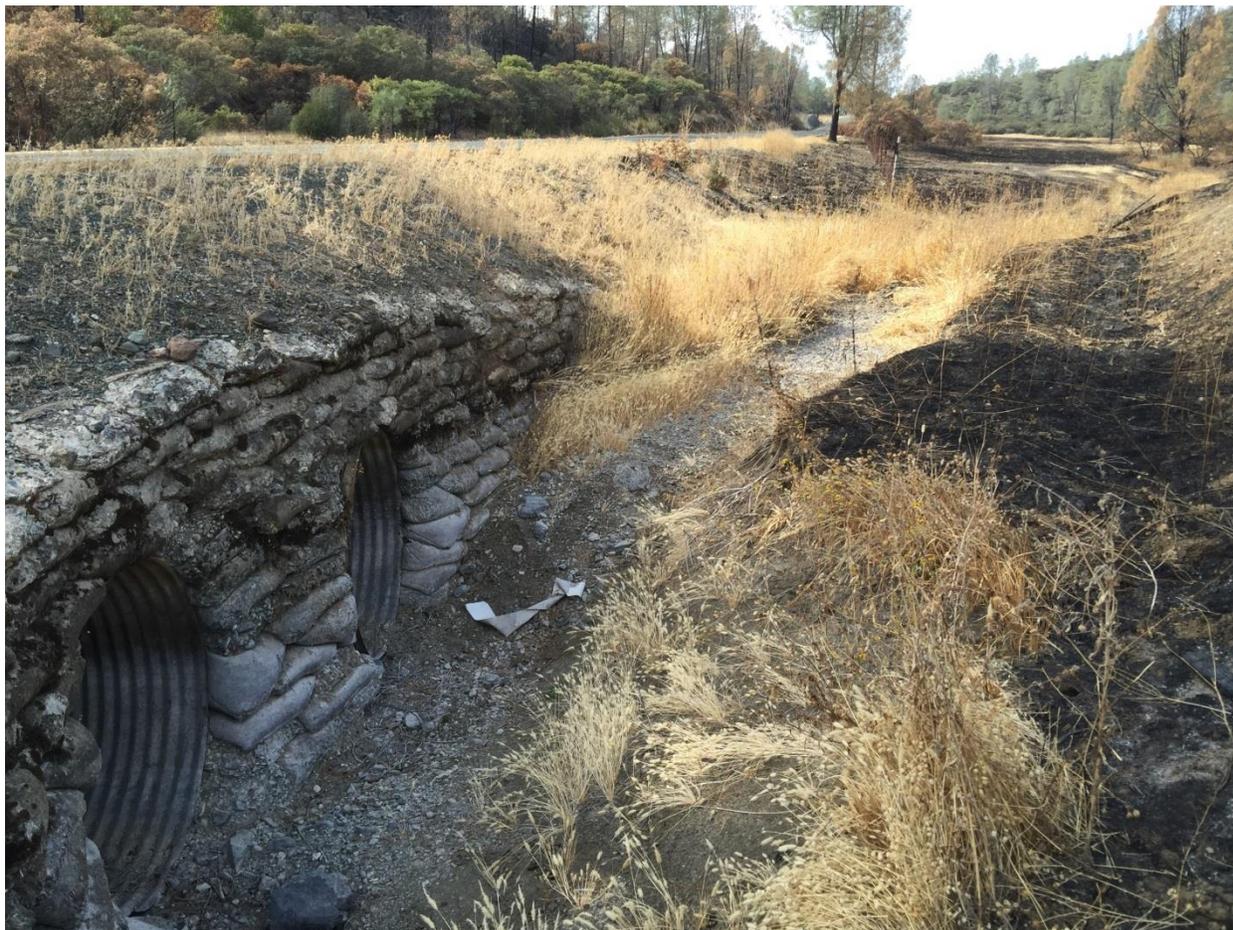
## Site 142

This site is two 48-inch culverts located on Butts Canyon Road (38.7178' N, 122.49262' W). The culverts are located on an unnamed tributary to Butts Creek. The tributary is a seasonally dry channel, in the Putah Creek watershed. Habitat type at this site is oak woodland. The unnamed tributary is seasonally dry. The outlets of the culverts are approximately 2.5 feet below the normal stream bed profile, increasing the risk of debris clogging the culverts. The threat is debris-laden flow piling up at the culverts and flooding onto the road.

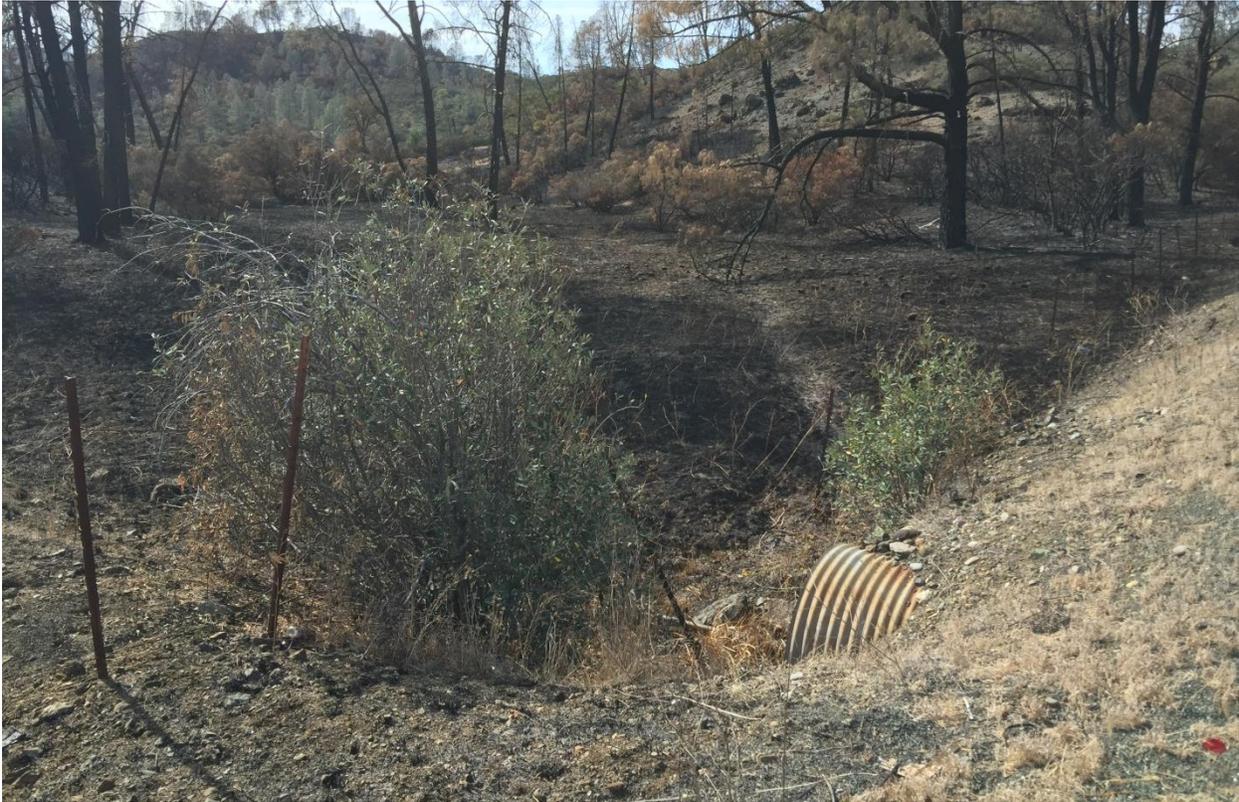
## Site 143

This site is a 48-inch culvert located on Butts Canyon Road (38.71824' N, 122.49591' W). The culvert is located on an unnamed tributary to Butts Creek. The tributary is a seasonally dry channel, in the Putah Creek watershed. Habitat type at this work site is oak woodland. The culvert is askew to the channel and has a barbed wire fence obstructing the inlet. The threat to existing infrastructure is debris-laden flow down the creek piling up on the fence and culvert and causing flooding of road and nearby area.

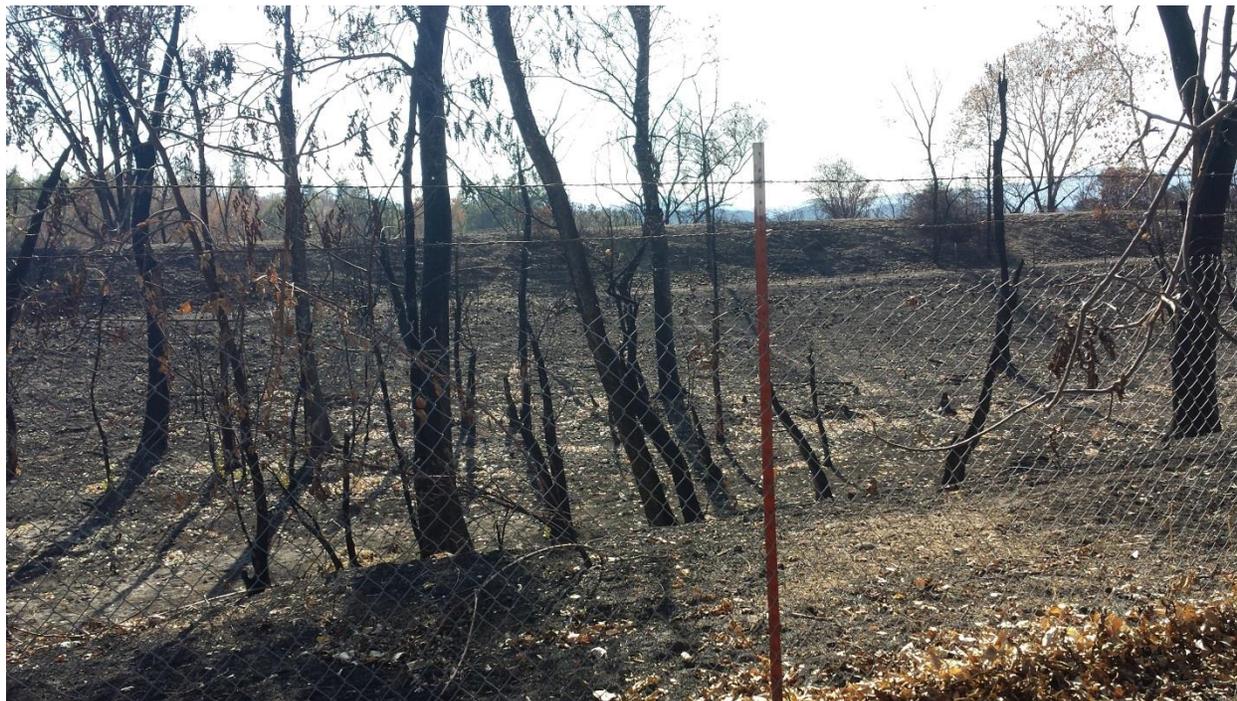
## Site 146

This site is a small neighborhood of single family homes located on Gold Flat Court, Oak Flat Road, Mountain Meadow Road, Horseshoe Court, Gooselake Court, Glencove Court, Magnolia Court, and Dove Court (38.78463' N, 122.53917' W). The neighborhood is located at the confluence of Coyote Creek and Putah Creek on the west end and along Putah Creek downstream. Coyote Creek is a seasonal dry creek while Putah Creek is a perennial fish bearing stream. Habitat type at this site is sparse riparian. The threat to existing infrastructure is debris-laden flooding and debris flow down Coyote Creek and Putah Creek rising to an elevation that will overtop the levee and impact the neighborhood.

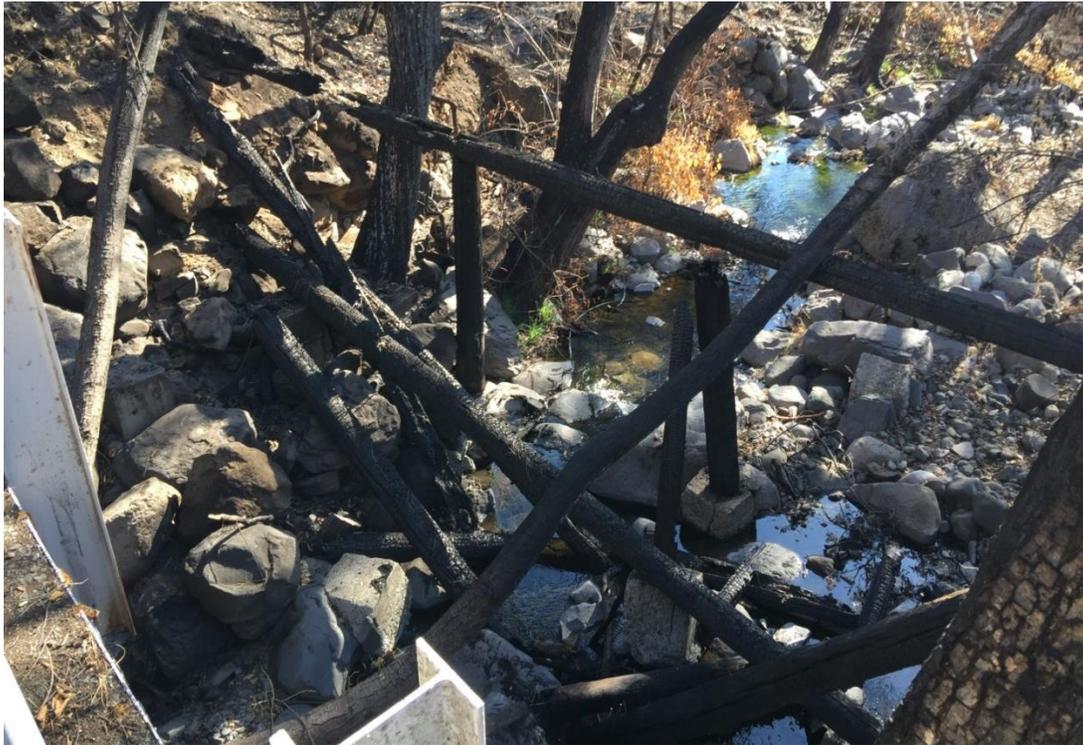
## Site 502

This site is a bridge located on Casa Grande Lane (38.78788' N, 122.69284' W). The bridge is located over the Putah Creek channel. Putah Creek is a perennial fish bearing stream. The habitat type at this site is oak woodland. There are legacy bridge pilings downstream of the bridge. The threat to existing infrastructure is debris-laden flooding and debris flow down Putah Creek catching on the legacy pilings.

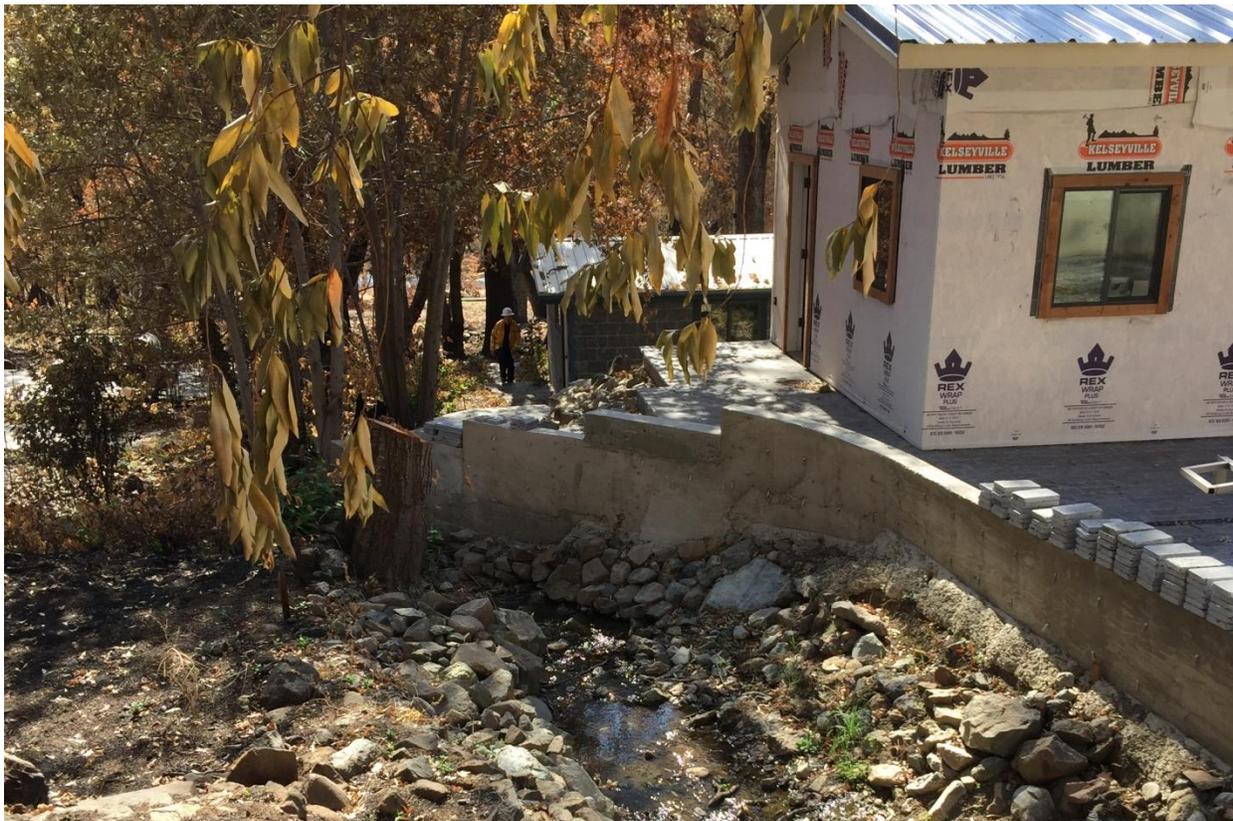
## Site 503

This site is a house under construction and a wine storage facility located on McKinley Drive (38.78438' N, 122.68629' W). The house is located along an unnamed tributary to Putah Creek. The tributary had water flowing at time of visit. Habitat at this site is oak woodland. Multiple structures are located adjacent to tributary, increasing the chance of debris clogging and local flooding. The threat to existing infrastructure is debris-laden flooding and debris flow down the creek rising to an elevation that will impact the home.

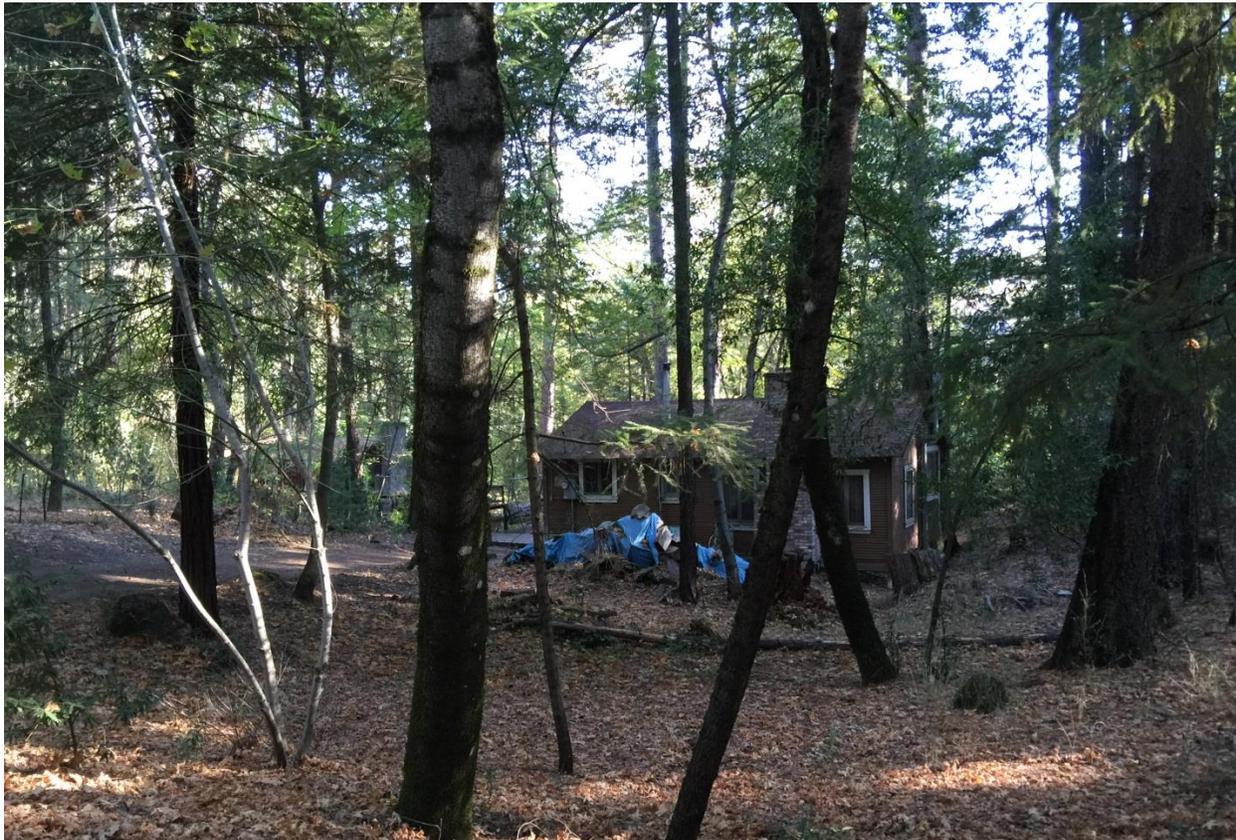
## Site 505

This site includes two single family homes located on Parnassus Drive (38.80953' N, 122.71228' W). The houses are located in a swale in the Putah Creek watershed. Habitat type at this site is mixed-conifer forest. The threat to existing infrastructure is debris-laden flooding and debris flow down the swale, flooding the road and damaging the homes.

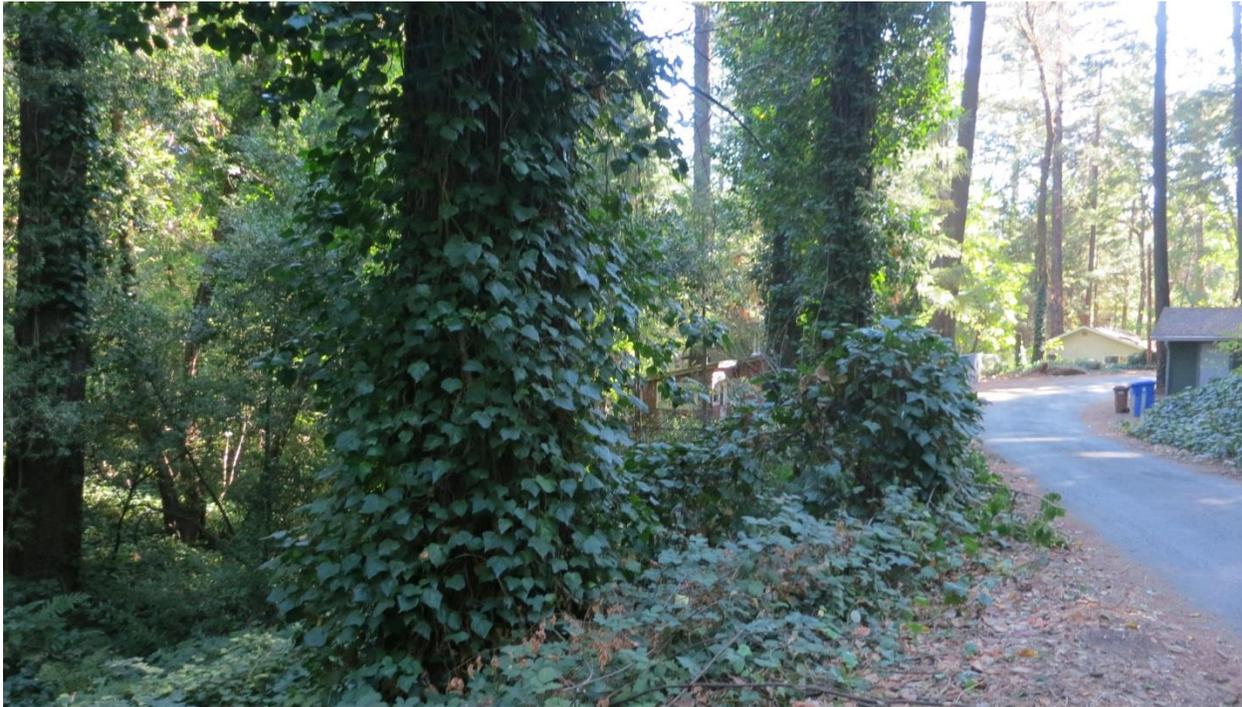
## Site 506

This site is two single family dwellings located on Maple Shadows Road (38.81098' N, 122.71249' W). The houses are located adjacent to an unnamed tributary to Putah Creek. This channel is a perennial flowing stream. Habitat type at this site is mixed-riparian. The channel is inundated with ivy. The threat to existing infrastructure is increased flow volume and debris flow rising to an elevation that will impact the homes.

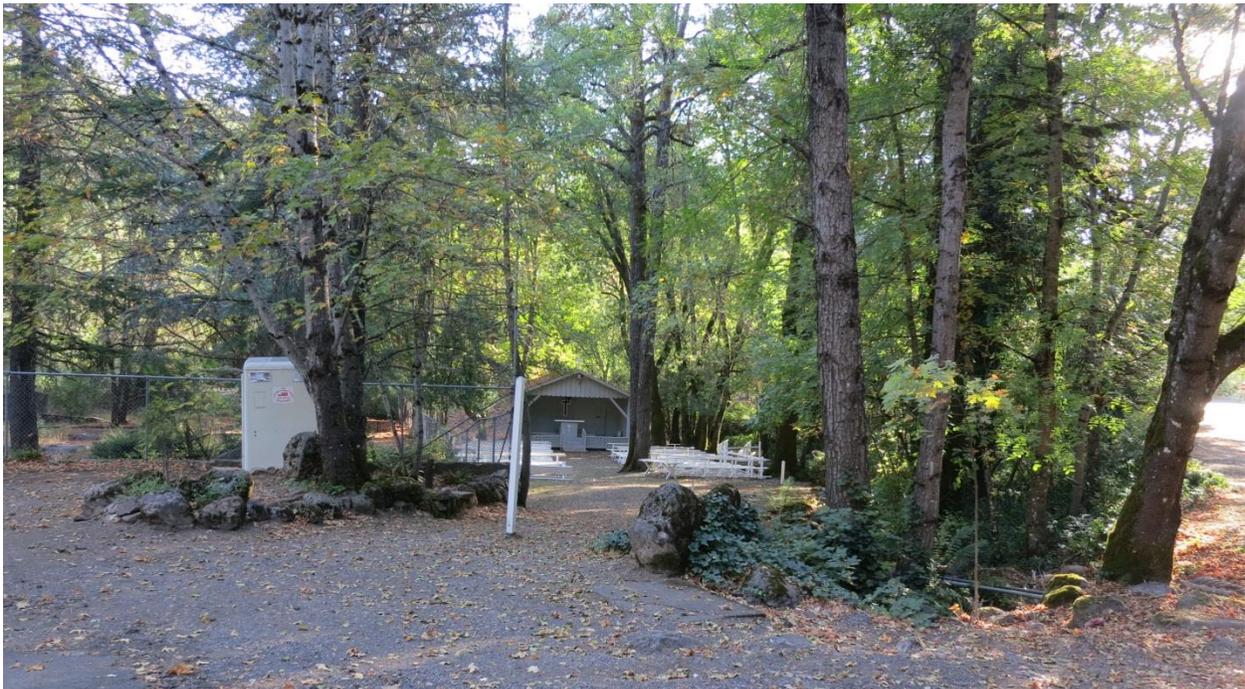
## Site 508

This site is a recreation hall and outdoor chapel located on Forest Lake Drive (38.81702' N, 122.71568' W). The buildings are located along Kelsey Creek. Kelsey Creek is a perennial fish bearing stream. Habitat type at this site is mixed-riparian. Three culverts converge at this location conveying flows into Kelsey Creek. The threat to existing infrastructure is increased flow and debris overwhelming the culverts causing flooding of the recreation hall and outdoor chapel.

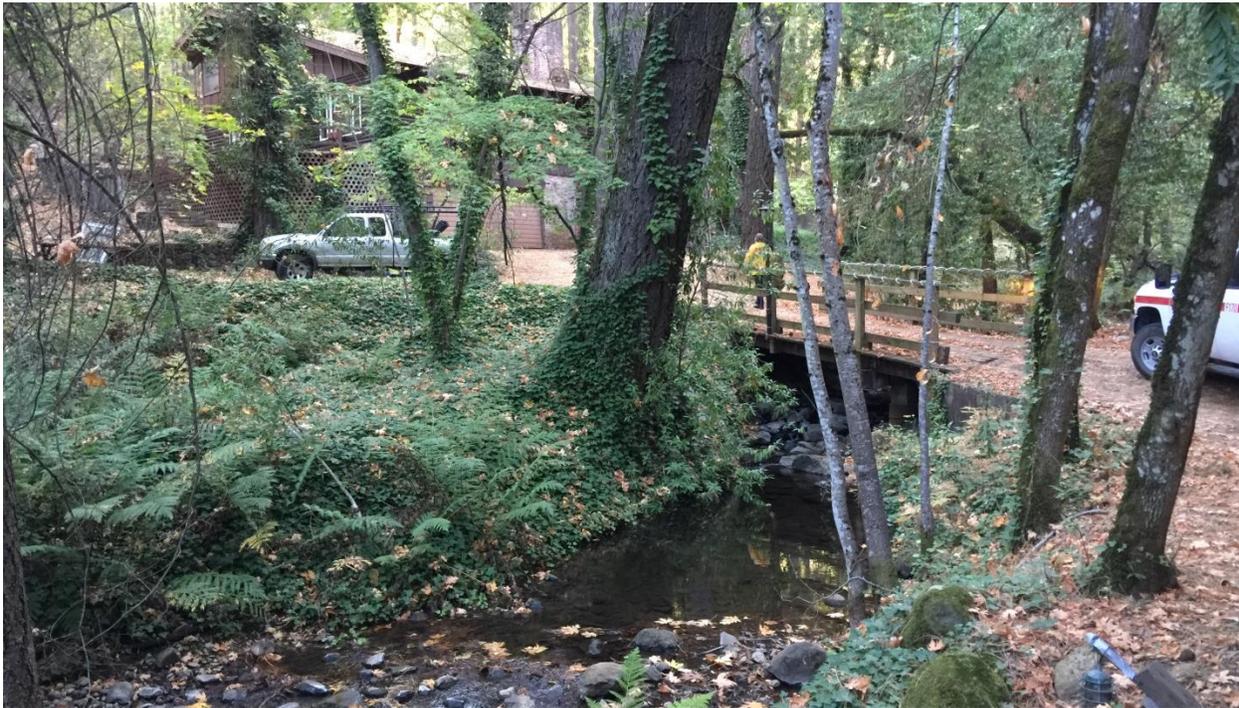
## Site 509

This site includes a private family home and bridge located on Cobb Blvd. (38.82199' N, 122.71492' W). The house is located along Jones Creek. Jones Creek is a perennial fish bearing stream in the Kelsey Creek watershed. Habitat type at this site is mixed-riparian. The threat to existing infrastructure is debris-laden flow down the creek piling up on the bridge and causing flooding of road and nearby home.

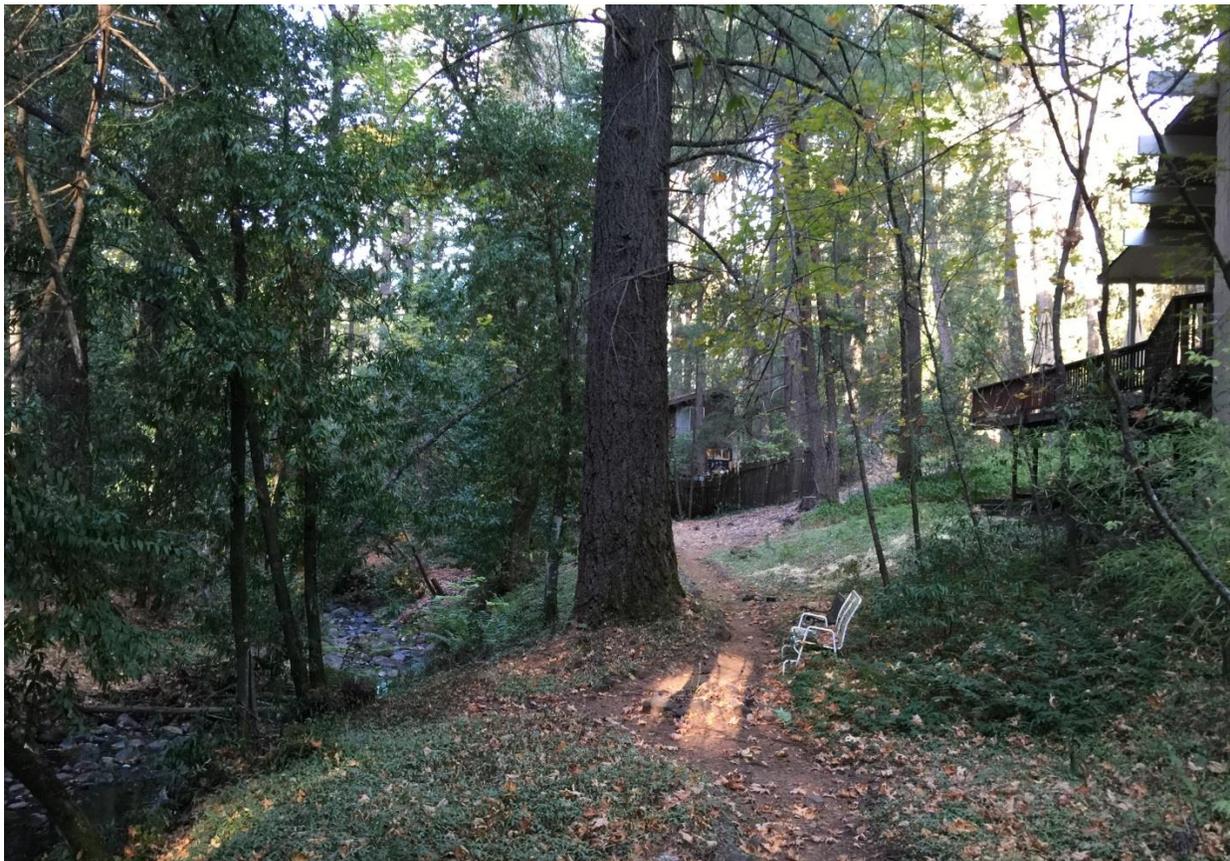
## Site 511

This site includes multiple single-family dwellings located along Twin Oaks Drive (38.82172' N, 122.71304' W). The homes are located along Jones Creek. Jones Creek is a perennial fish bearing stream, in the Kelsey Creek watershed. Habitat type at this work site is mixed-riparian. The threat to existing infrastructure is debris-laden flooding and debris flow down Jones Creek rising to an elevation that will impact the homes.

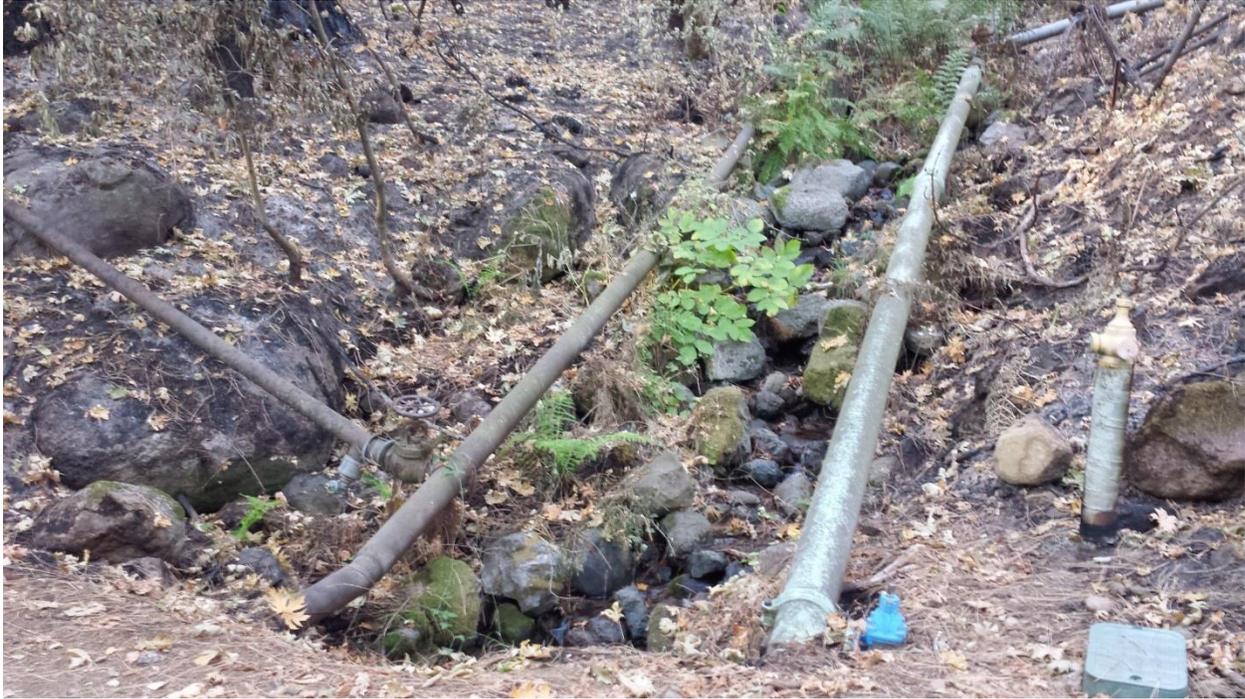
## Site 512

This site is near multiple single family homes located on Reed Road (38.82077' N, 122.72399' W). The homes are located at an unnamed tributary to Kelsey Creek. Little flow present at the time of the site review. Habitat type at this site is mixed-riparian. A culvert conveys flow under Reed Road. Threat to existing infrastructure is debris-laden flooding and debris flow down the tributary from steep (45-50%) slopes to the downslope neighborhood. There are multiple pipes in the tributary that may increase the risk of flooding due to debris obstruction.

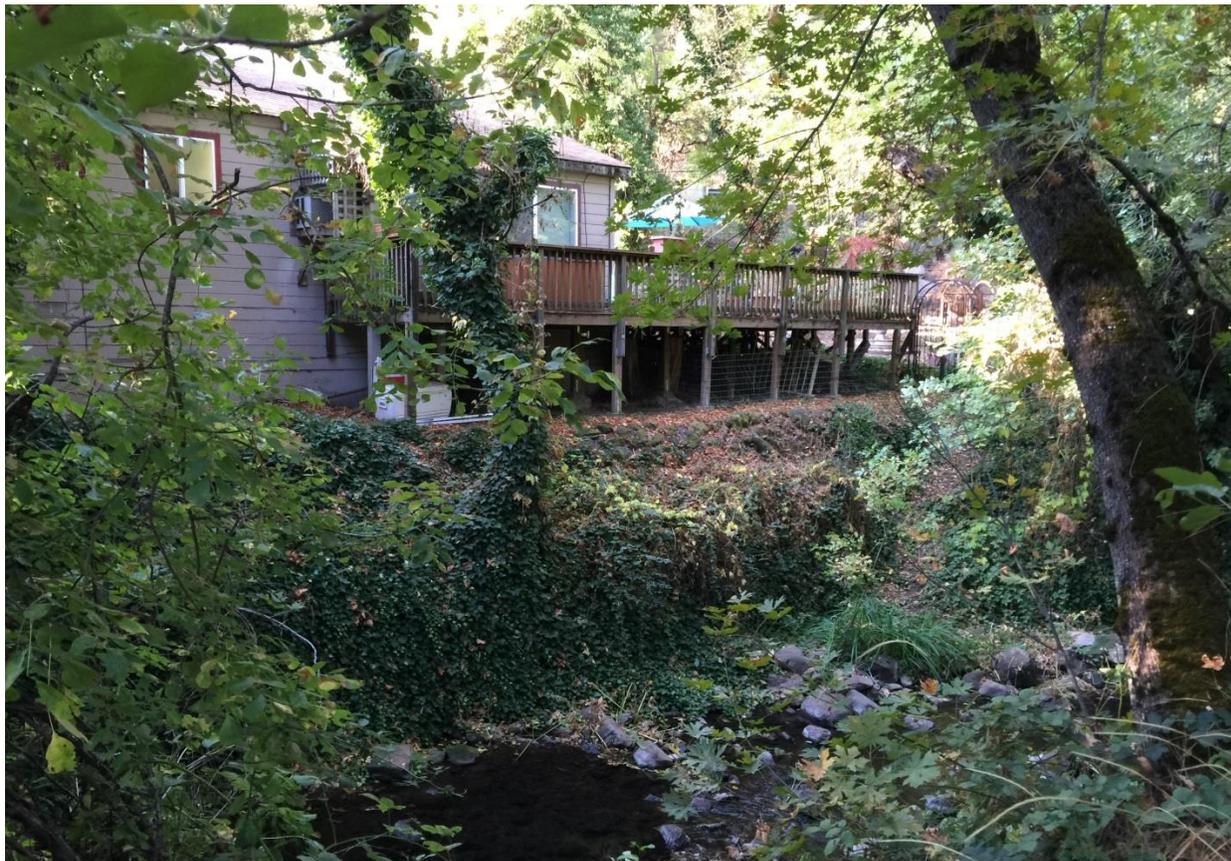
## Site 513

This site included businesses, homes, and bridges located near the Cobb village center, along Highway 175 (38.82403' N, 122.72139' W). The structures are located along Kelsey Creek. Kelsey Creek is a perennial fish bearing stream. Habitat type at this work site is mixed-riparian. The threat to existing infrastructure is debris-laden flooding and debris flow down Kelsey Creek rising to an elevation that will impact the homes and businesses.

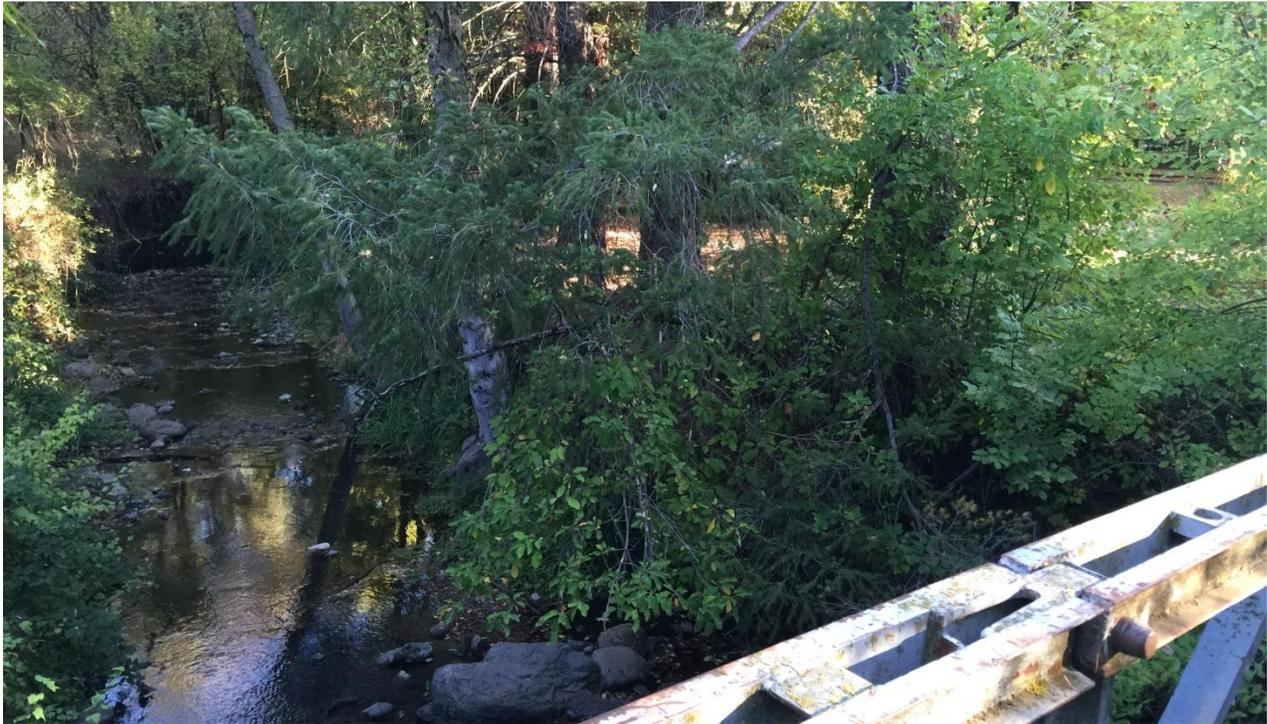
## Site 515

This site includes two single family homes located on Rainbow Drive (38.82742' N, 122.72665' W). The homes are located along Kelsey Creek. Kelsey Creek is a perennial fishing bearing stream. Habitat type at this work site is mixed-riparian. The threat is debris-laden flow down the channel causing flooding and debris flow related damage to homes.

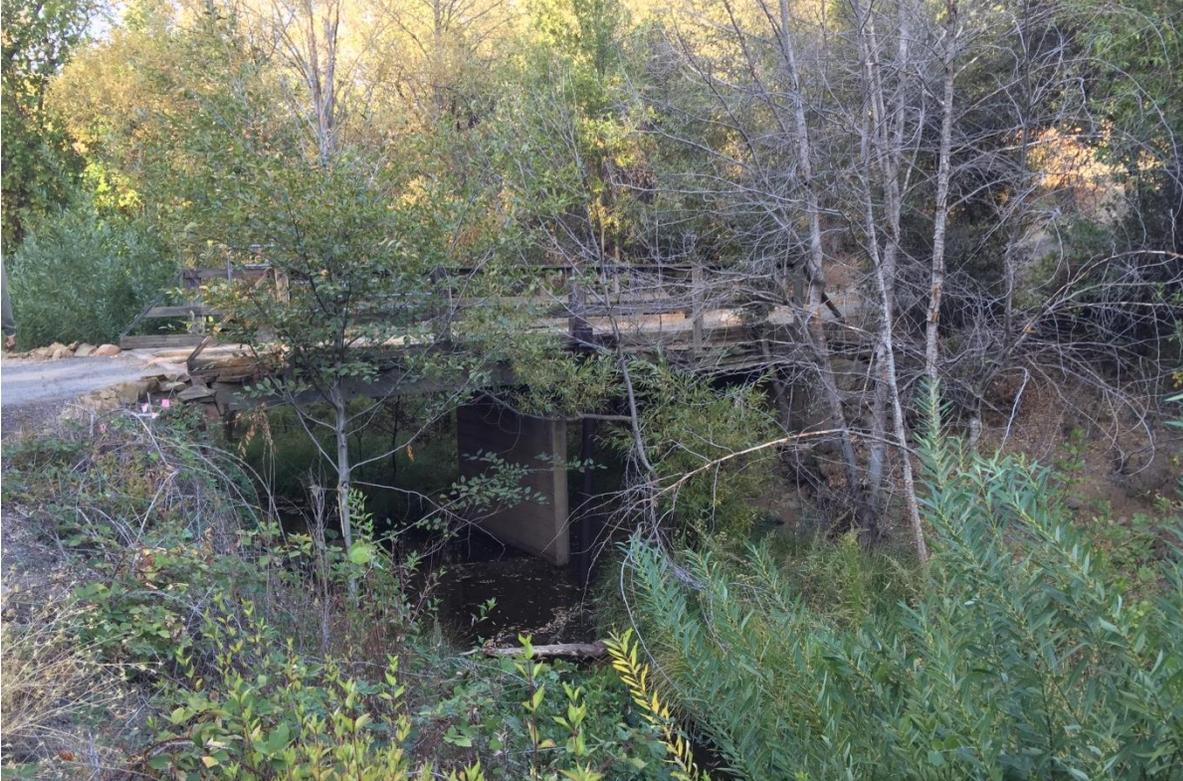
## Site 518

This site is a private bridge off of Seigler Canyon Road (38.89415' N, 122.65332' W). The bridge is located over Seigler Canyon Creek. Seigler Creek was flowing at time of visit and in the Cache Creek watershed. The habitat at this site is mixed-riparian. The bridge has a concrete center support wall in the channel. The threat to existing infrastructure is debris-laden flow down the creek piling up on the bridge and causing flooding of road and nearby area.

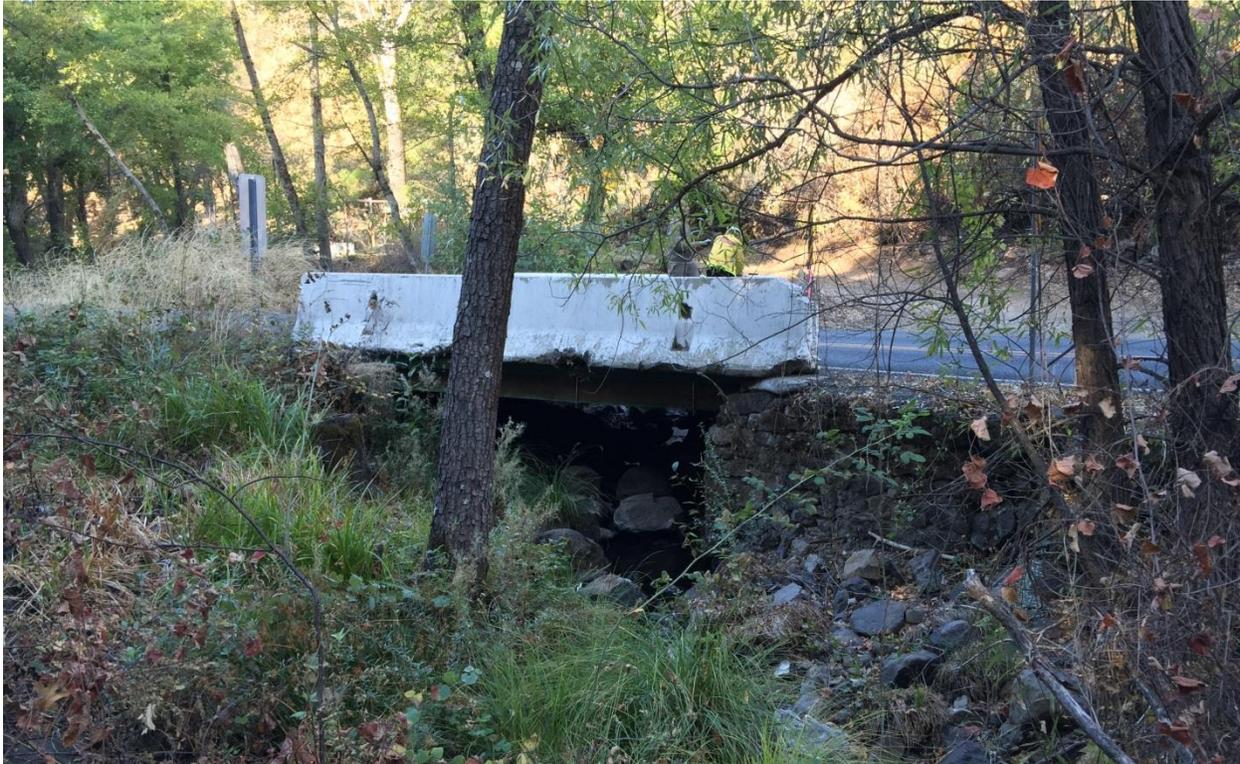
## Site 519

This site is a bridge on Seigler Canyon Road (38.87958' N, 122.67556' W). The bridge is located over Seigler Canyon Creek. Seigler Creek was flowing at time of visit and in the Cache Creek watershed. Habitat type at this site is mixed-riparian. Bridge is narrow and has been reduced to single lane traffic with K-rails set to protect bridge edges. The threat to existing infrastructure is debris-laden flow down the creek piling up on the bridge and causing flooding of road and nearby area.
