DEPARTMENT OF FORESTRY
AND FIRE PROTECTION

INVESTIGATION REPORT

Case Number: 07-3522-075

Case Name: MARTIN

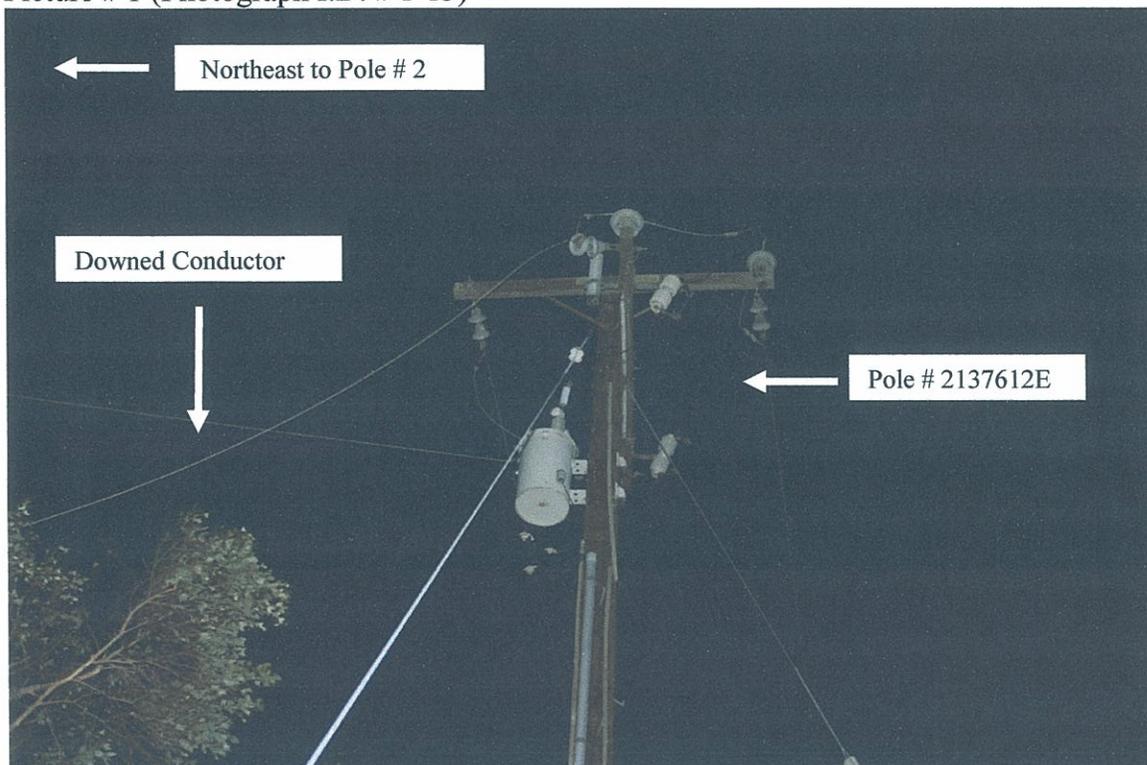
10- ATTACHMENT: Photographs
Picture # 1 (Photograph I.D. # 1-13)

24 The length of conductor found on the ground was still attached to pole number
25 2137612E. The opposite end had detached from above the insulator on the single cross
26 arm attached to pole number-2 located one span northeast of pole number 2137612E. The
27 end of the conductor fell to the ground landing approximately 40 to 50 feet away from the
28 pole. The detached end landed in dirt and was buried just under the surface of scattered
29 pine needles. There was no evidence of burn marks on the ground at this point, or in the
30 area between the end of the conductor and the pole it had detached from. The mechanism
31 causing the conductor to fall could not be determined specifically, but the appearance on
32 the end of the conductor, having a fresh break with discoloration similar to having been
33 burned, indicated it may have arced at the moment of breaking. After taking photographs
34 of the end in its original position, I later moved it for photography with a contrasting

View looking southeast: the span of conductor found on the ground was still attached to pole number 2137612E.

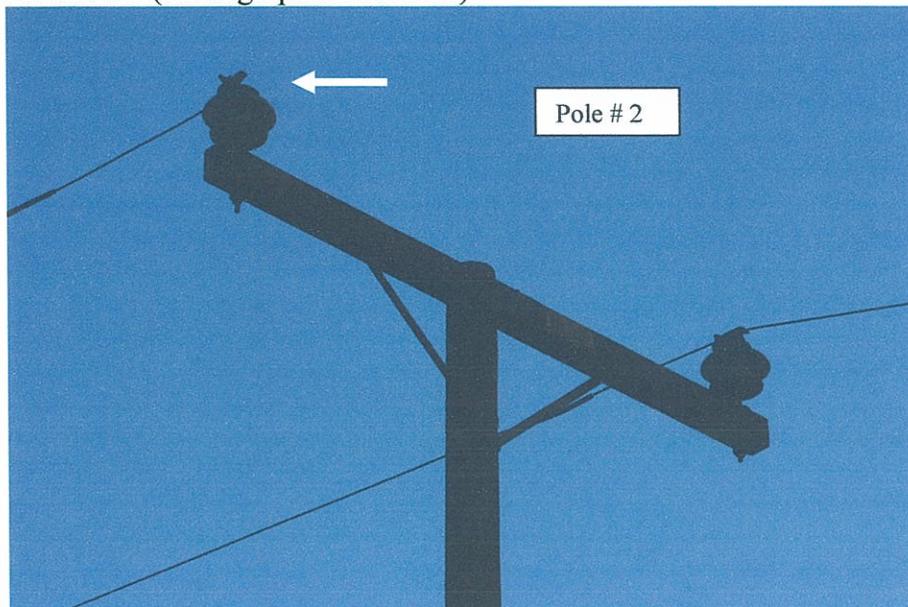
Picture # 2 (Photograph I.D. # 1-28)

The opposite end of the conductor had detached from above the insulator on the single cross arm attached to pole number 2, which was located one span northeast of pole number 2137612E.

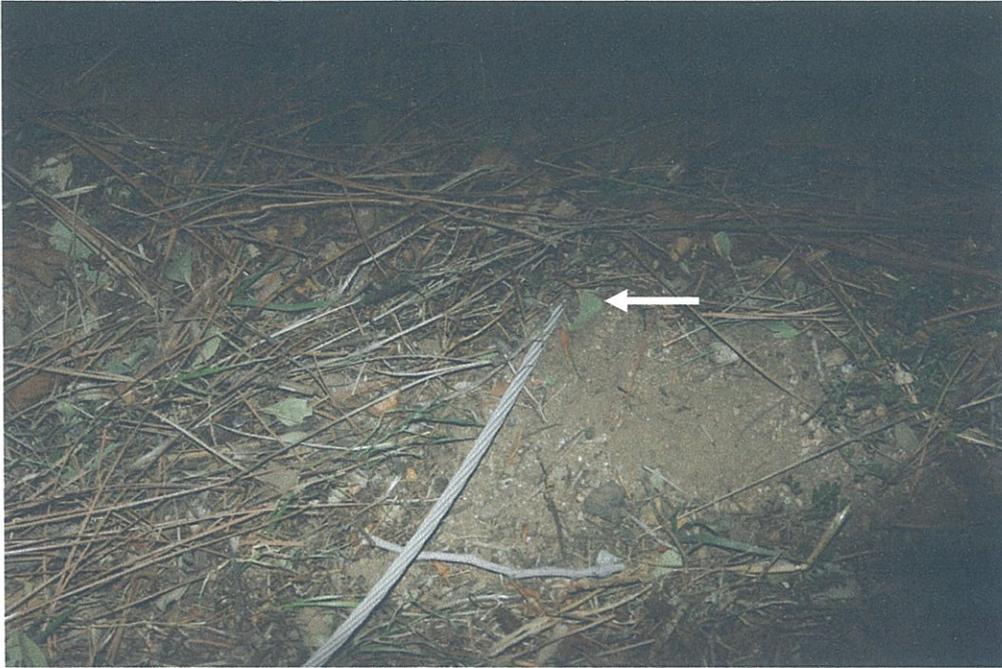
Picture # 3 (Photograph I.D. # 1-8)

The end of the conductor fell to the ground landing approximately 40 to 50 feet away from pole number 2. The detached end landed in dirt and was buried just under the surface of scattered pine needles.

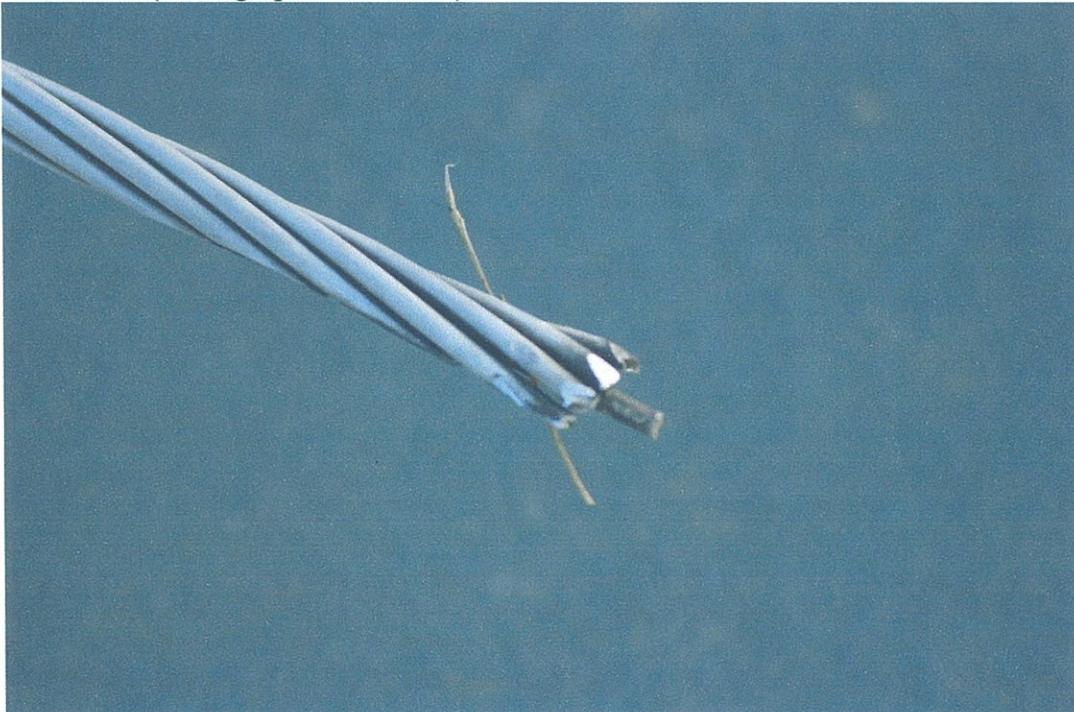
Picture # 4 (Photograph I.D. # 1-34)

The mechanism causing the conductor to fall could not be determined specifically, but the appearance on the end of the conductor, having a fresh break with discoloration similar to having been burned, indicated it may have arced at the moment of failing.

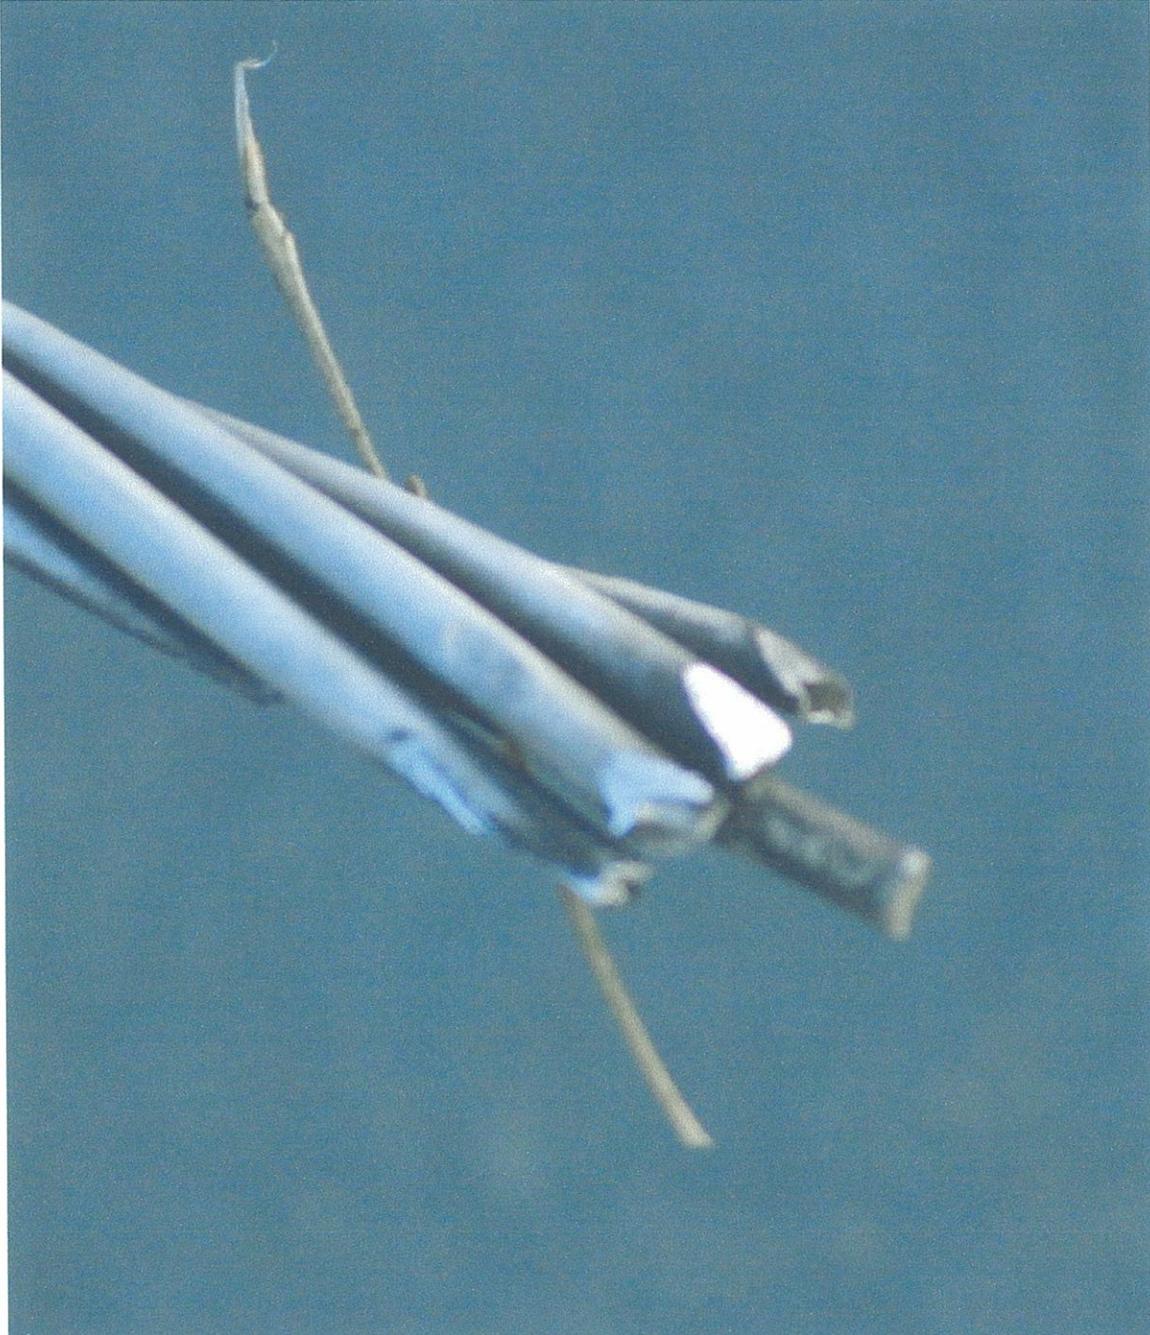
Picture # 5 (Photograph I.D. # 1-34 Enlarged)

Enlarged view of picture # 5: the conductor broke at that point where it had been attached to the insulator. The individual wire strands, comprising the whole of the broken end, were shiny in appearance with defined beveled shaped ends similar to the end of a cylindrical wire broke into two pieces by bending it back and forth until weakened to its breaking point.

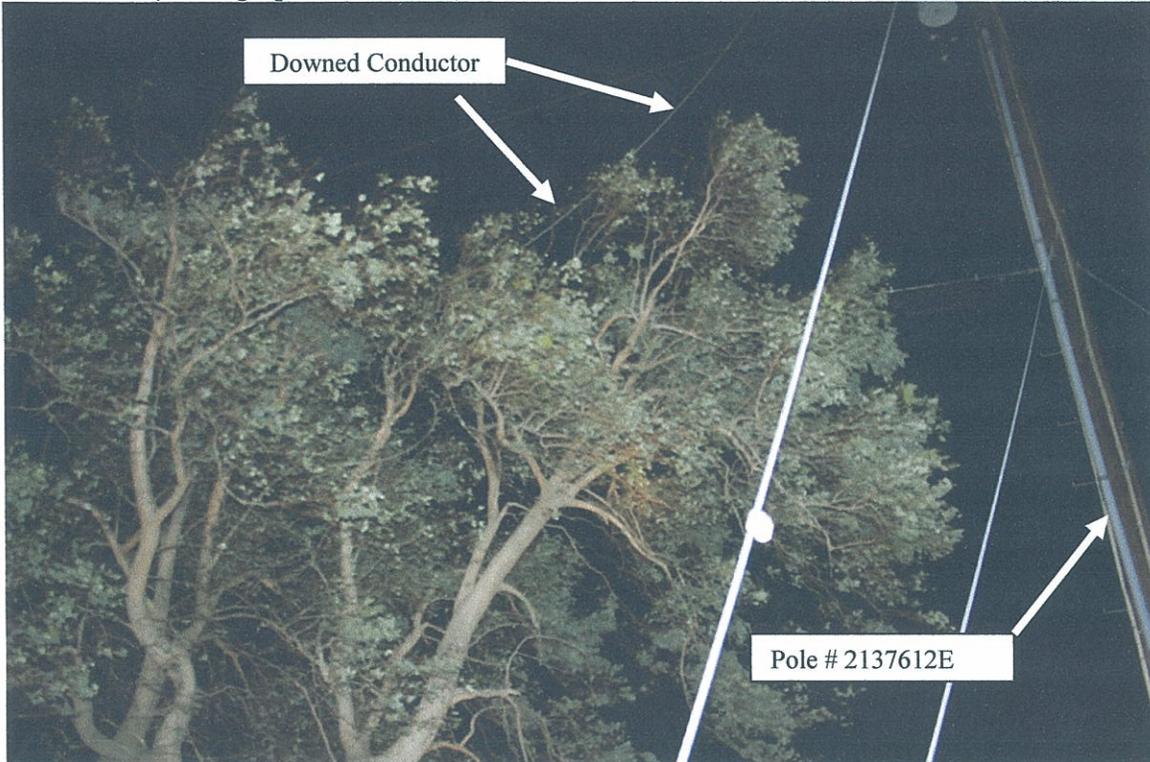
Picture # 6 (Photograph I.D. # 1-17)

37 When the conductor broke free from its insulator on pole number 2, the slack fell
38 down on top of a tree and into its branches. The tree was located on the southwest edge of
39 the cement driveway leading into 1701 Martin Ranch Road. The base of the tree was
40 approximately 15 feet northwest of pole number 2137612E. I estimated the height of the
41 tree branches were 10 to 15 feet below the level of the conductor that was still suspended
42 between the utility poles. The vegetation I observed was compliant with the required
43 clearance of four feet minimal separation between all vegetation and conductors, as
44 specified in Section 4293.(a) of the Public Resources Code. The branches in the tree did
45 not show any burn marks at the time of my initial examination. After the conductor fell
46 into the branches, it landed across the northeast edge of the driveway and onto an area of

1 dried grass bordered by the driveway and Martin Ranch Road. It then lay across the road
2 and back into dirt where the conductor's broken end was located next to pole number 2.
3

When the conductor broke free from its insulator on pole number 2, the slack fell down on top of a tree, located on the southwest edge of the cement driveway leading into 1701 Martin Ranch Road, and through its branches. The base of the tree was approximately 15 feet northwest of the base of pole number 2137612E. After falling on top of the tree, the conductor landed across the northeast edge of the driveway and onto an area of dried grass bordered by the driveway and Martin Ranch Road. The conductor lay across the road and back into dirt where its broken end was located next to pole number 2.

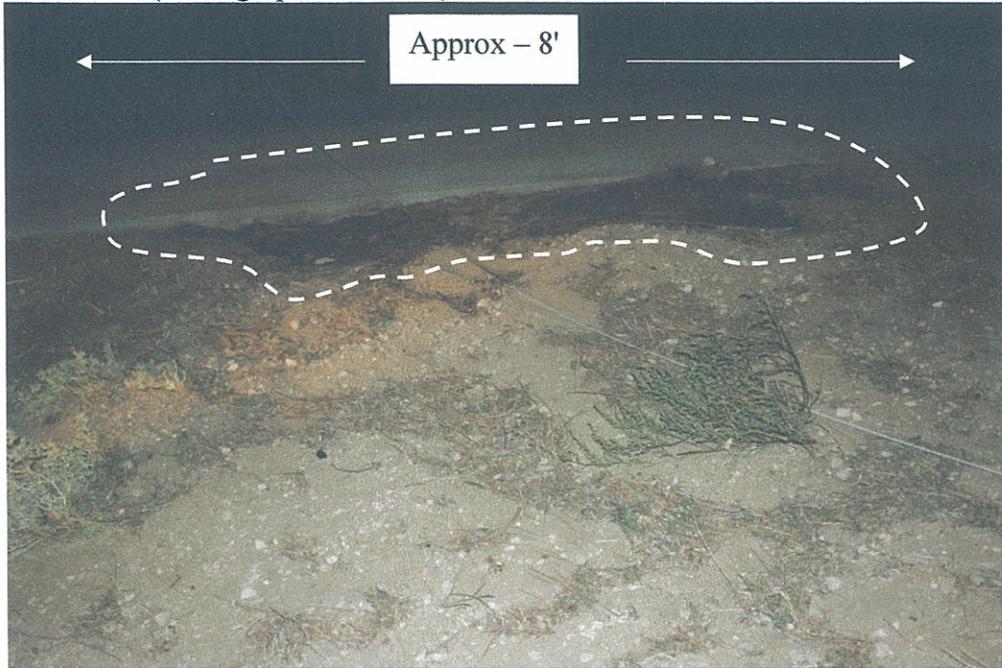
Picture # 7 (Photograph I.D. # 1-4)

4 There were three areas of sparse grass burned underneath the conductor that was
5 lying on the ground. The first area examined was approximately eight feet in length along
6 the northeast edge of the driveway, and it varied in width from approximately 2 to 18
7 inches wide. The conductor lay across this burned area perpendicular to the length of the
8 burn, and the conductor was slightly discolored compared to its gray colored appearance
9 where it had not been exposed to any heat. There was a small tree stump with an
10 approximate 2-inch diameter base against the edge of the driveway within the perimeter
11 of burn area # 1. The stump had the appearance of being recently cut. I located the
12 corresponding cut end of branch lying on the south side of pole number 2137612E
13 approximately 15 to 20 feet away. I examined the cut branch, and there was no indication
14 it had burned. I determined the branch had been cut prior to the fire.

There were three areas of sparse grass burned underneath the conductor lying on the ground. The first area examined was approximately 8 feet in length along the northeast edge of the driveway, and it varied in width from approximately two to eighteen inches wide.

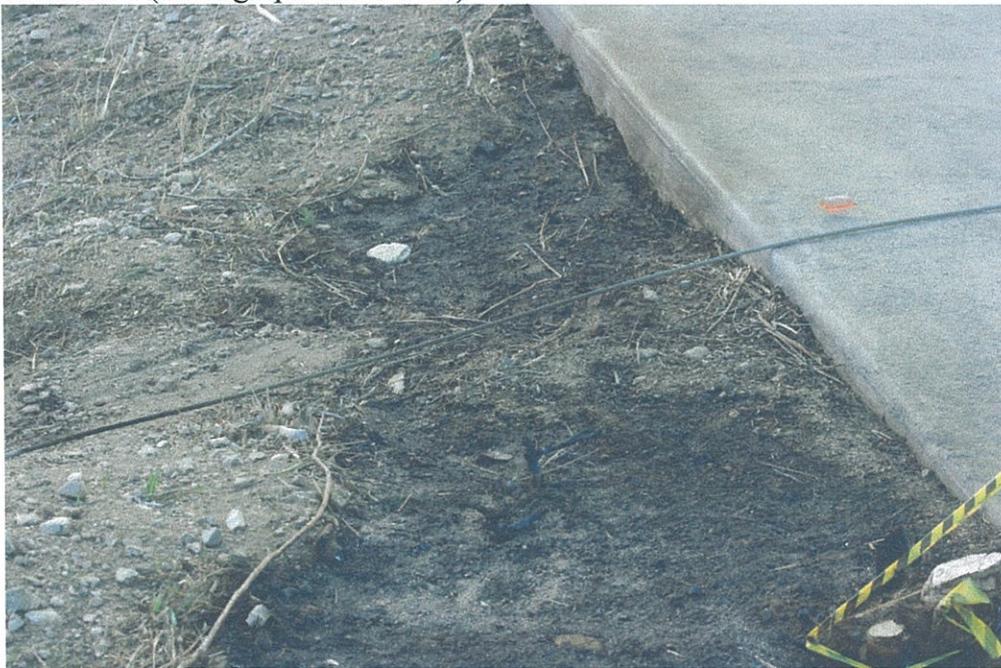
Picture # 8 (Photograph I.D. # 1-45)

The conductor laid across burn area # 1 perpendicular to the length of the burn, and the conductor was slightly discolored when compared to its gray colored appearance where it had not been near any heat.

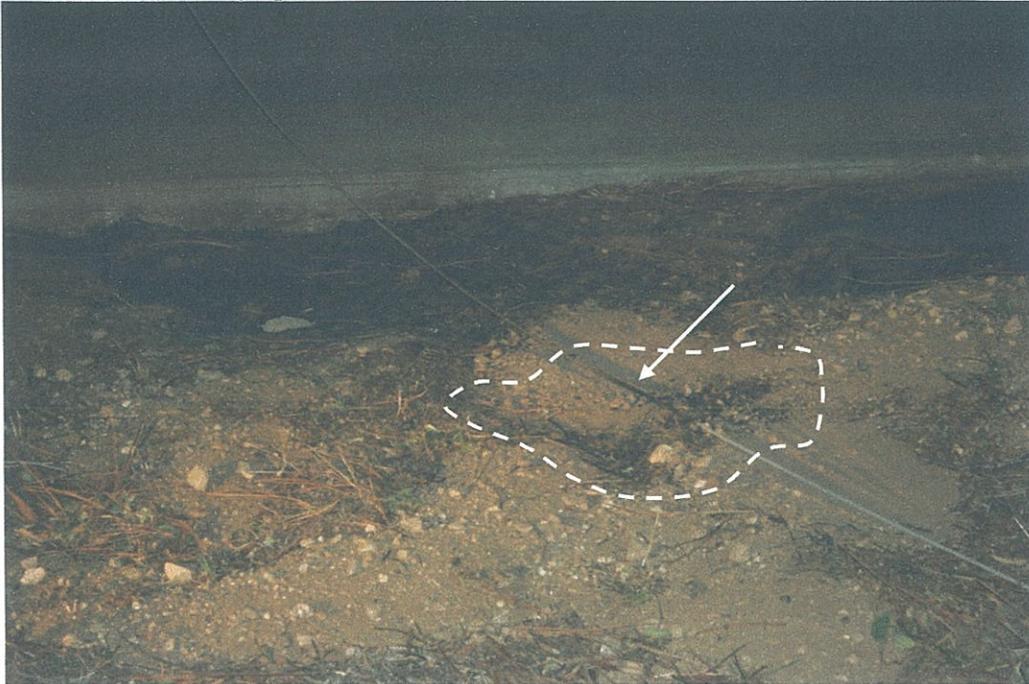
Picture # 9 (Photograph I.D. # 1-5)

16 A second burned area with a narrow oblong patch of sparse grass, about 18 inches
17 long, and 10 to 12 inches north of burn area # 1, was also found underneath the downed
18 conductor. The conductor was severely discolored with a black soot type residue. The
19 discoloration along the conductor corresponded to the width of burn area underneath it. It
20 was my conclusion there would not have been enough heat from the available fuel load of
21 burning grass to cause this discoloration, but an electrical arc would. This observation
22 supported my examination of the conductor in burn area # 1 when I compared it to the
23 light grey color section of the conductor in burn area # 1 where it had been exposed to
24 more heat because more grass had burned around it, but the conductor had little
25 discoloration.
26

Burn area # 2 was ten to twelve inches north of the first burn on the edge of the driveway, and the conductor was lying over it. The conductor on top of the area was severely discolored with a black soot type residue. The discoloration along the conductor corresponded to the width of burn area underneath it.

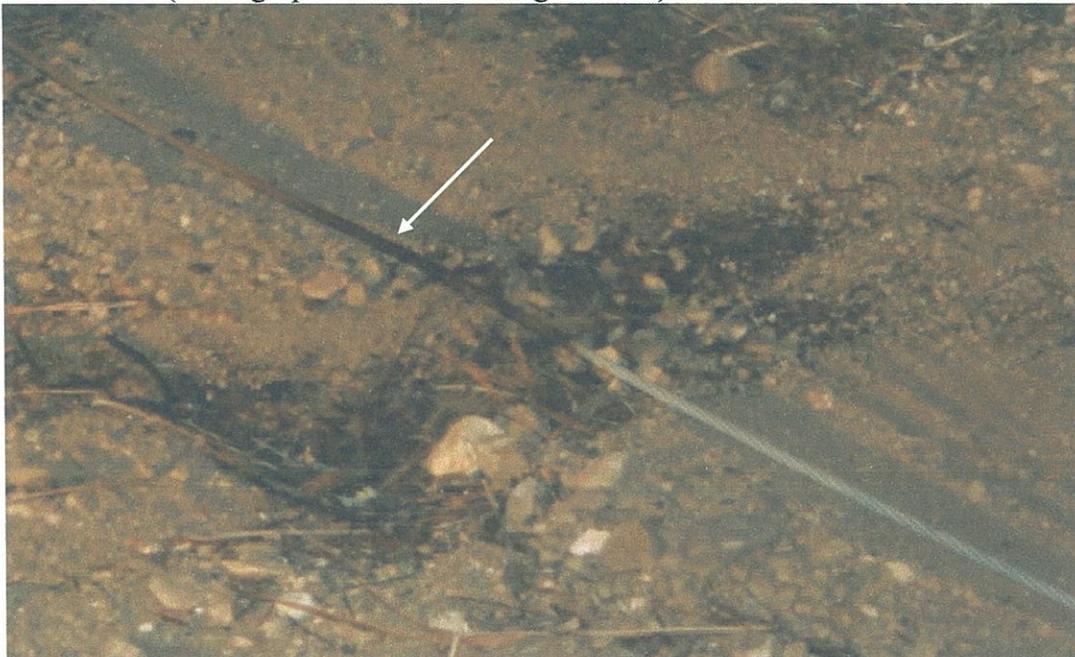
Picture # 10 (Photograph I.D. # 1-5 Enlarged View)

Dark discoloration on the conductor was the result of flame or heat hotter than the sparse grass underneath it could have produced.

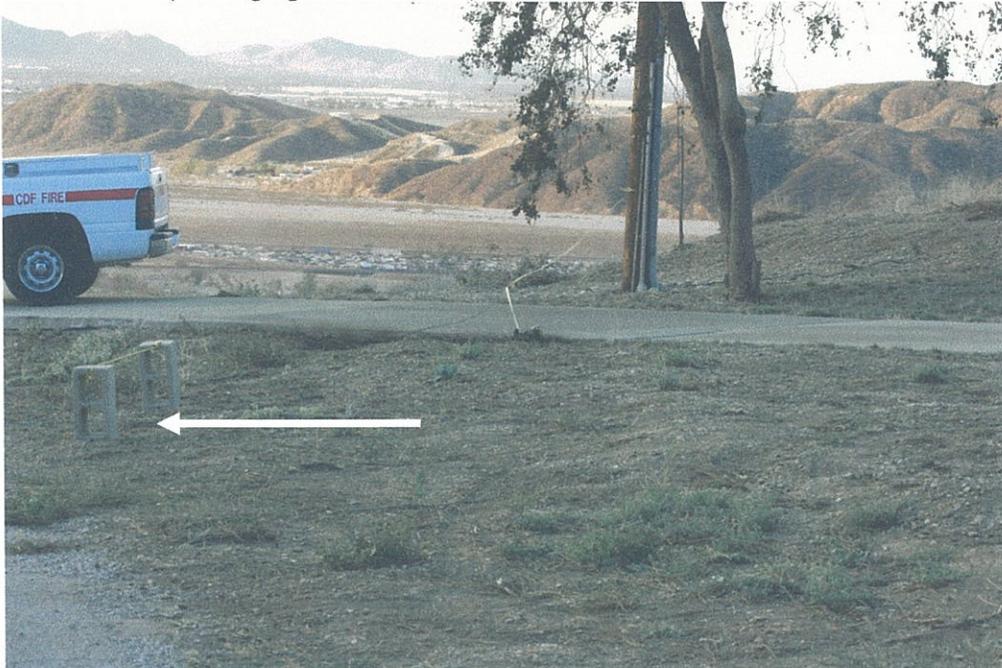
Picture # 11 (Photograph I.D. # 1-36)

The third area of sparse grass that burned (indicated by the white arrow in this picture and in picture # 12 below) was approximately 15 feet northeast of the burned area at the edge of the driveway.

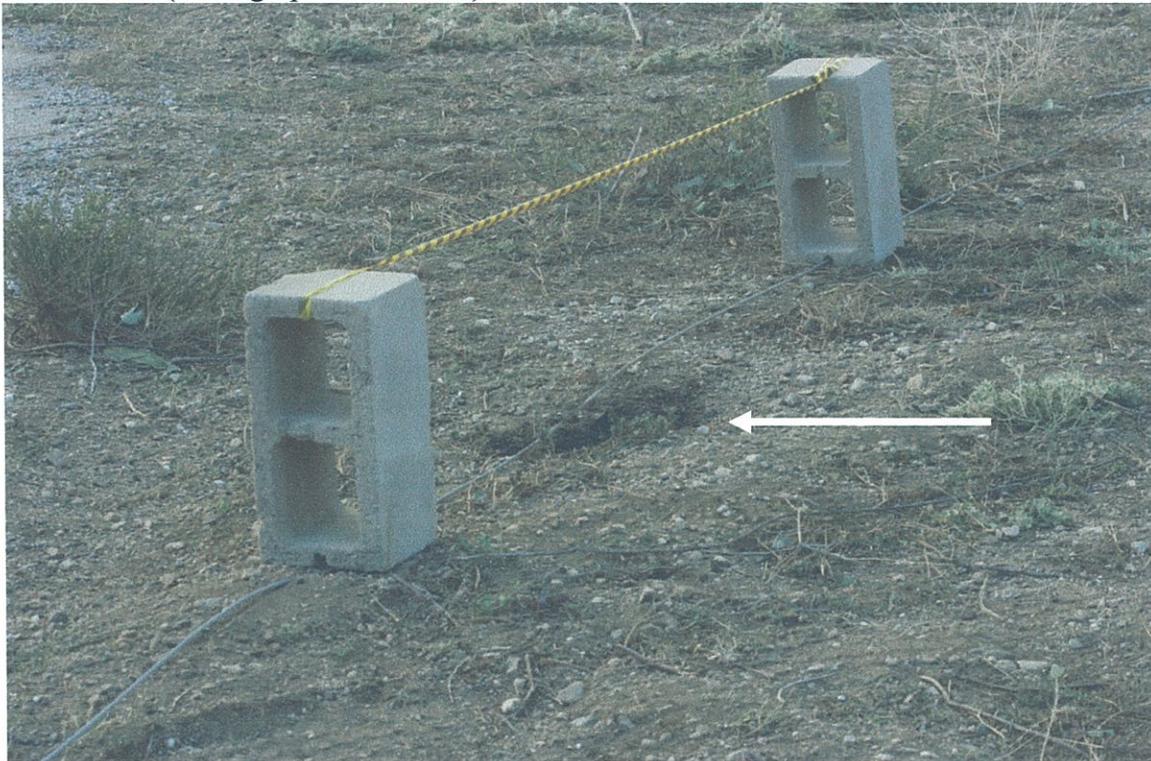
Picture # 12 (Photograph I.D. # 1-37)

Burn area # 3.

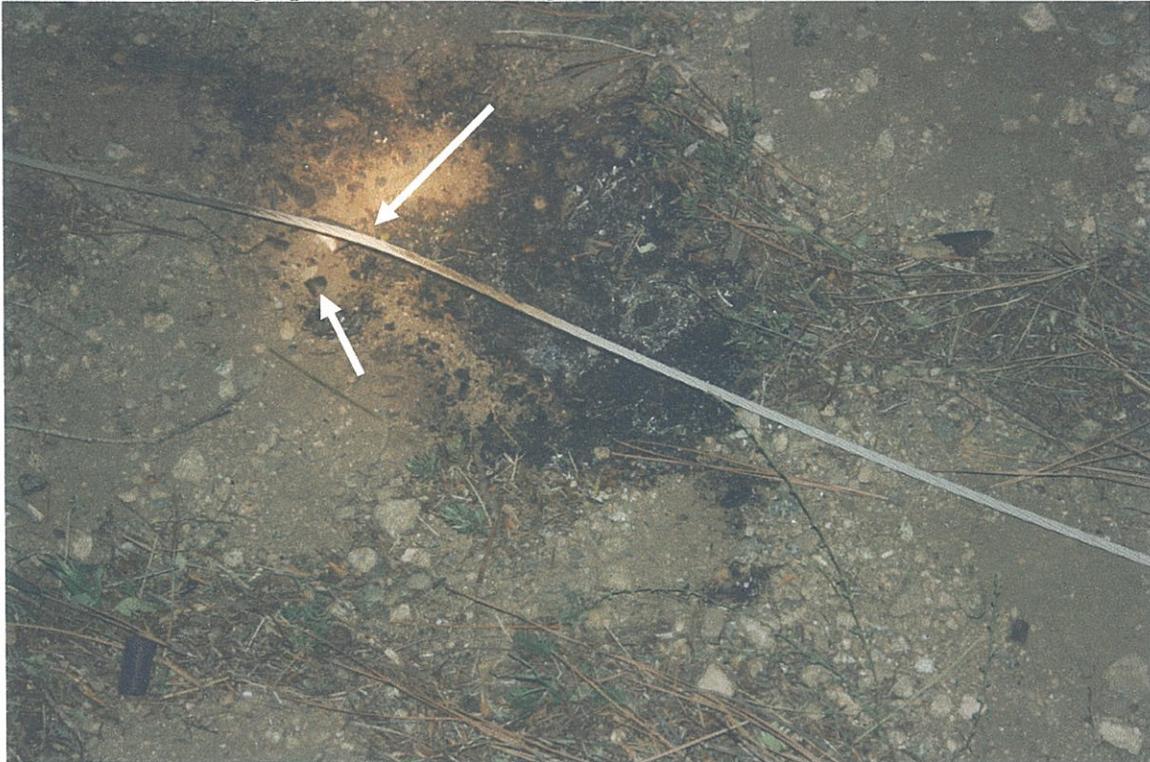
Picture # 13 (Photograph I.D. # 1-6) Enlarged View

27 The third area of sparse grass that burned was approximately 15 feet northeast of
28 burn area # 1 at the edge of the driveway. It was oblong in shape and approximately 20
29 inches in diameter. The grass that was burned under the downed conductor would have
30 burned with low heat intensity, because of its short length of less than one to two inches
31 and minimal density, but several rocks within this burned area had a black colored
32 appearance indicative of being scorched by high heat. Additionally, the dark sooty type
33 discoloration on the conductor lying over this burned area indicated it had been exposed
34 to more heat than the grass alone would have produced while burning. The conductor
35 also had evidence of pitting on its individual strands making up the circumference of the
36 conductor.
37

Burn area # 3 was oblong in shape, and approximately 20 inches in diameter. The grass under the conductor would have burned with low heat intensity because of its short length and minimal density, but several rocks within this burned area had a black colored appearance of having been scorched by high heat. Additionally, the dark soot type discoloration on the conductor over the burned area indicated it had been exposed to more heat than the grass alone would have produced while burning (arrows indicate the location of the scorched rocks).

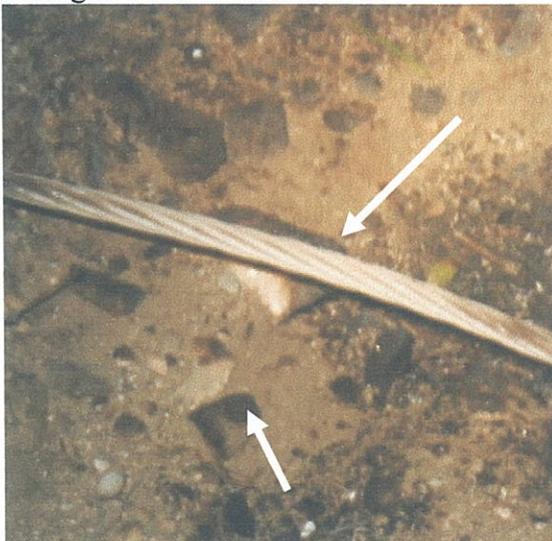
Enlarged View of Picture # 13

Arrows point to scorched rocks.

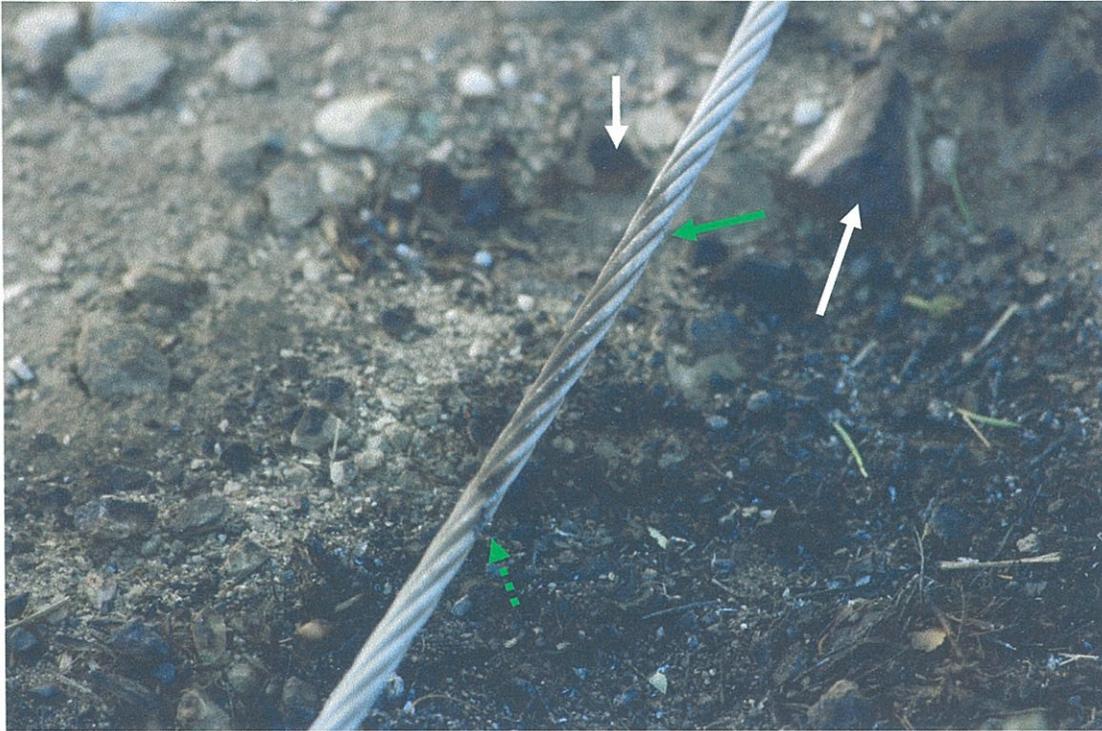
Picture # 14 (Photograph I.D. # 1-39)

Close-up view of the scorched rocks shown in picture # 13 (white arrows): The conductor also had evidence of pitting on the individual strands of the conductor (pitting indicated by the green arrows).

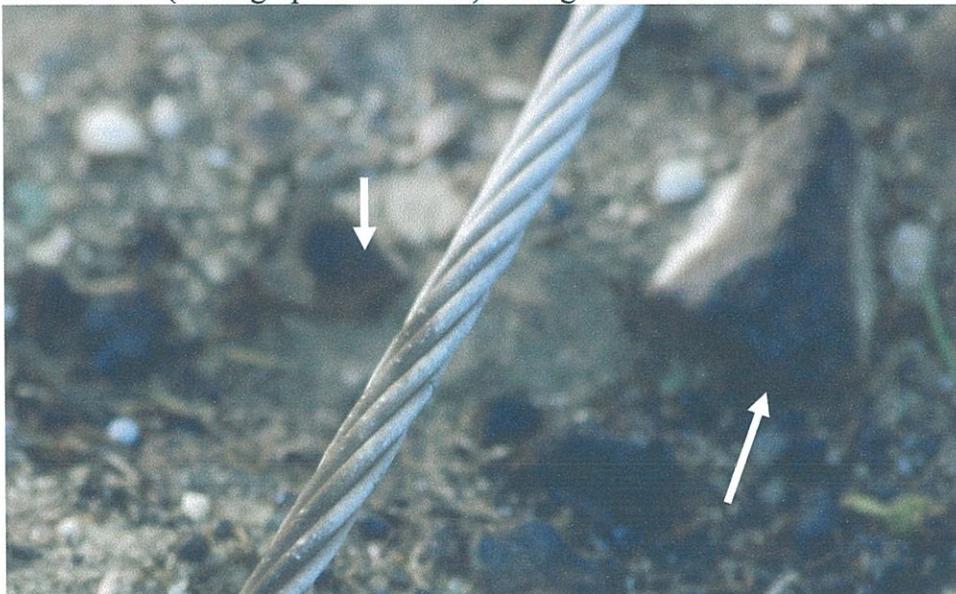
Picture # 15 (Photograph I.D. # 1-39) Enlarged View

The scorch marks on the rocks indicated directional heat from the top down. This was evident by the unburned edges at ground level around the rocks. The conductor was found on top of the large rock, shown on the right side in this image, when taking the initial photographs (see picture # 13, photograph I.D. # 1-6).

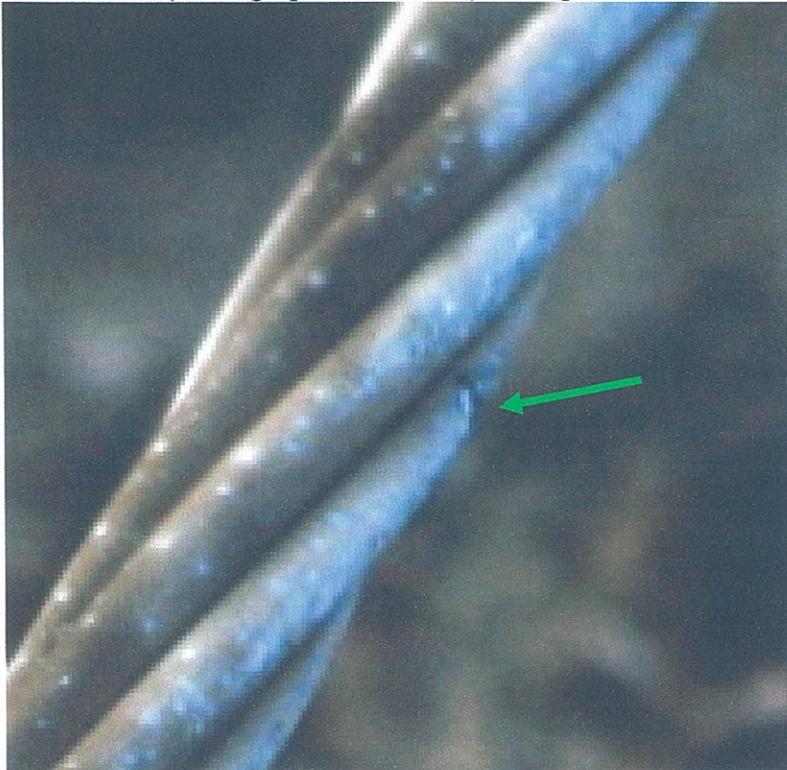
Picture # 16 (Photograph I.D. # 1-39) Enlarged View

Detailed close-up view of the pitting identified by the solid green arrow in Picture # 14.

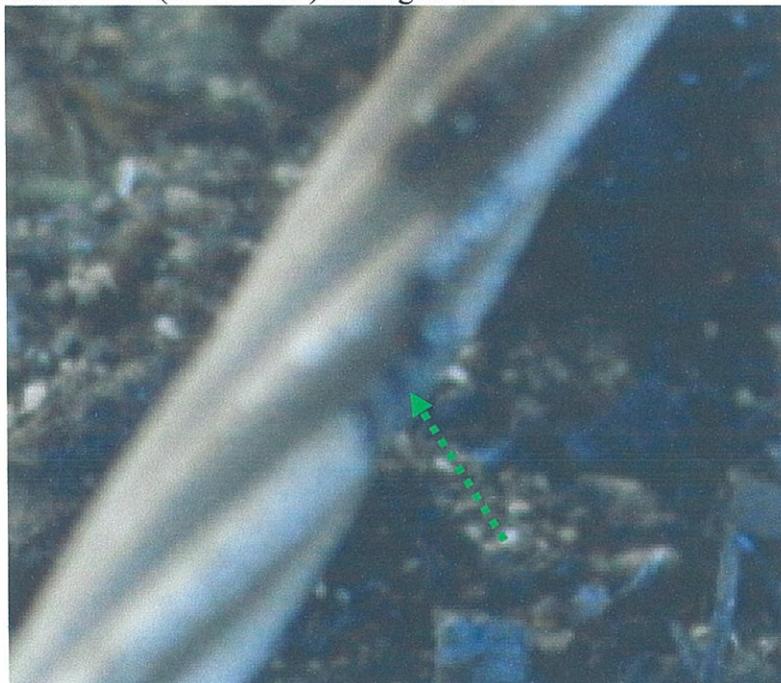
Picture # 17 (I.D. # 1-39) Enlarged View

Detailed close-up view of pitting identified by dashed green arrow in Picture # 14 (Photograph I.D. # 1-39).

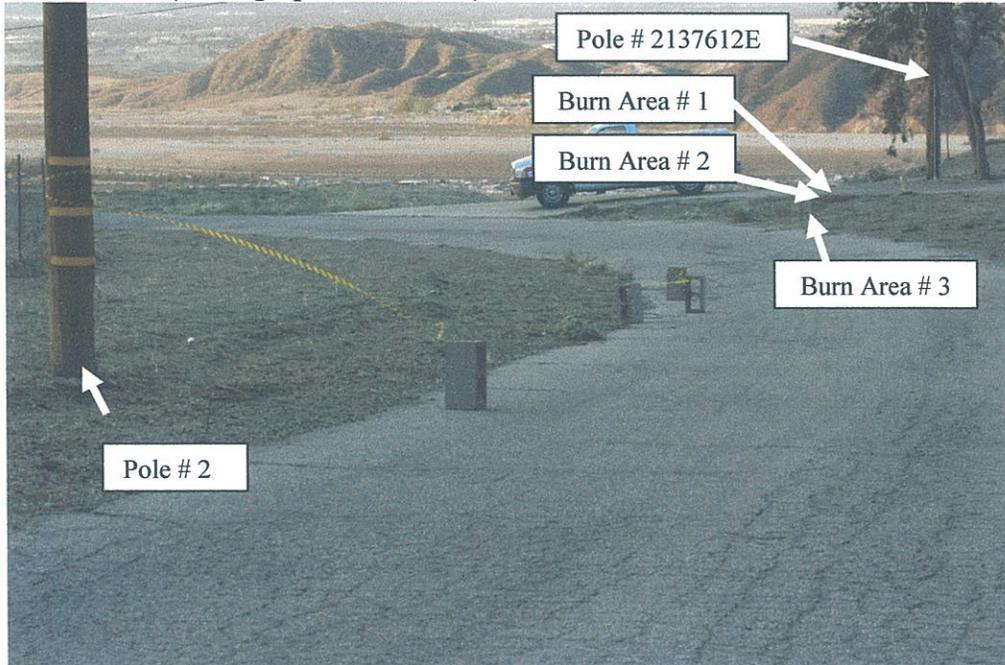
Picture # 18 (Photograph I.D. # 1-30)

View looking south: cinder blocks and black & yellow colored flagging were used to secure the area of the downed conductor, and to identify the initial area of examination.

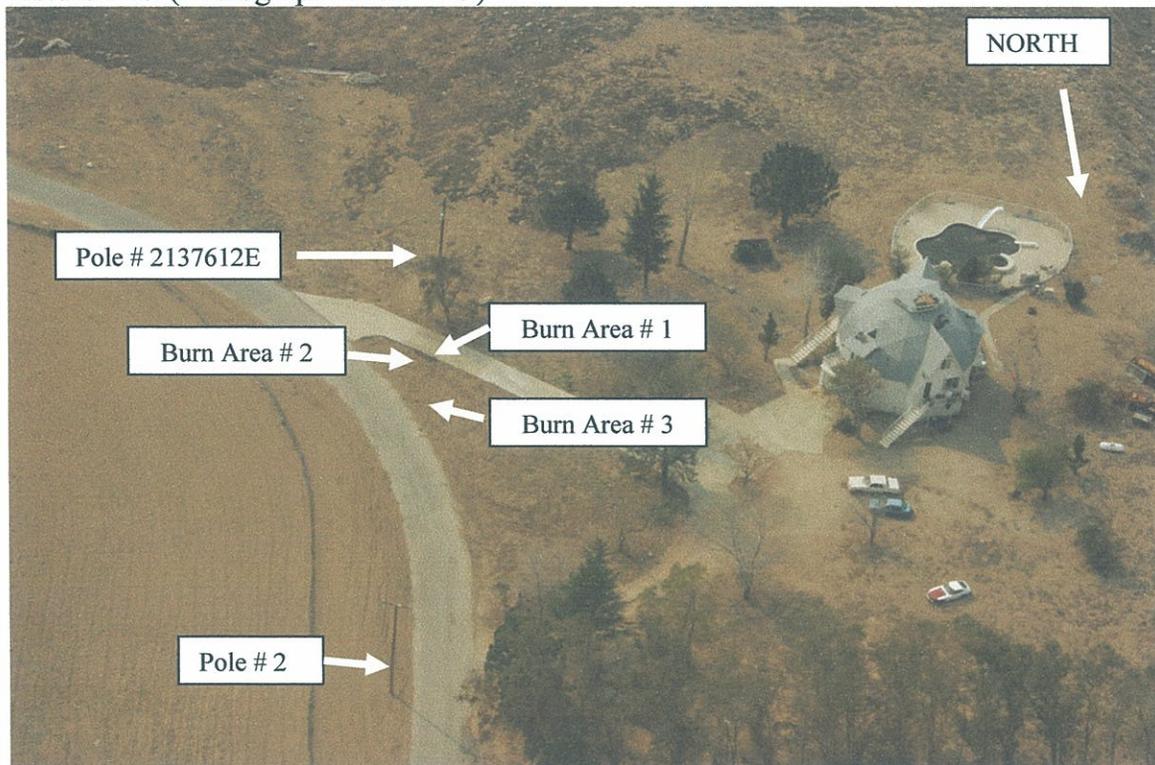
Picture # 19 (Photograph I.D. # 4-29)

Aerial view with the same identifiers as shown in picture # 18

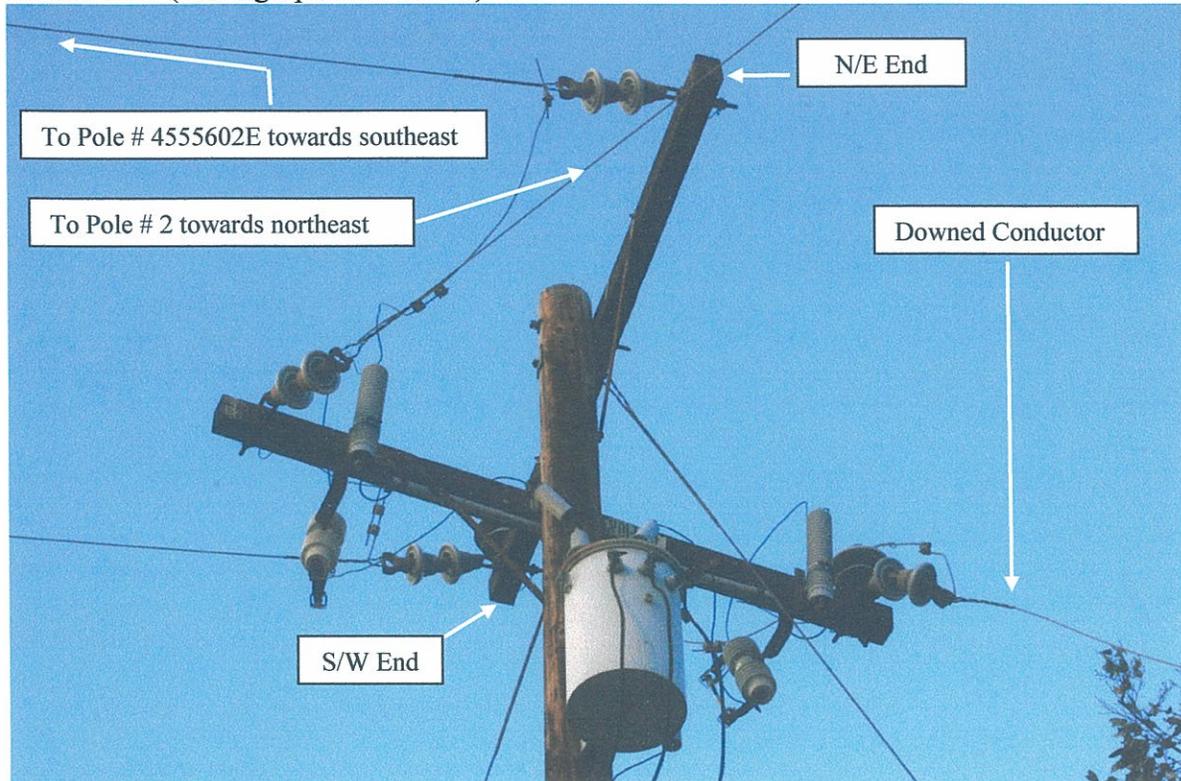
Picture # 20 (Photograph I.D. # 1-58)

The pole hardware consisted of the transformer, lightning arrestors, arm mounted liquid filled glass fuses, two cross arms, insulators, ground wire and gye wires, and miscellaneous connectors. The upper cross arm was oriented northeast to southwest. Its conductors were received at each end of the upper cross arm coming from pole number 4555602E located approximately 260 feet, and one span away, towards the southeast. The upper cross arm conductors changed their direction 90 degrees towards the northeast after transitioning to the lower cross arm.

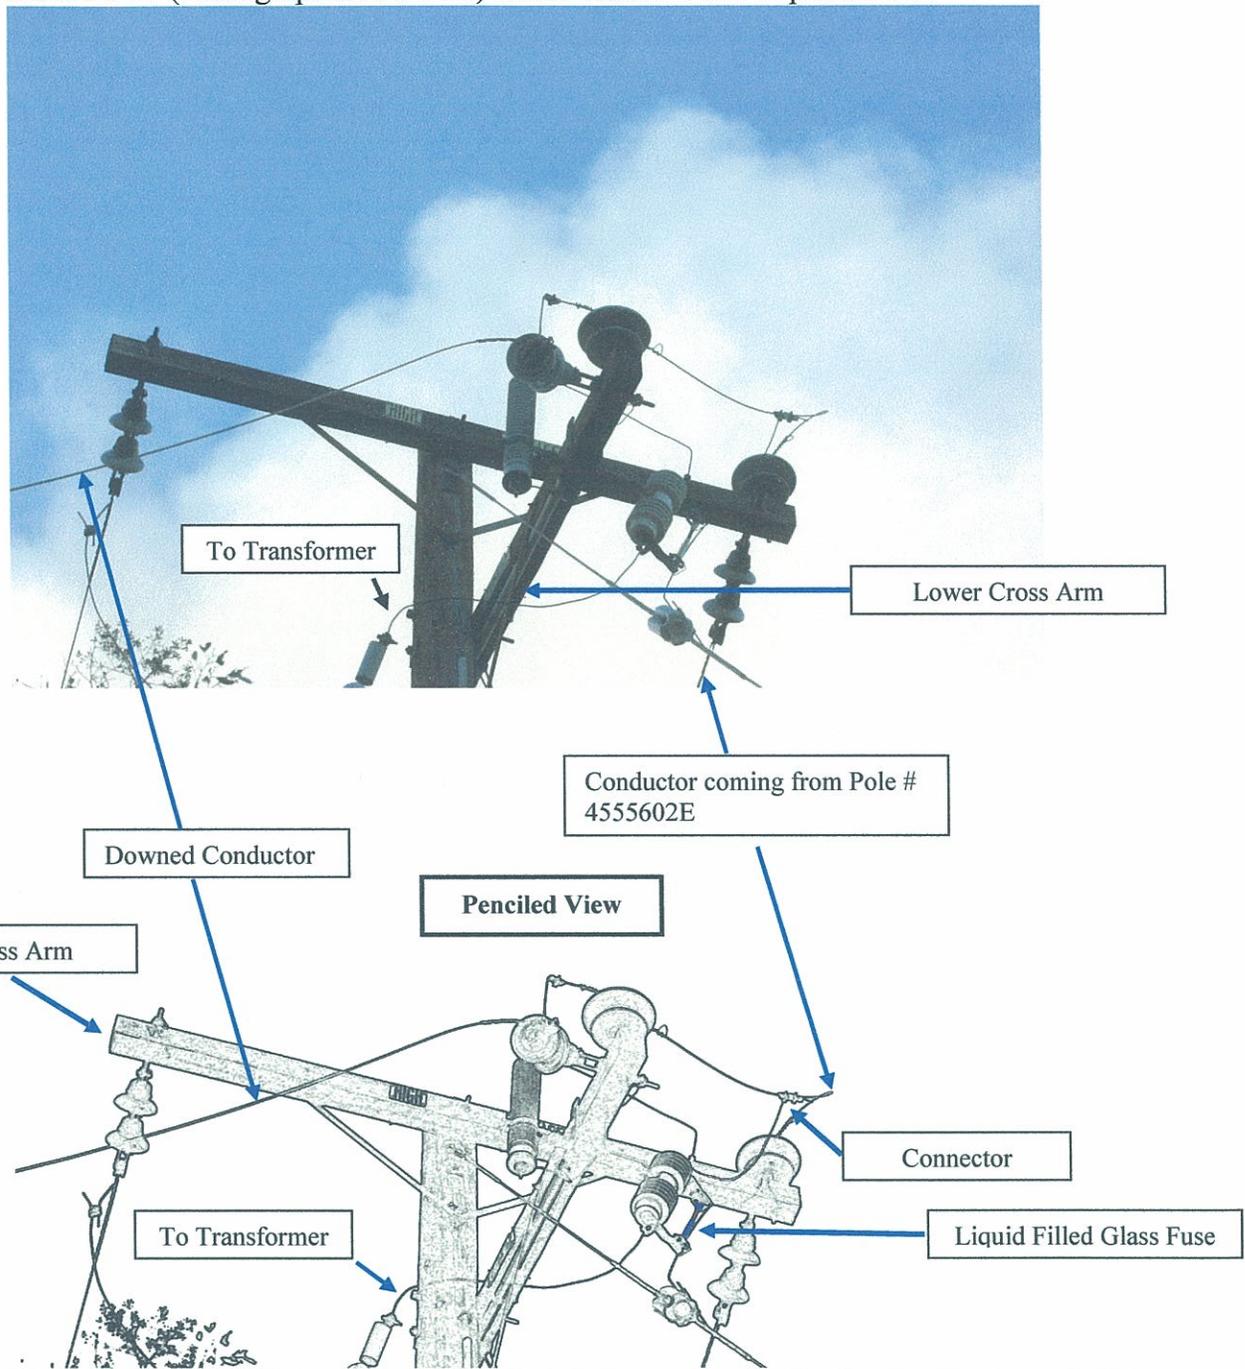
Picture # 21 (Photograph I.D. # 1-58) with Penciled View of picture # 17

Each conductor, in its transition from the upper cross arm to the lower cross arm, had a connector attached to it allowing for a section on each conductor to split and connect to their respective side of the transformer with a liquid filled glass fuse in between the split and transformer.

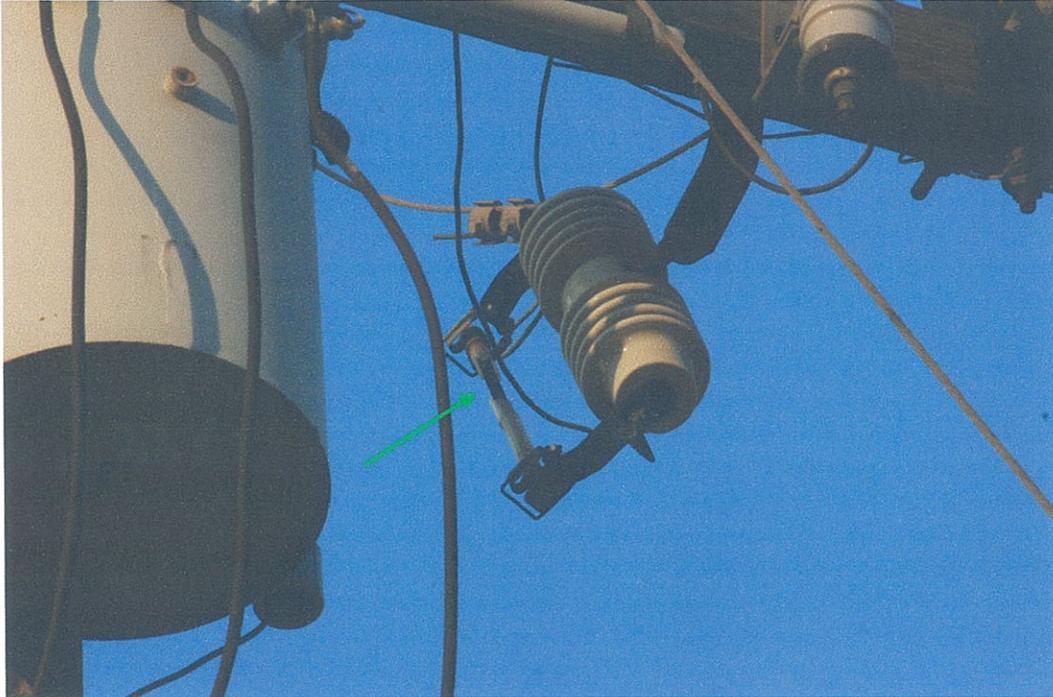
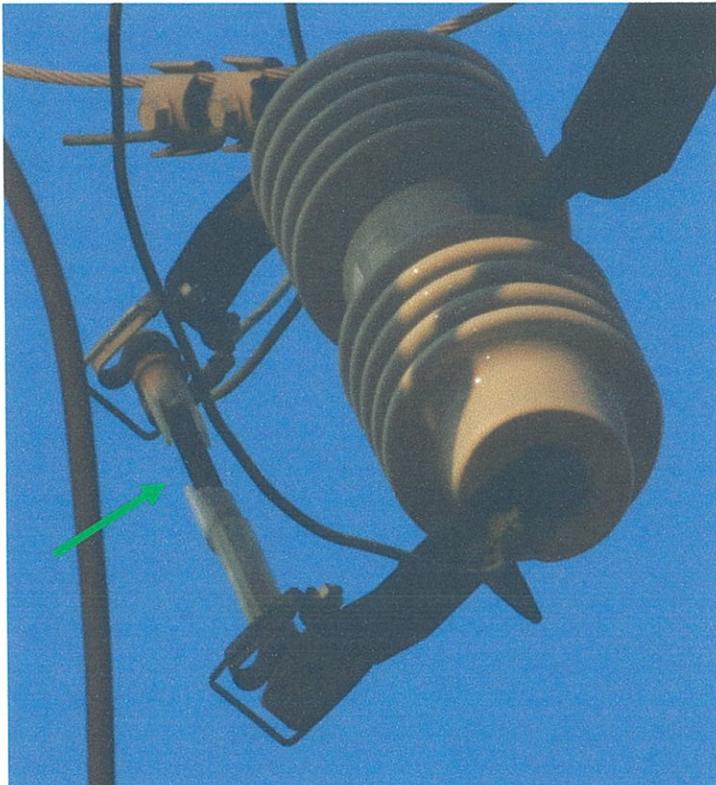
Picture # 22 (Photograph I.D. # 1-60) with Enlarged view of Liquid Filled Glass Fuse

The liquid filled glass fuse on the side of the downed conductor had blown (tripped) and glass was missing from around its length. The liquid filled glass fuse on the opposite side was still intact with no indication it had blown.
