DEPARTMENT OF FORESTRY
AND FIRE PROTECTION

INVESTIGATION REPORT

Case Number: 07-3522-075

Case Name: MARTIN

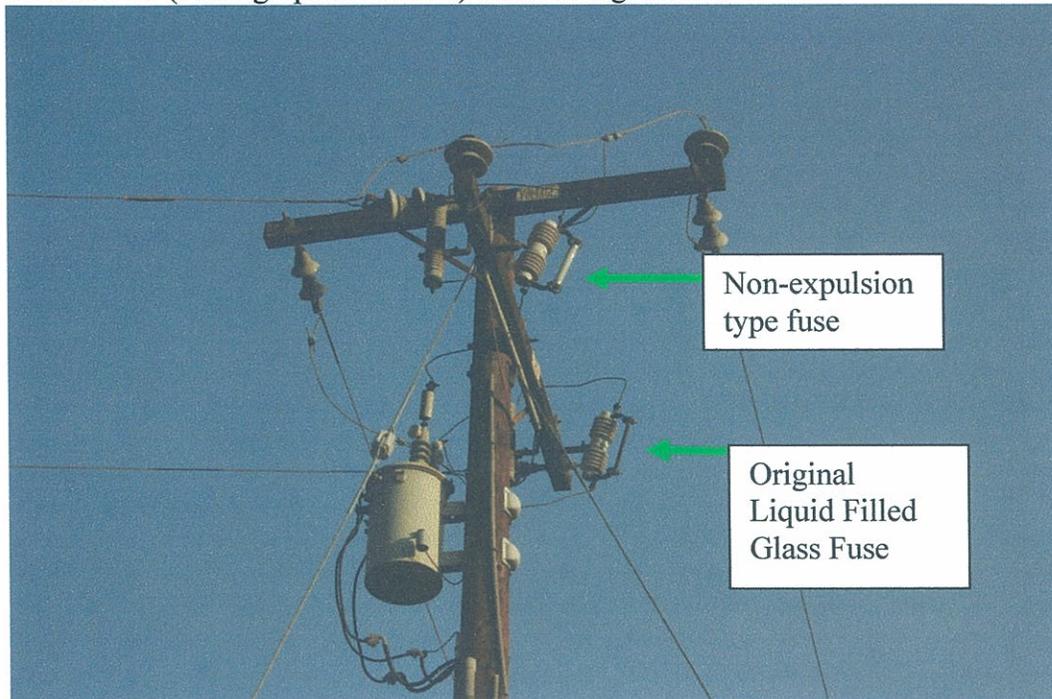
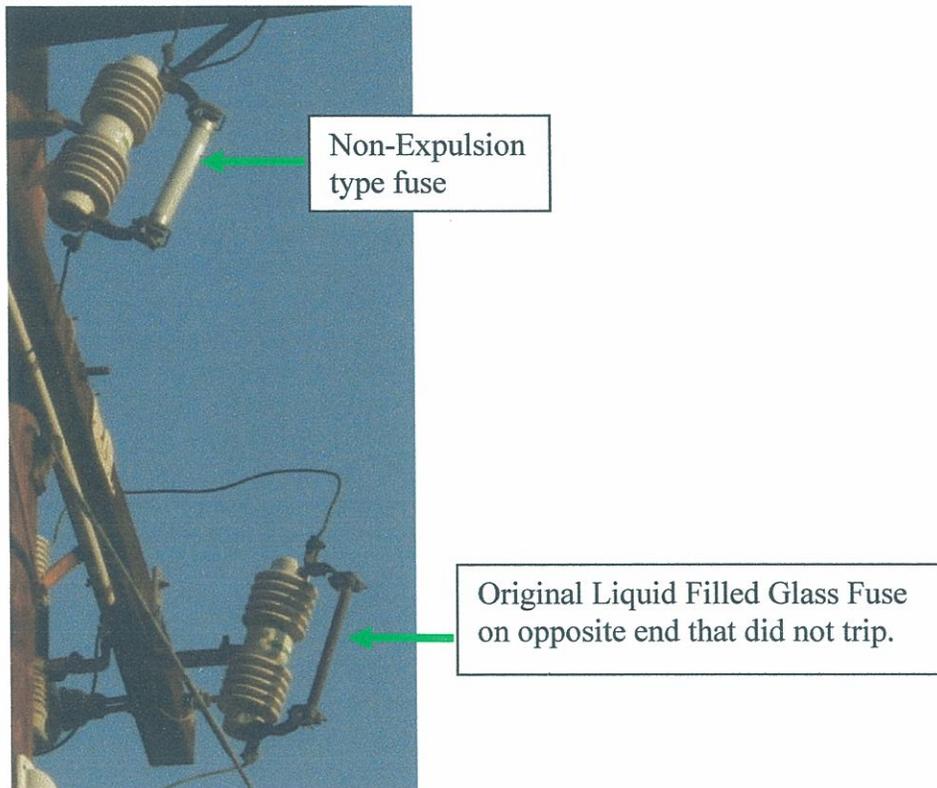
Picture # 23 (Photograph I.D. # 2-4) with Enlarged View

On October 24, 2007, I noted the blown liquid filled glass fuse on pole number 2137612E had been replaced with a non-expulsion type fuse. The liquid filled glass fuse located on the opposite side that did not trip was not replaced.

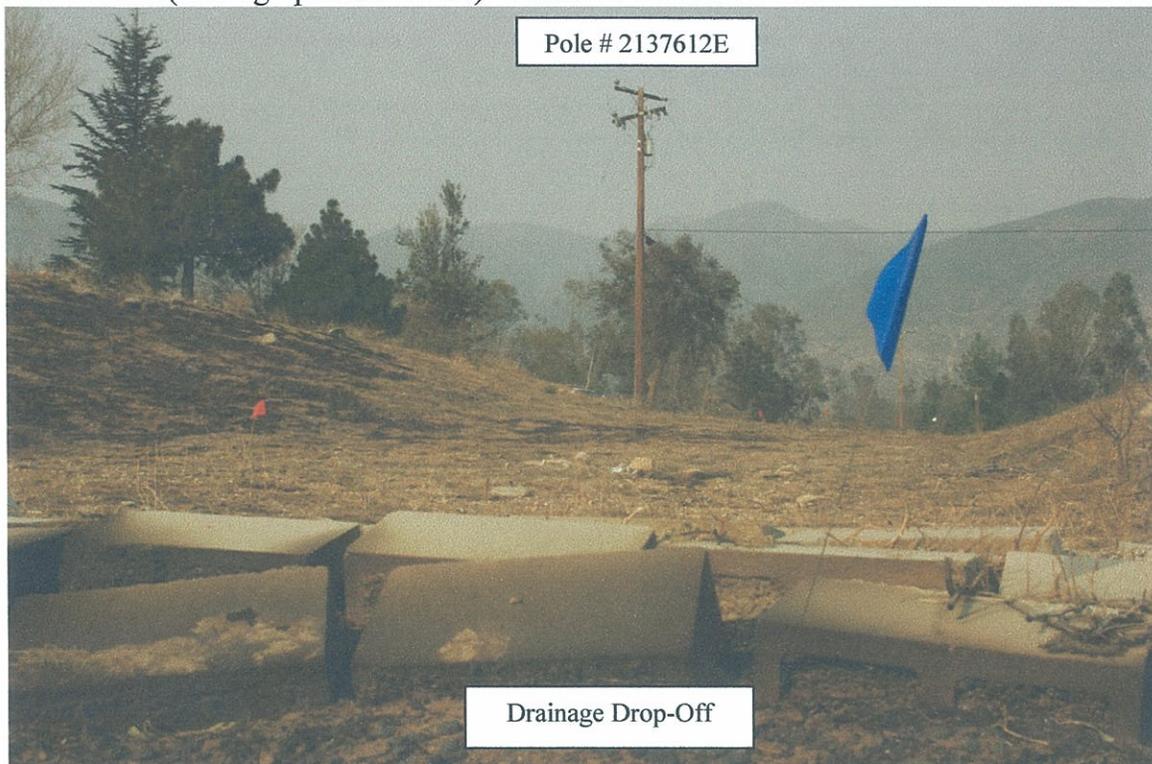
Picture # 24 (Photograph I.D. # 5-14)

29 On October 23, 2007, at about 8:10 a.m., I began examining the surrounding fire
30 area and noted there were numerous burned spots in a natural drainage south of pole
31 number 2137612E. The drainage was approximately 45 feet wide until it made a drop-off
32 approximately 170 feet southwest of the pole. The top of the drop-off had been lined with
33 cinder blocks to prevent erosion in the event of heavy water run-off. From the end of the
34 drop-off, the drainage continued another 150 feet south to Martin Ranch Road and the S-
35 curve behind (W-7) Monica Soares' residence. The topography created a channel to funnel
36 the wind and any burning embers being fanned by the strong Santa Ana winds coming
37 from the north and northwest.

View looking north: there were numerous burned spots in a natural drainage south of pole number 2137612E. The drainage was approximately 45 feet wide until it made a drop-off approximately 170 feet southwest of the pole. The top of the drop-off had been lined with cinder blocks, most likely to prevent erosion in the event of heavy water run-off.

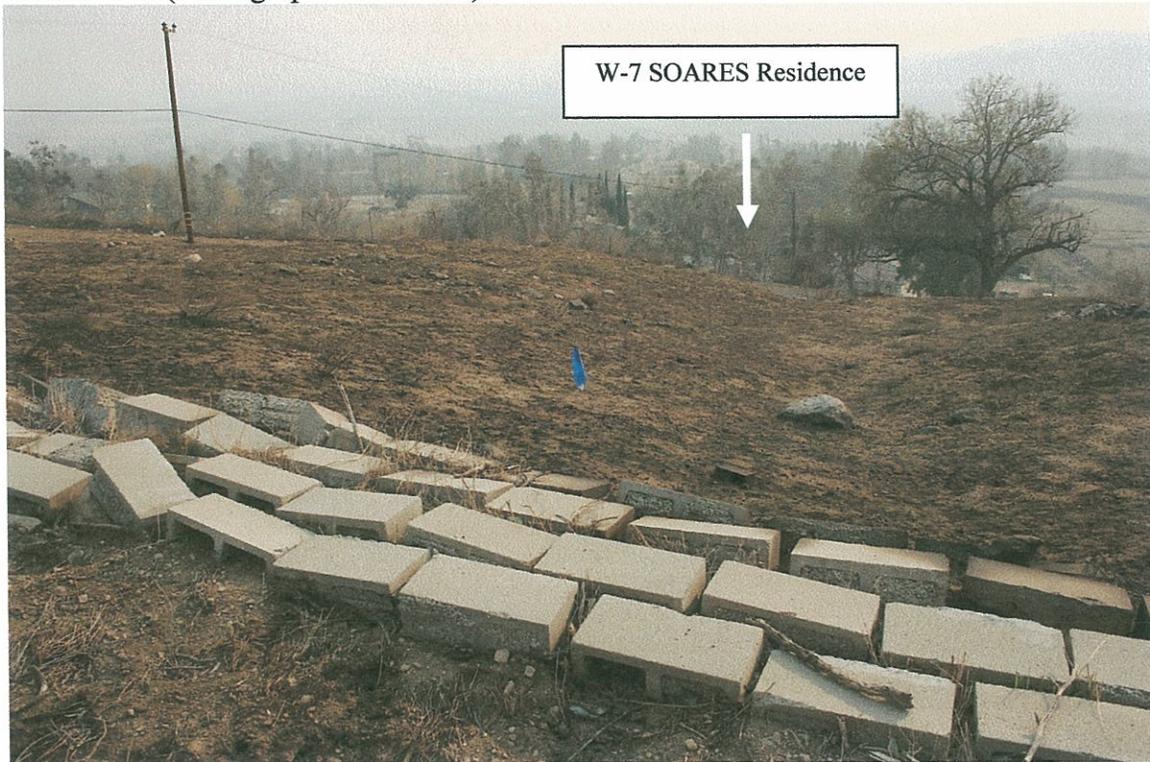
Picture # 25 (Photograph I.D. # 5-11)

View looking south: from the end of the drop-off the drainage continued another 150 feet to Martin Ranch Road and the S-curve behind W-7 SOARES' residence. As a result of this topography, the drainage became a channel to funnel the wind and burning embers being fanned in advance of the fire origin by the strong Santa Ana winds coming from the north and northwest.

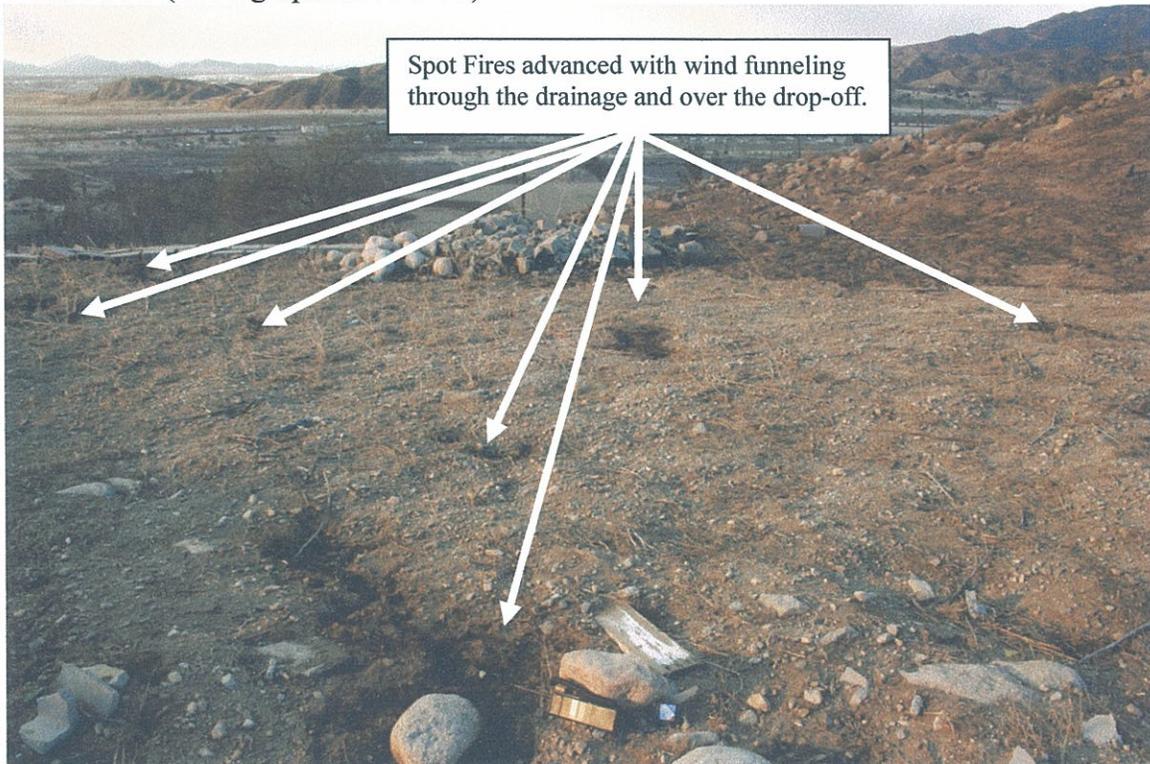
Picture # 26 (Photograph I.D. # 1-81)

View looking south from a point between pole # 2137612E and the drainage drop-off

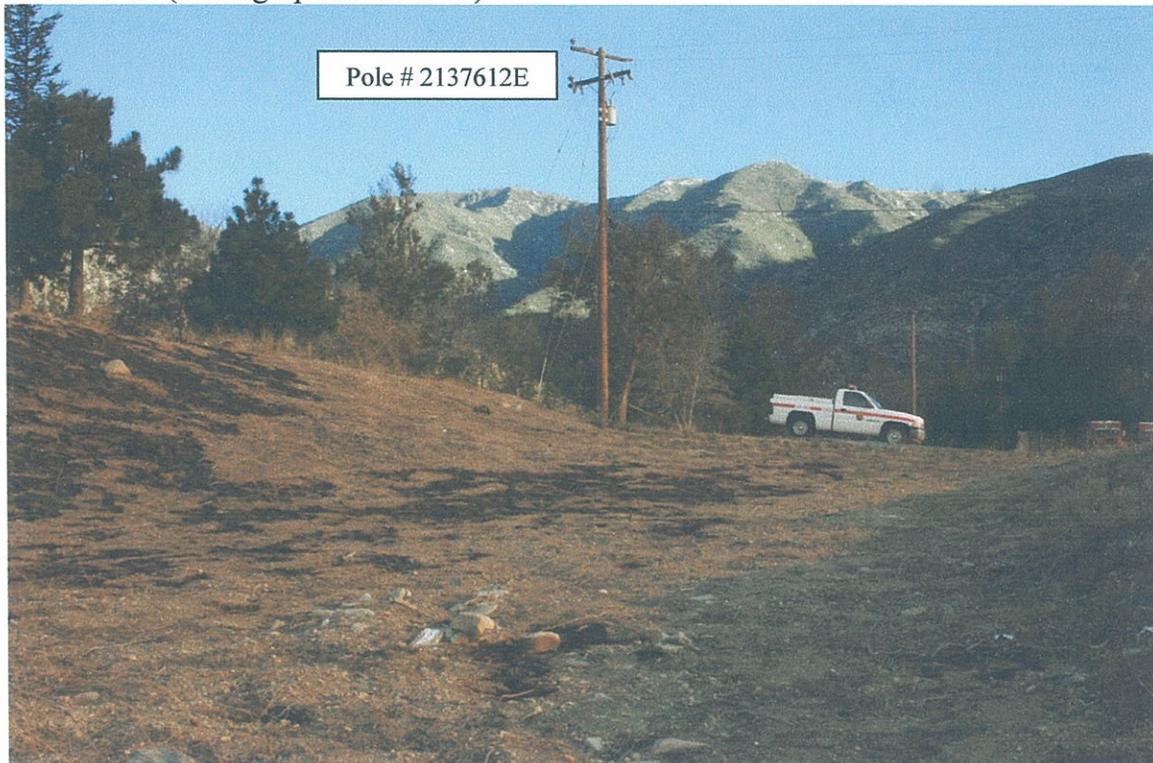
Picture # 27 (Photograph I.D. # 1-83)

View looking north from the drainage drop-off towards pole # 2137612E.

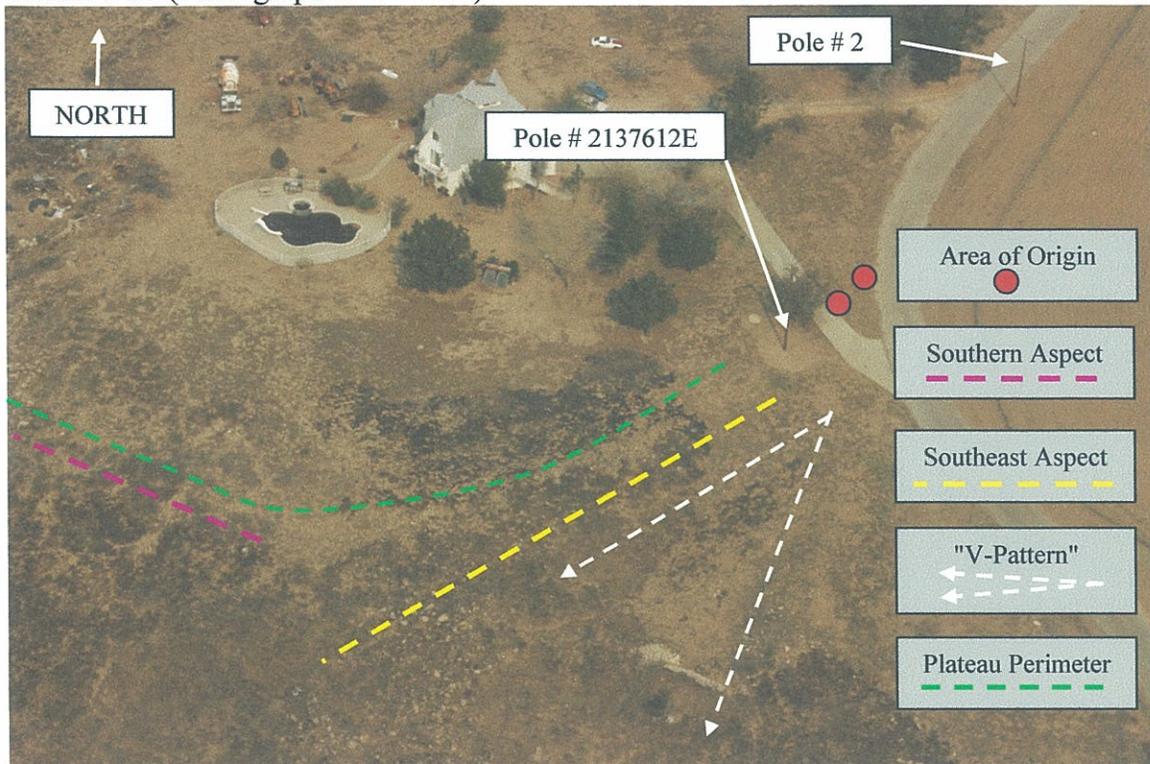
Picture # 28 (Photograph I.D. # 4-24)

Aerial view showing area the spot fires burned in the drainage, and the "V-Pattern" created by the increase in number and size of the spot fires as they advanced in front of the area of origin pushed by strong wind. The fire also back-burned up the southeast aspect of the drainage onto the flat ground plateau surrounding the dome house. The fire then burned over the southern edge of the plateau southwest of the dome house.

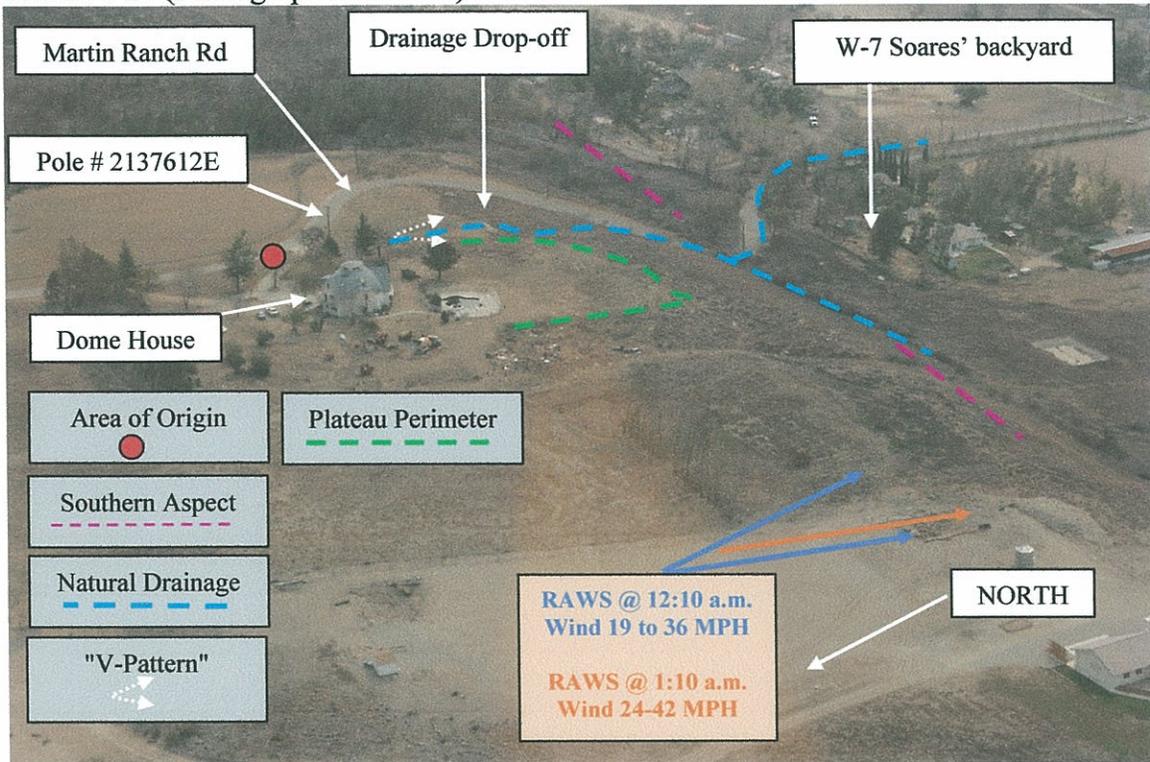
Picture # 29 (Photograph I.D. # 4-3)

The fire advanced beyond the drainage drop-off and began its back-burning progression toward the northeast and along Martin Ranch Road. Most of the natural drainage was sheltered from cross winds coming from the west by the height of the sloping hillside on the west side of the drainage until the drainage reached Martin Ranch Road at the S-curve behind W-7 SOARES' backyard. At that point, and towards the west, the plateau's elevation which was providing a shelter from cross winds on the west side of the drainage had a steep drop-off on the south facing hillside, and there was no longer a barrier to influence the cross winds. This topographical transition significantly contributed to the southeasterly spread of the fire at that point where the natural drainage met Martin Ranch Road. As a result, the intensity and rate of fire spread increased with advancing spot fires and burned up the southern exposure on the opposite side of Martin Ranch Road behind W-7 SOARES' backyard.

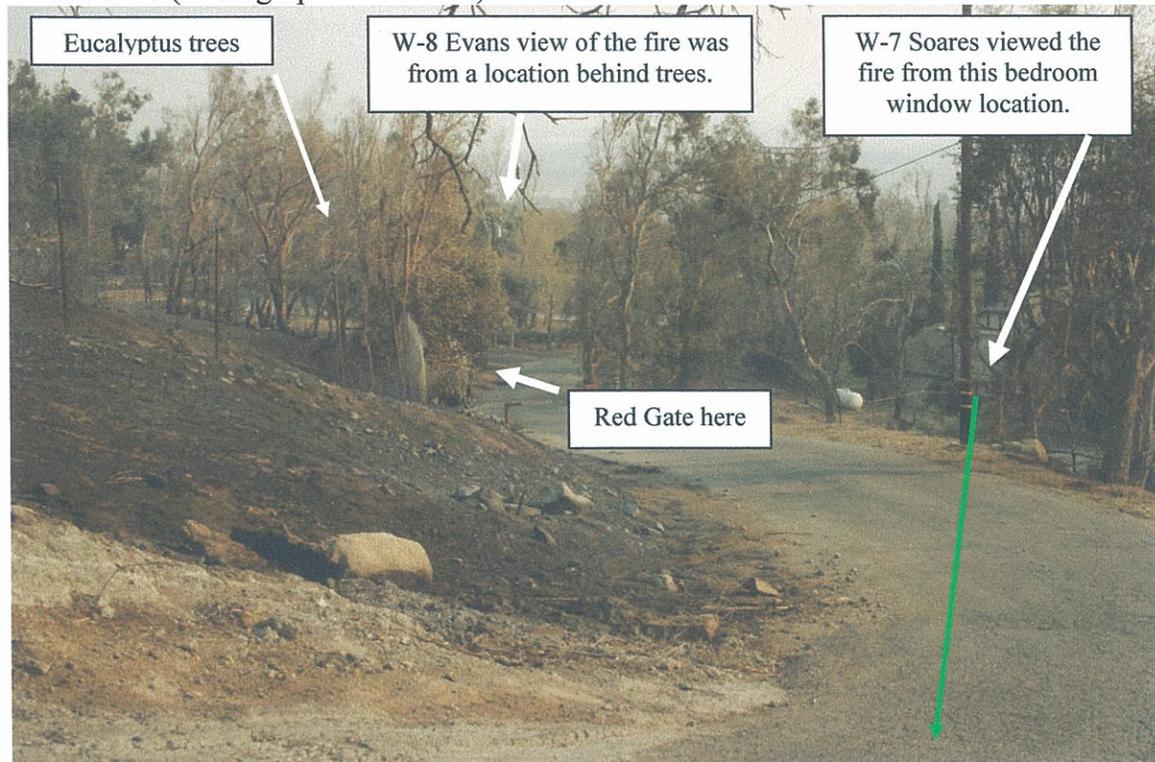
Picture # 30 (Photograph I.D. # 5-42)

Photographer location: Martin Ranch Road in the S-curve where the natural drainage meets the road (looking southeast). W-7 SOARES' residence is on the right side adjacent to the propane tank, and the direction where she first saw the fire is indicated with the green arrow. W-8 EVANS stated she first saw the fire where the car had turned around by the red gate twenty minutes earlier. The eucalyptus trees lining the road showed intense burning all the way down to ground level occurred through the vegetation, and the fire was well established when it burned in and around the area of the red gate.

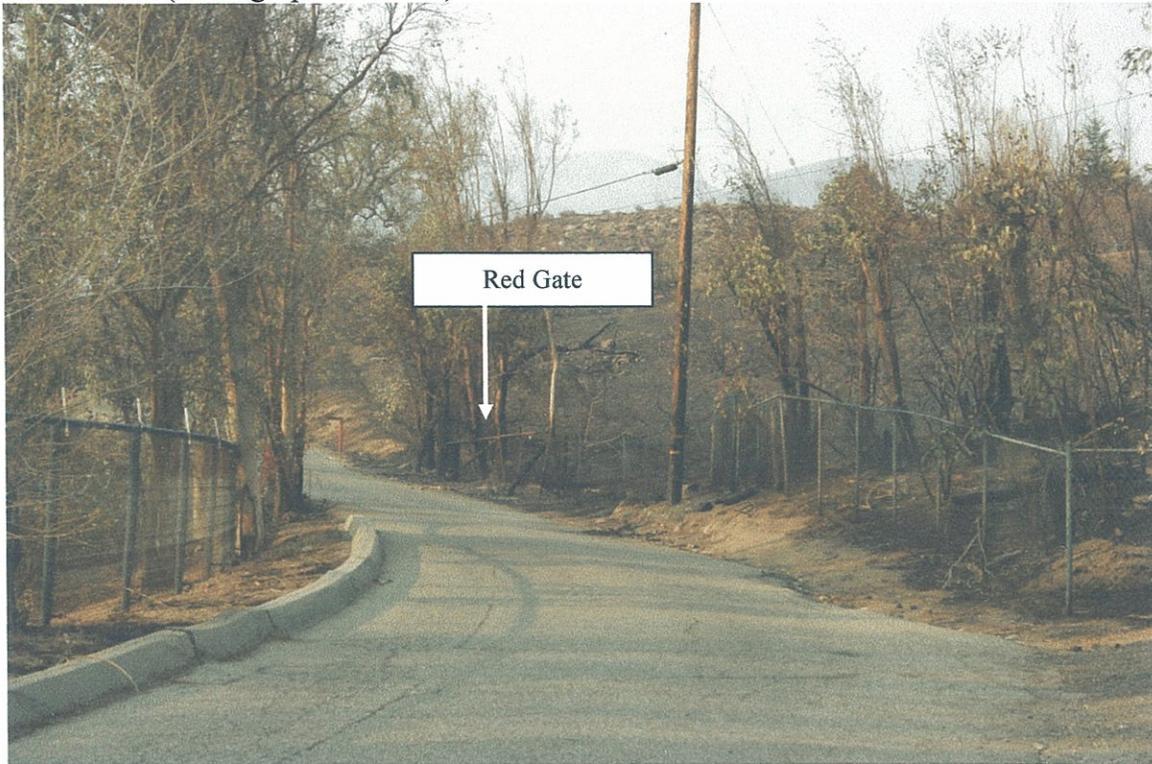
Picture # 31 (Photograph I.D. # 45)

View looking northwest on Martin Ranch Road, and W-7 SOARES' residence is on the left hand side out of view. The red colored gate is indicated by the white arrow. This is the area W-8 EVANS saw the unidentified vehicle turn around approximately twenty minutes prior to the fire, and she also identified this area as where she first saw the fire.

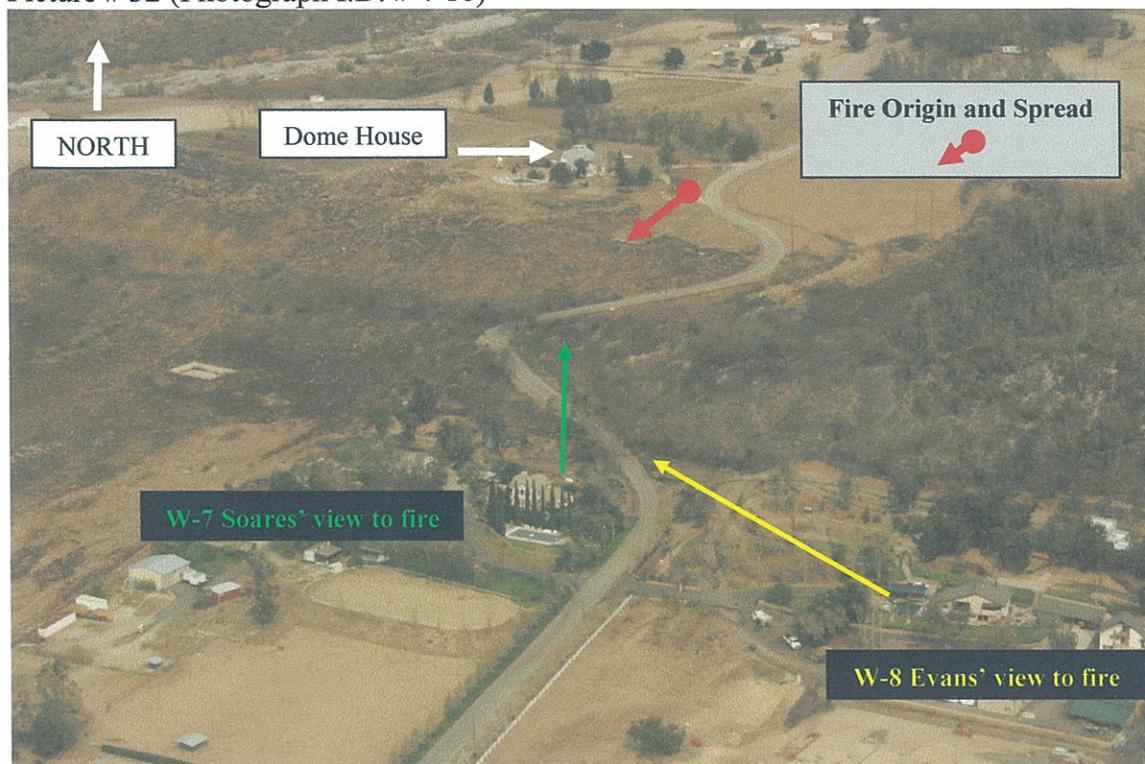
Picture # 32 (Photograph I.D. # 4-10)

W-7 SOARES looked out her north facing bedroom window and saw fire burning behind her house on the hillside in the direction of the dome house. When W-8 EVANS arrived outside by her pool, she looked towards the red gate area and could see fire was burning in that area.
