10- ATTACHMENT: Photographs
Picture # 1 (Photograph I.D. # 1-13)

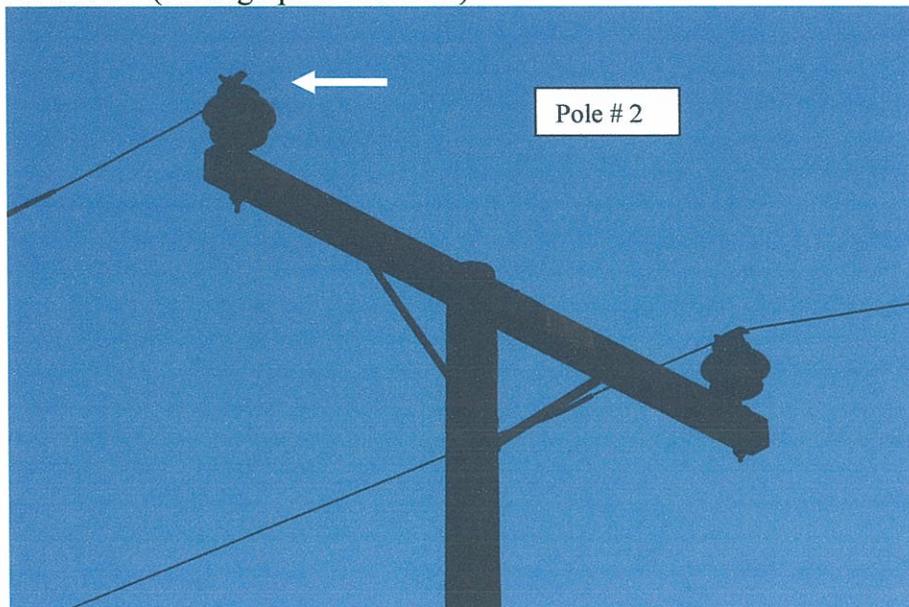
Picture # 2 (Photograph I.D. # 1-28)

The opposite end of the conductor had detached from above the insulator on the single cross arm attached to pole number 2, which was located one span northeast of pole number 2137612E.

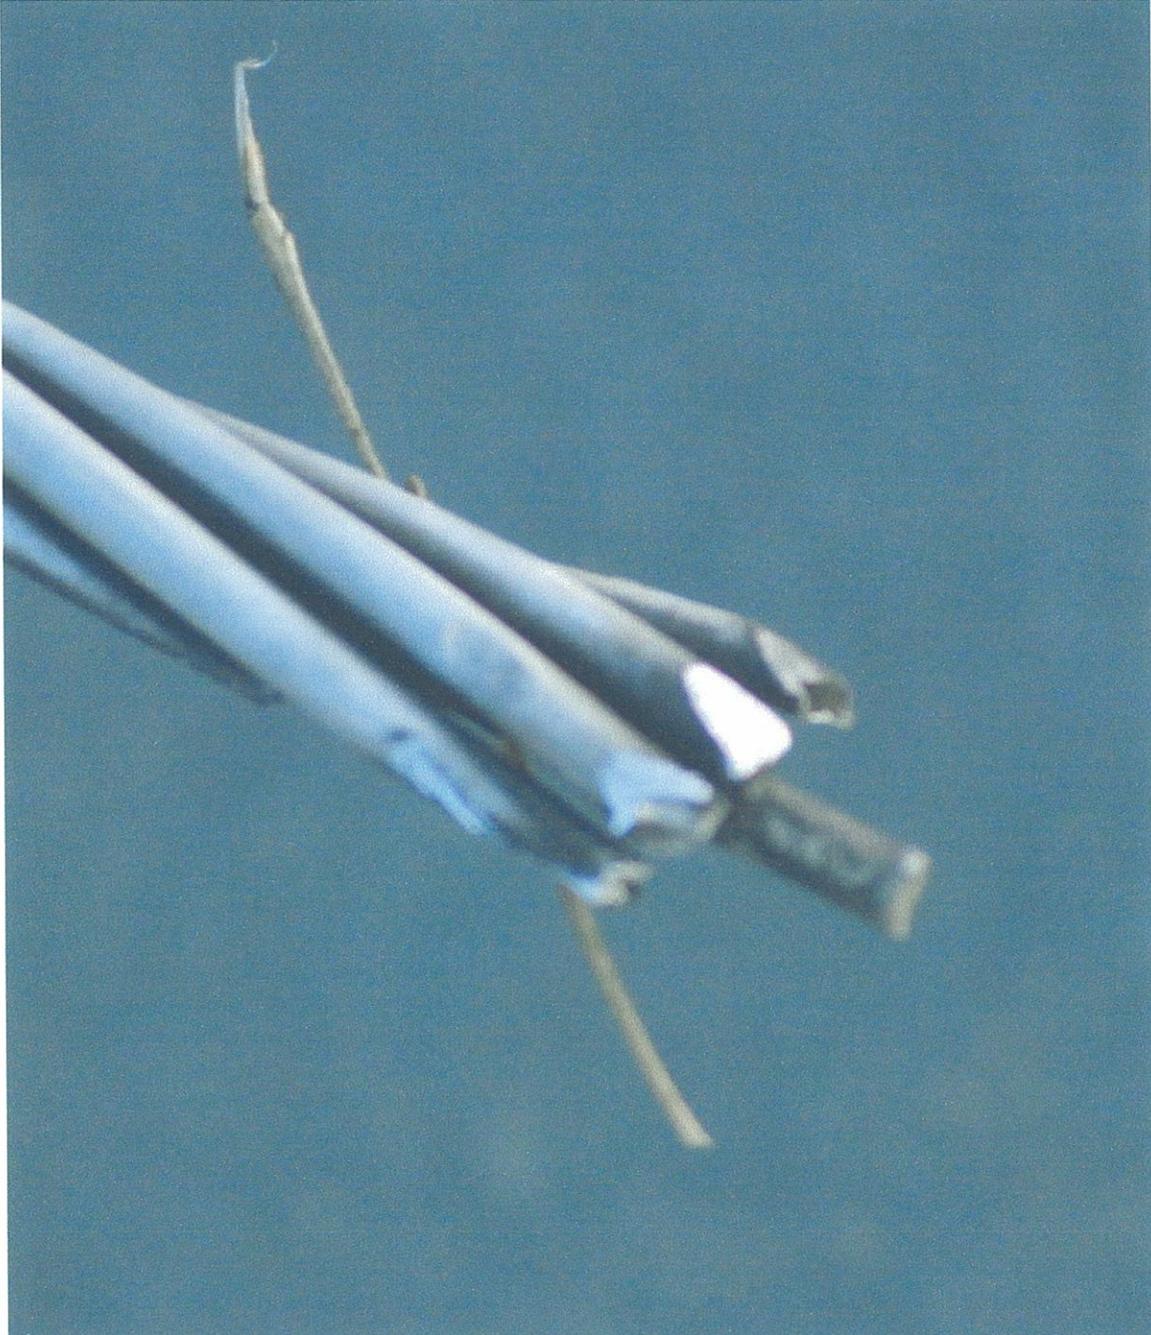
Picture # 5 (Photograph I.D. # 1-34 Enlarged)

Enlarged view of picture # 5: the conductor broke at that point where it had been attached to the insulator. The individual wire strands, comprising the whole of the broken end, were shiny in appearance with defined beveled shaped ends similar to the end of a cylindrical wire broke into two pieces by bending it back and forth until weakened to its breaking point.

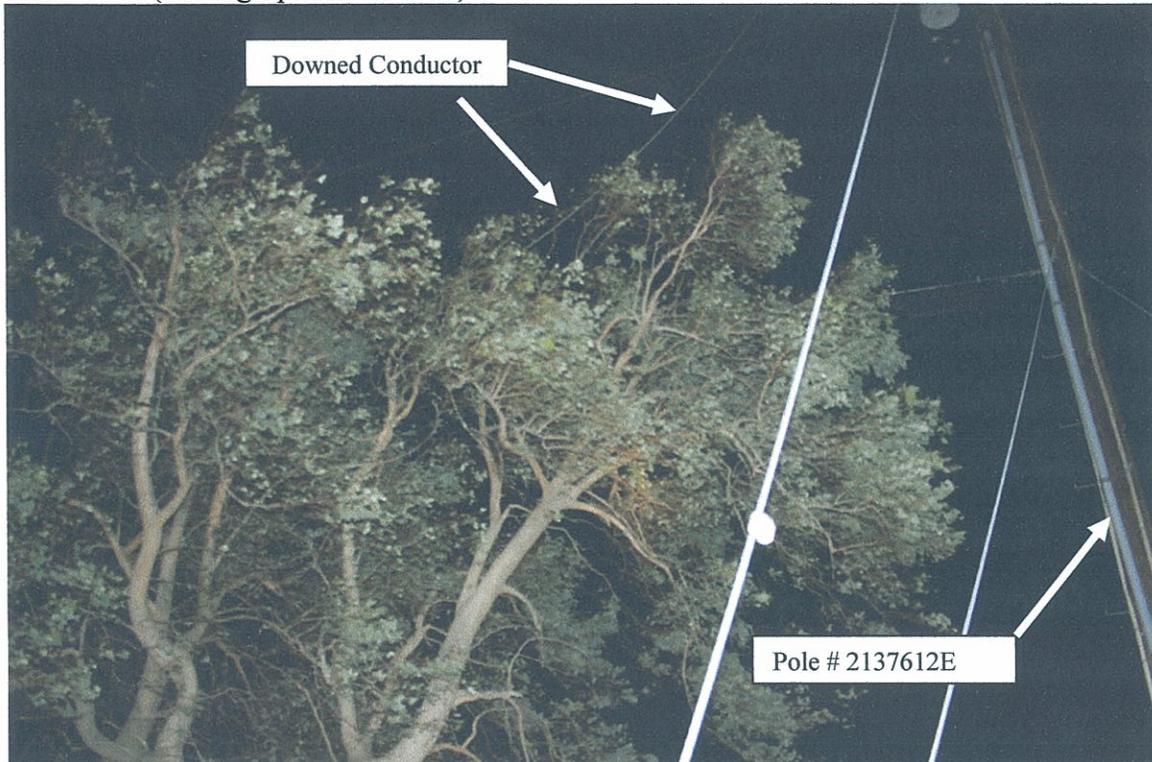
Picture # 6 (Photograph I.D. # 1-17)

When the conductor broke free from its insulator on pole number 2, the slack fell down on top of a tree, located on the southwest edge of the cement driveway leading into 1701 Martin Ranch Road, and through its branches. The base of the tree was approximately 15 feet northwest of the base of pole number 2137612E. After falling on top of the tree, the conductor landed across the northeast edge of the driveway and onto an area of dried grass bordered by the driveway and Martin Ranch Road. The conductor lay across the road and back into dirt where its broken end was located next to pole number 2.

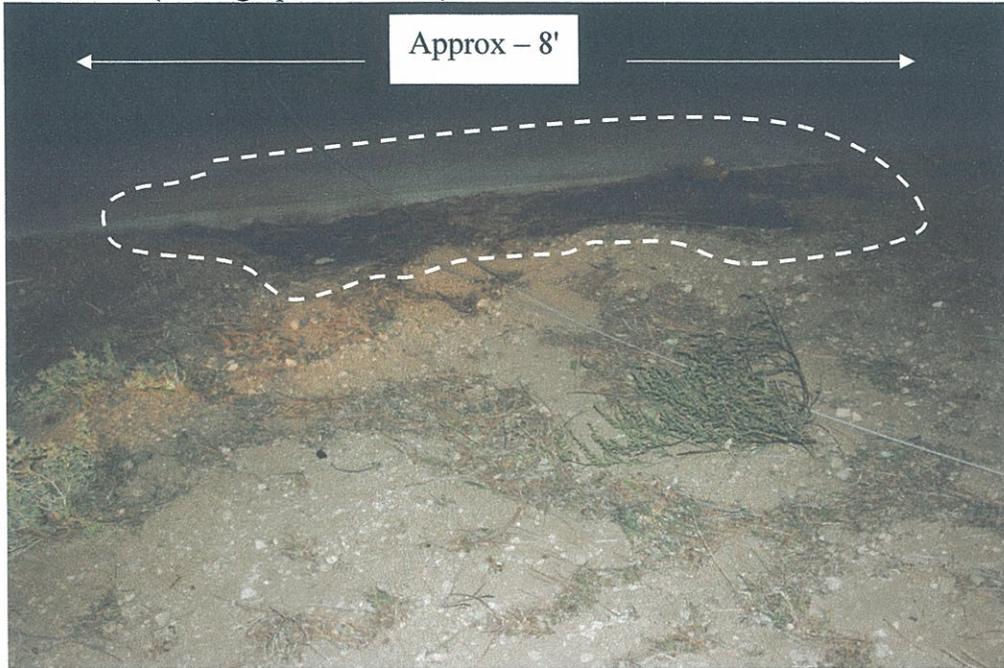
Picture # 7 (Photograph I.D. # 1-4)

There were three areas of sparse grass burned underneath the conductor lying on the ground. The first area examined was approximately 8 feet in length along the northeast edge of the driveway, and it varied in width from approximately two to eighteen inches wide.

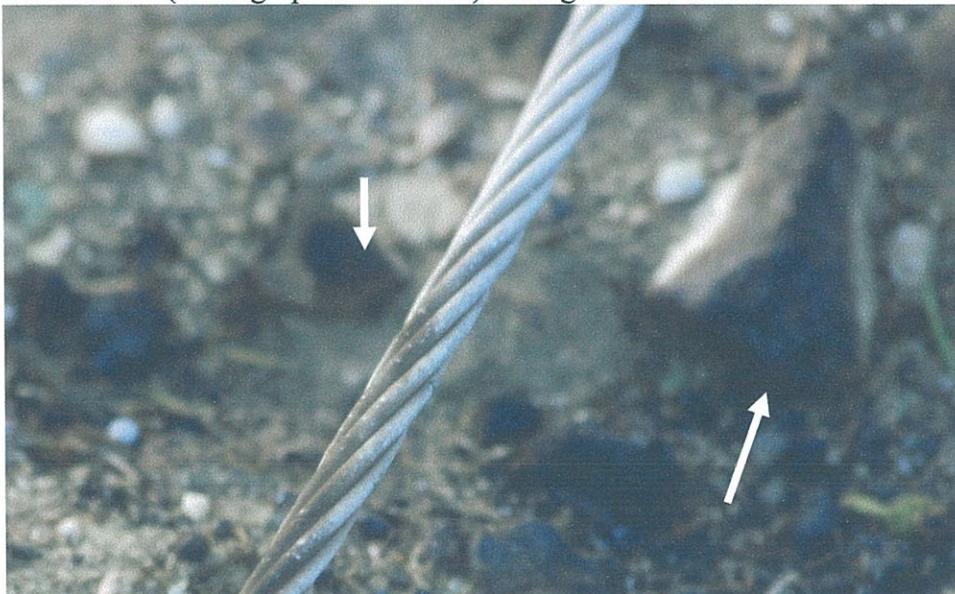
Picture # 15 (Photograph I.D. # 1-39) Enlarged View

The scorch marks on the rocks indicated directional heat from the top down. This was evident by the unburned edges at ground level around the rocks. The conductor was found on top of the large rock, shown on the right side in this image, when taking the initial photographs (see picture # 13, photograph I.D. # 1-6).

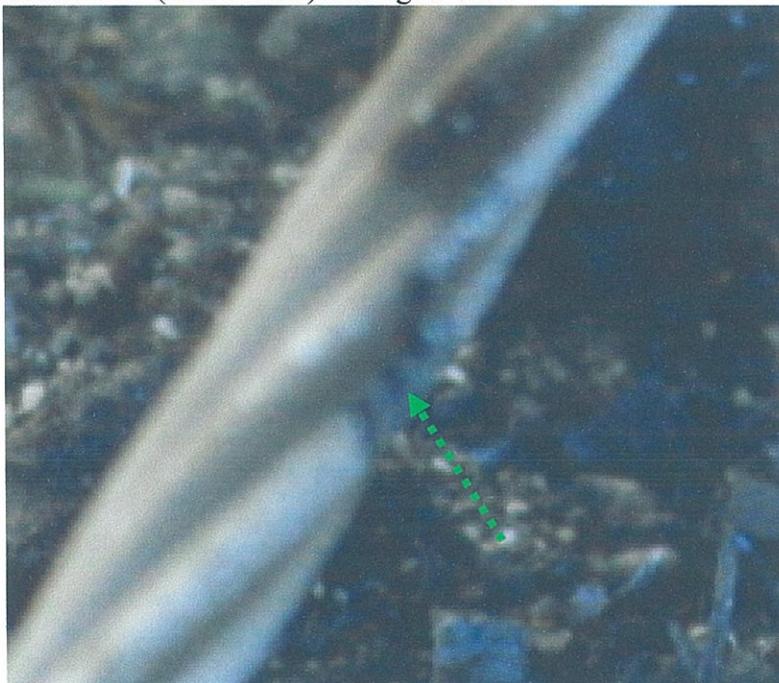
Picture # 17 (I.D. # 1-39) Enlarged View

Detailed close-up view of pitting identified by dashed green arrow in Picture # 14 (Photograph I.D. # 1-39).

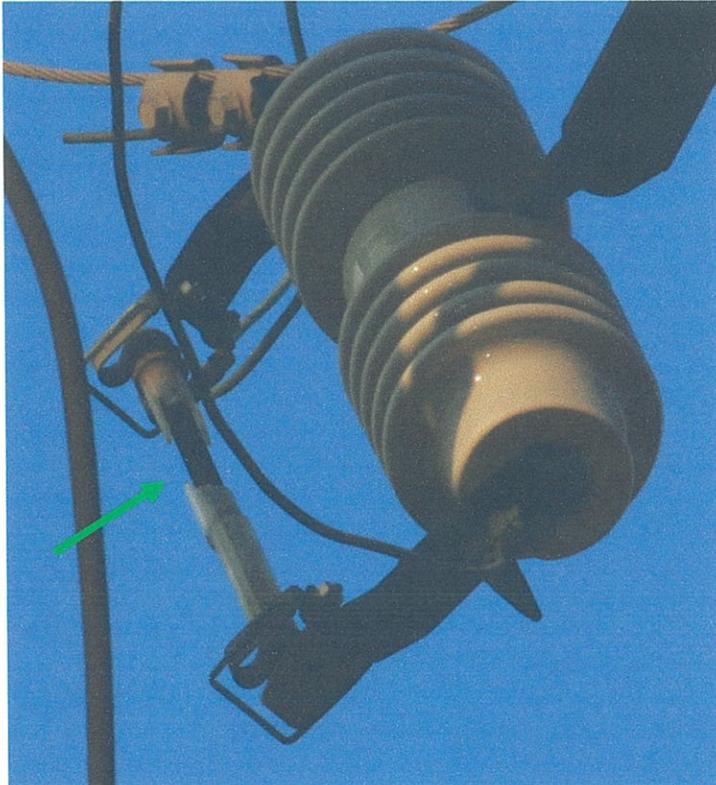
Picture # 22 (Photograph I.D. # 1-60) with Enlarged view of Liquid Filled Glass Fuse

The liquid filled glass fuse on the side of the downed conductor had blown (tripped) and glass was missing from around its length. The liquid filled glass fuse on the opposite side was still intact with no indication it had blown.

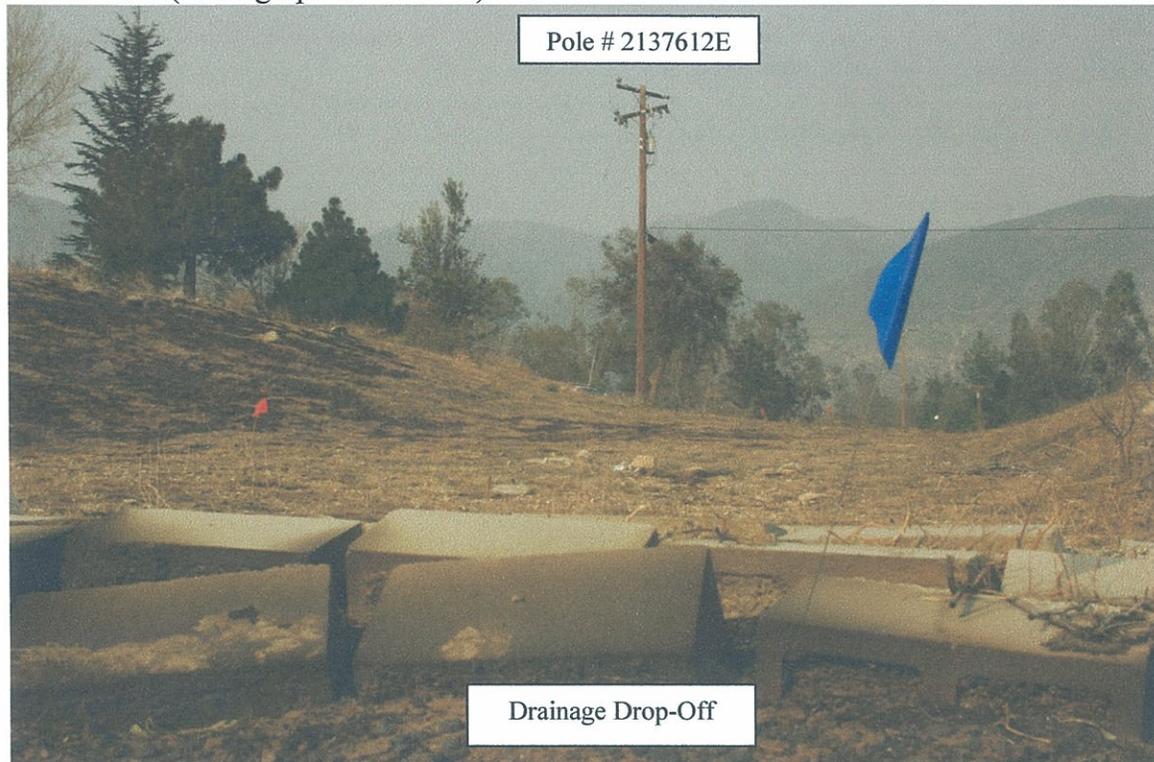
Picture # 24 (Photograph I.D. # 5-14)

View looking north: there were numerous burned spots in a natural drainage south of pole number 2137612E. The drainage was approximately 45 feet wide until it made a drop-off approximately 170 feet southwest of the pole. The top of the drop-off had been lined with cinder blocks, most likely to prevent erosion in the event of heavy water run-off.

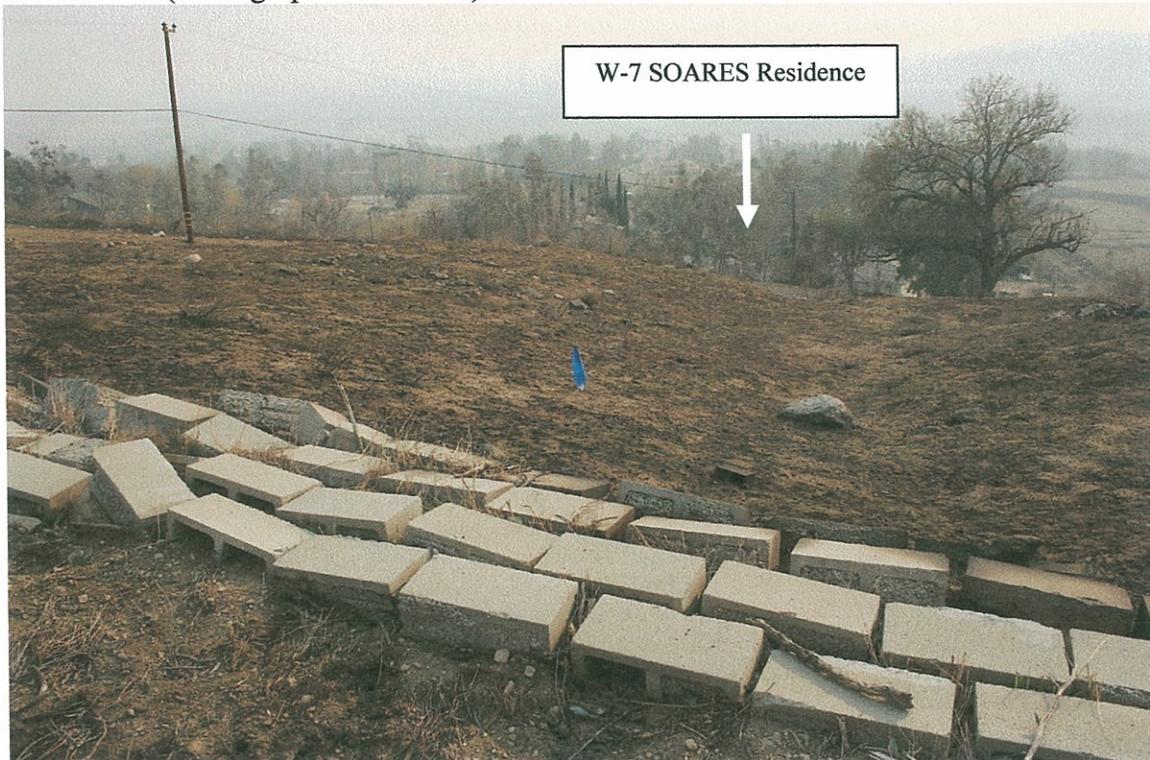
Picture # 25 (Photograph I.D. # 5-11)

View looking south: from the end of the drop-off the drainage continued another 150 feet to Martin Ranch Road and the S-curve behind W-7 SOARES' residence. As a result of this topography, the drainage became a channel to funnel the wind and burning embers being fanned in advance of the fire origin by the strong Santa Ana winds coming from the north and northwest.
