Project Status Memorandum		
To:	Mr. Shane Cunningham CalFire PO Box 994246 Sacramento, CA 94244-2460	Subject: Status to date Re: Investigation of Valley Fire, Lake Co 8015 High Valley Rd, Kelseyville, CA Incident # CALNU 008670 Request # O-351 DOL 9/12/2015 Contract # 7CA02326
From:	Jim Nolt, P.E.	Date: September 30, 2015

CALFIRE - INCIDENT # CALNU 008670, REQUEST # 0-351

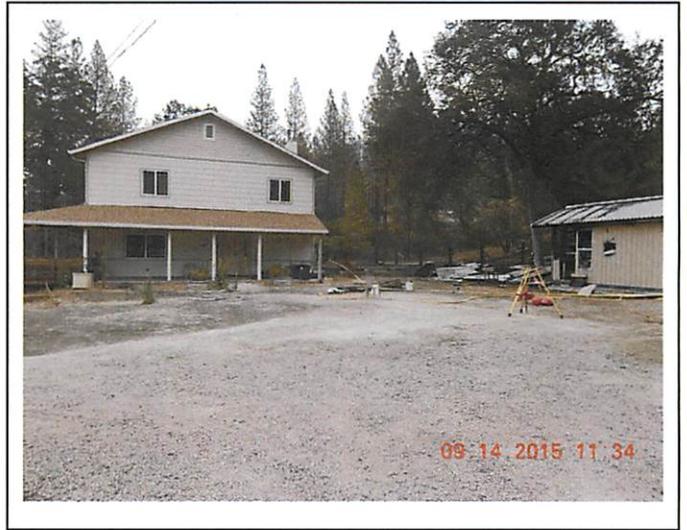
Photo 2

- 3.01 I was asked by CalFire to assist with the examination of the subject fire scene.
- 3.02 When I completed my initial site survey (see photos 2 through 4 as typical) my attention was directed at the remains of an electrical conductor splice (see photos 5 & 6 as typical).

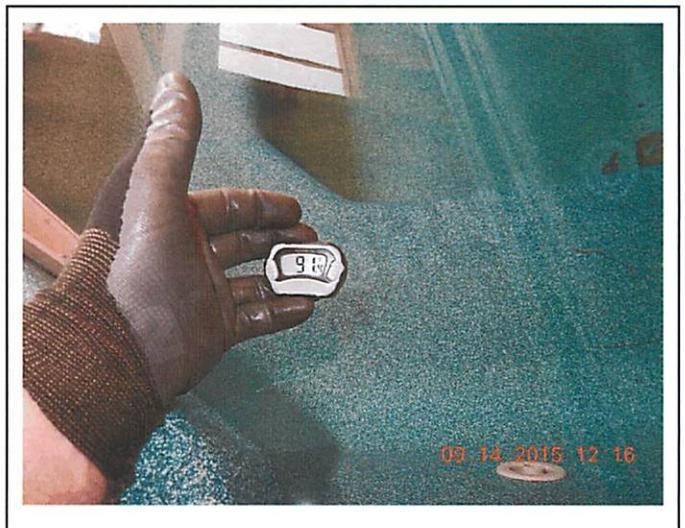
Photo 10

- 3.03 This splice was one of two splices made in the branch circuit conductors providing power from a 2-pole 40-amp circuit breaker (see photos 4 & 17 as typical) to an operating spa/hot-tub (see photos 9 & 10 as typical).

- 3.12 The 91°F temperature of the water in the hot tub was maintained by a 5.5 kW, 240V heater (see photos 10 and 16 as typical). The heating element appeared to be functional.

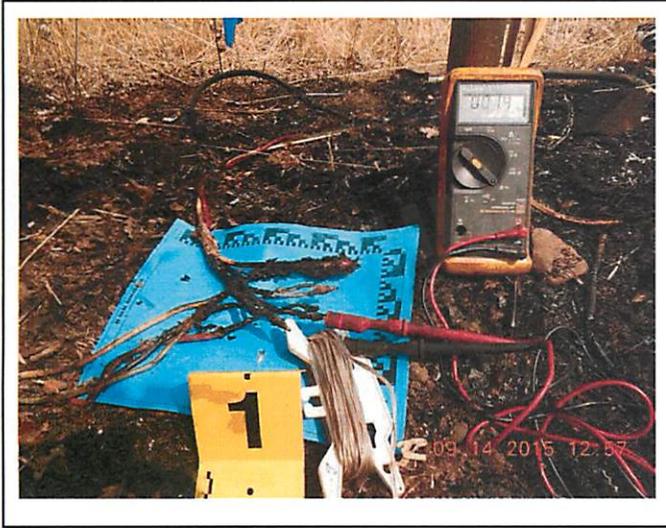
Photo 19

- 3.14 I was able to confirm that conductors at the splice of interest were provided power by the 2-pole 40-amp circuit breaker. See photos 18 through 21 as typical.

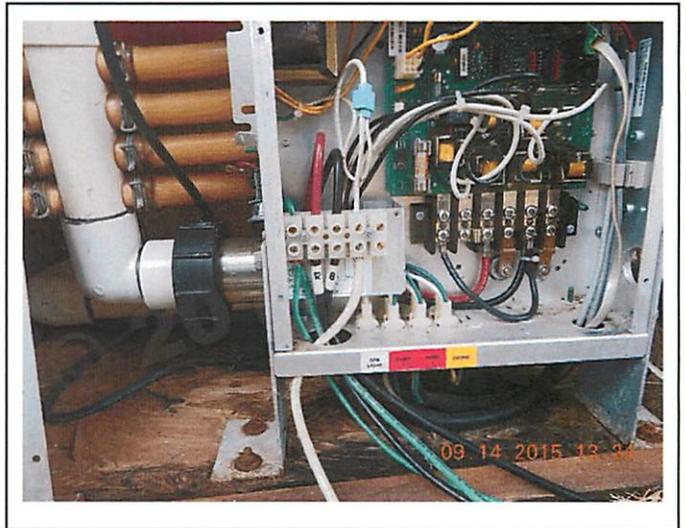
Photo 22

- 3.10 Near the hot tub the jacketed conductors were again spliced to other unjacketed conductors (see photo 9 as typical) that were terminated onto an electrical terminal strip inside the hot tub control enclosure. See the conductors labeled "R" & "B" depicted in photo 22 as typical. Photo 23 shows the same terminations after the conductors had been removed for collection.
