# Valley Fire

State Post Fire Watershed Emergency Response Team  
Addendum I

Hazard Site Evaluation

October 2015

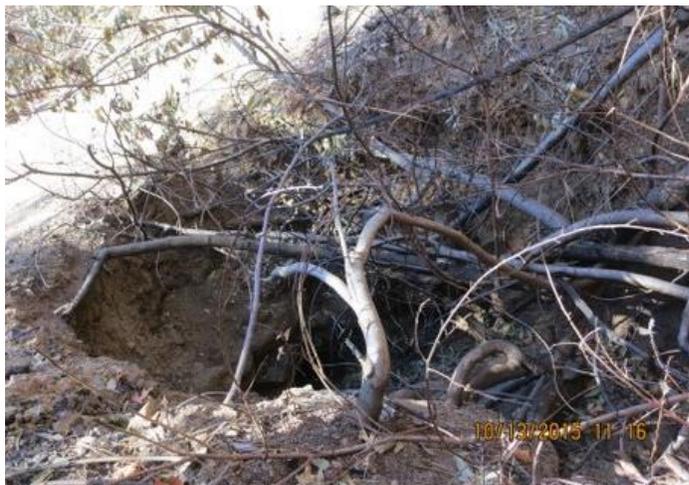
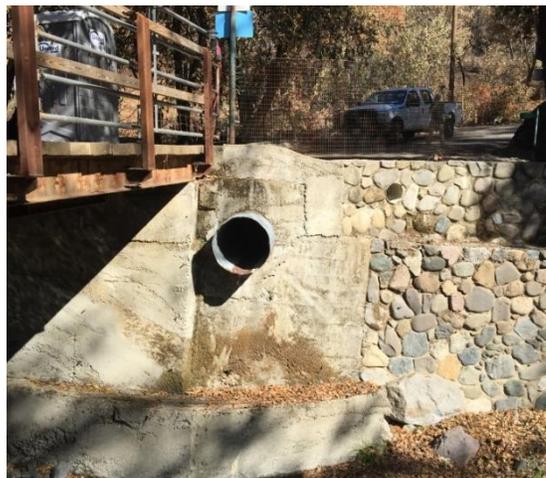
## Site 105

This site is a home with an adjacent 24-inch culvert fed by a small steep drainage located on Van Dorn Reservoir Road (38.776' N, 122.703' W). The culvert runs under the driveway of the property and flows into the Anderson Creek channel. Anderson Creek is a perennial fish bearing stream in the Putah Creek watershed. The habitat at this site is mixed-riparian. The culvert regularly clogs with debris during normal years according to the property owner. The threat to existing infrastructure is overflow flooding into the home and washing out access road to four properties downstream.

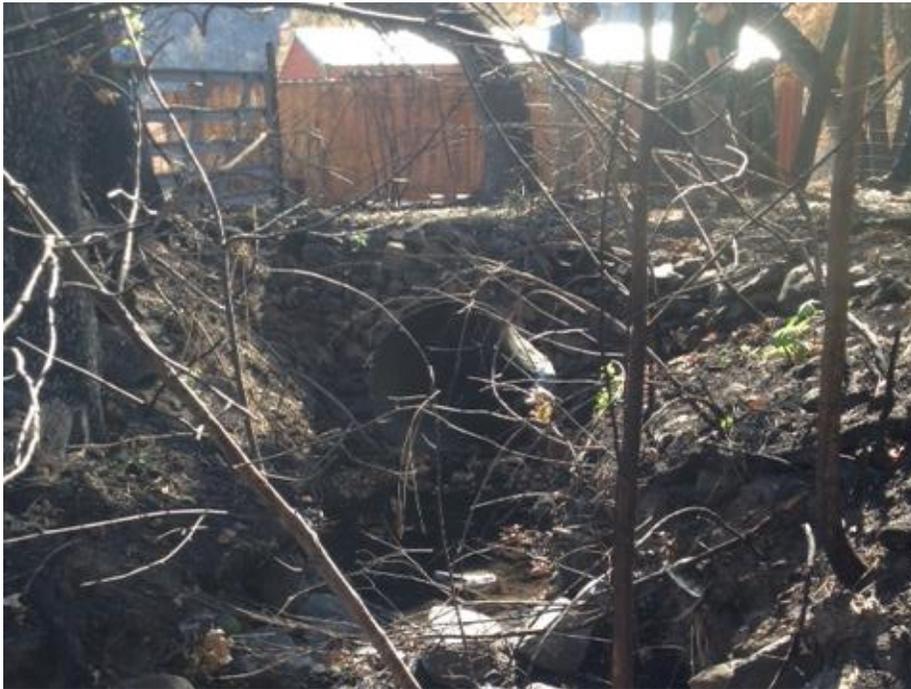
## Site 113

This site is a 36 to 48-inch culvert near a single family dwelling with outbuilding located on Monte Vista Court (38.77714' N, 122.66990' W). The dwelling is located on an unnamed tributary to Putah Creek. The tributary is seasonally dry. Habitat type at this site is oak woodland. Site was heavily burned. The threat to existing infrastructure is debris-laden flow down the creek piling up on the culvert and causing flooding of nearby buildings.

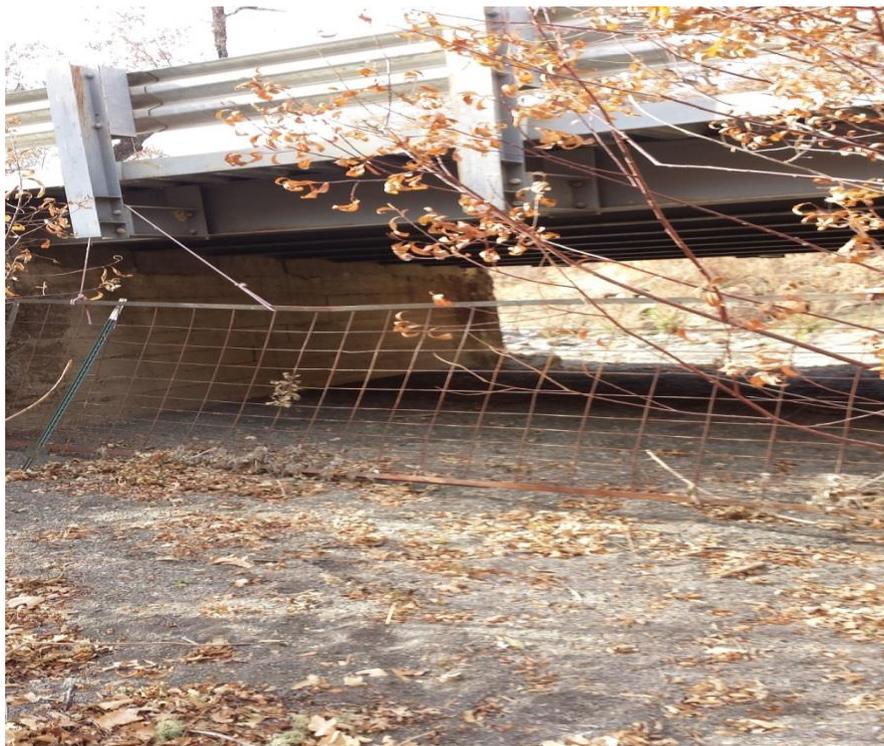
## Site 116

This site is a bridge located on Big Canyon Road (38.77676' N, 122.61748' W). The bridge is located over the Harbin Creek channel. Harbin Creek is a seasonally dry channel in the Putah Creek watershed. The habitat type is oak woodland. There is a fence suspended from the bridge that obstructs debris passage when channel is flowing. The threat to existing infrastructure is debris buildup during high flow flooding the road and surrounding area.

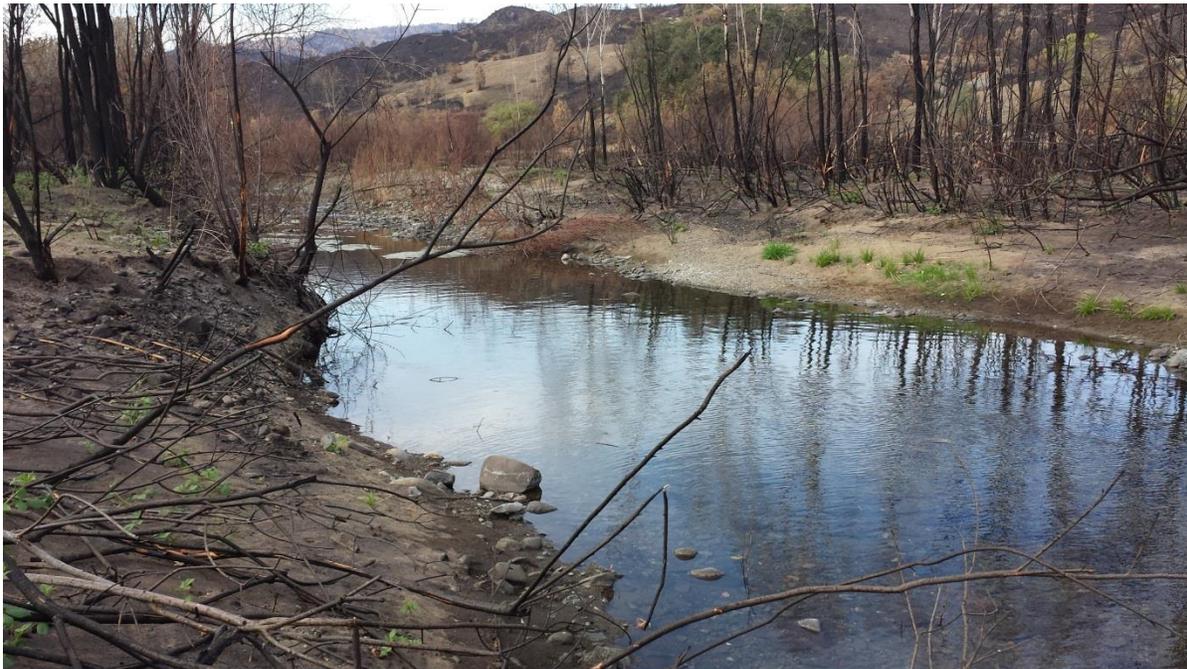
## Site 117

This site is multiple homes in a community along Putah Creek, in the vicinity of Santa Barbara and Napa Streets west of Middletown (38.76307' N, 122.62952' W). Putah Creek is a perennial fish bearing stream. The habitat type at this site is oak woodland. The threat is flooding to multiple single family dwellings.

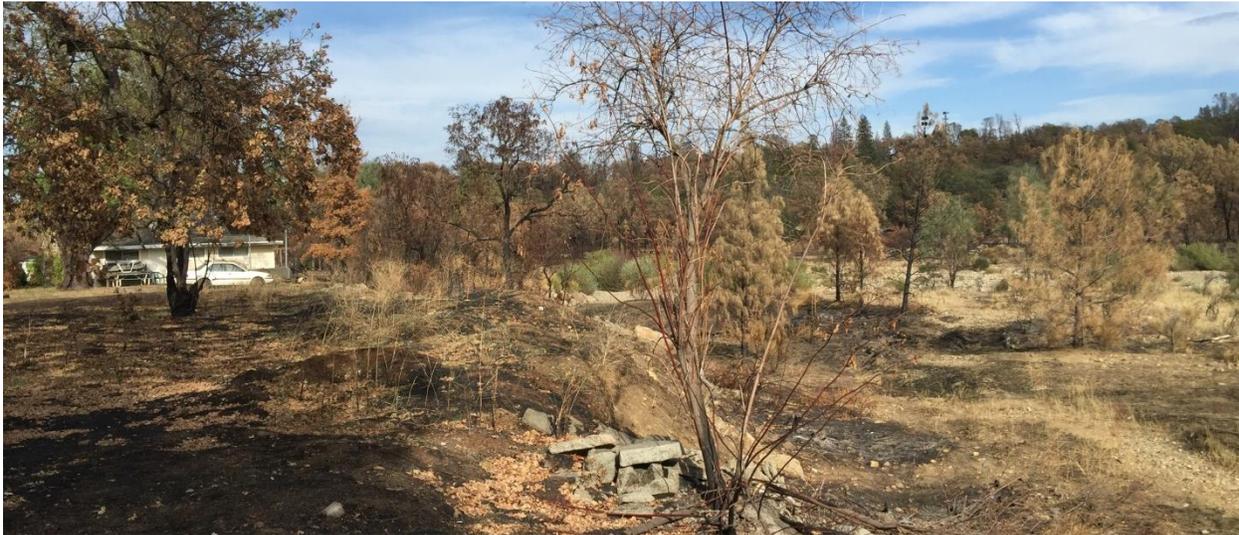
## Site 119

This site is a community of single family homes located near Main Street in Middletown (38.25062' N, 122.61407' W). The community is located along Saint Helena Creek. Saint Helena Creek is a seasonally dry channel in the Putah Creek watershed. Habitat type at this site is oak woodland. The threat to existing infrastructure is debris-laden flooding and debris flow down Saint Helena Creek.

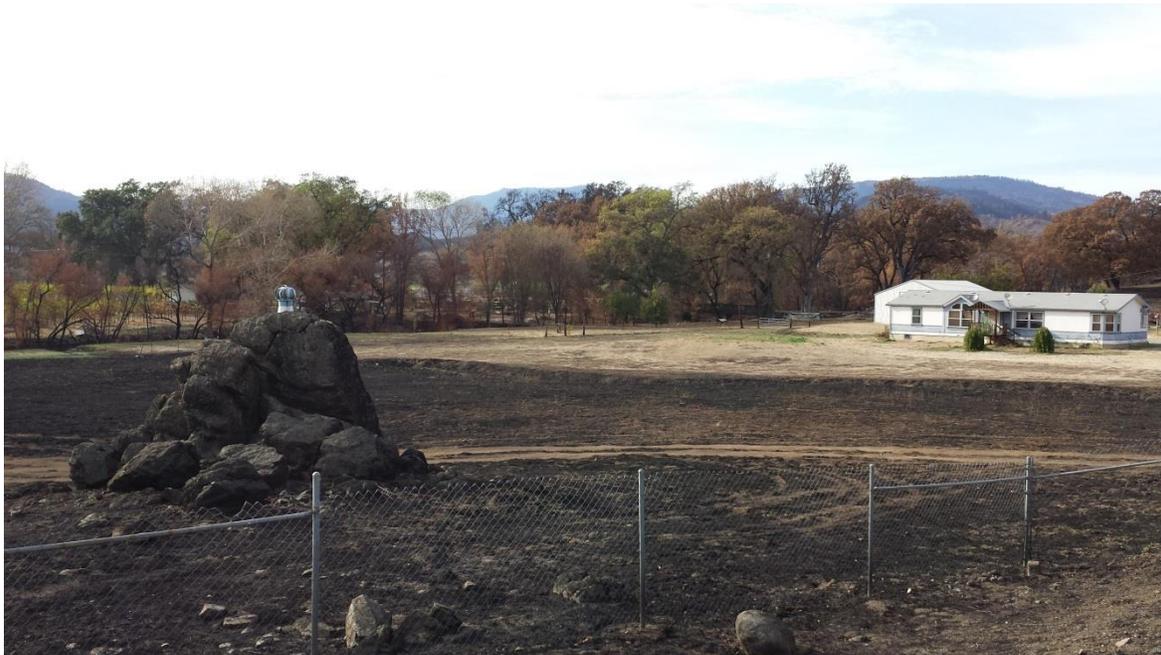
## Site 121

This site is a single family dwelling located on Highway 29 and Saint Helena Lane in Middletown (38.76261' N, 122.60133' W). The house is along Lupiyoma Creek. Lupiyoma Creek is a seasonally dry channel in the Putah Creek watershed. The habitat type at this site is oak woodland. The threat is debris laden flooding to the house.

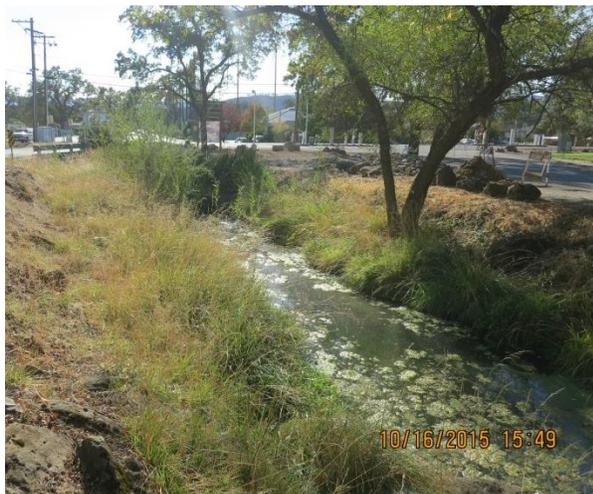
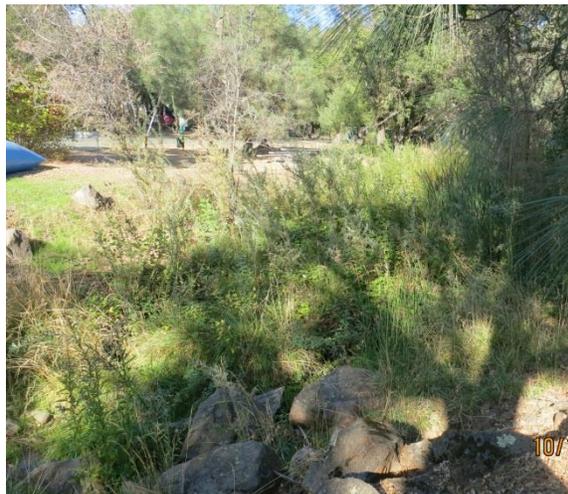
## Site 127

This site is located on Hartmann Road adjacent to Hidden Valley Lake Campground (38.79904' N, 122.55145' W). This work location is on Gallagher Creek, a tributary to Coyote Creek, in the Putah Creek watershed. The habitat type within this reach of Gallagher Creek is mixed-riparian and emergent vegetation. This section of Gallagher Creek is downstream of the burn area and upstream of the bridge at Hartmann Road (Site 126). The creek may experience higher than average flow events and debris laden flow. The threat is debris laden flow backing up on in-stream vegetation or at the bridge at Hartmann Road and flooding the campground, Hartmann Road, and surrounding buildings.

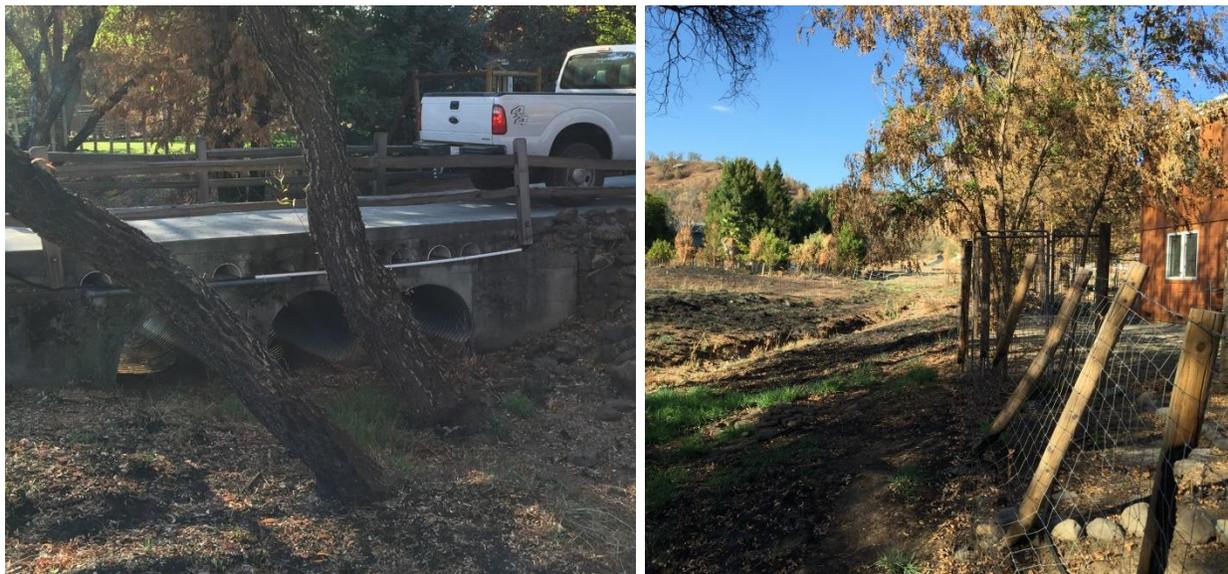
## Site 128

This site is a single family home with outbuildings and culverts on Hartmann Road (38.80014' N, 122.54394' W). The home is located at the convergence of Gallagher Creek and an unnamed tributary. Gallagher Creek and the tributary are seasonally dry channels, in the Putah Creek watershed. The habitat type at this work site is oak woodland. There are three, 36-inch culverts under the access drive across Gallagher Creek. Several dead trees are blocking the entrance to the culverts. The threat is debris laden flow piling up at the culverts causing flooding onto the home. In addition, general flooding at the convergence will put the property at risk

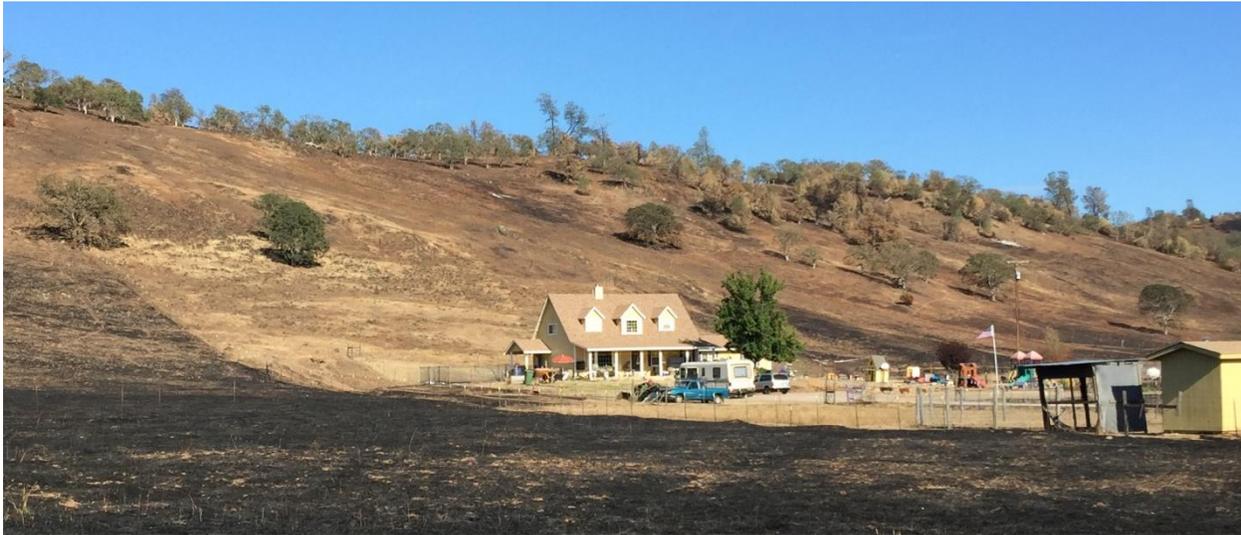
## Site 131

This site is a single family home located on Stinson Road (38.80197' N, 122.54121' W). The home is in the area of the Gallagher Creek channel. Gallagher Creek is a seasonally dry channel in the Putah Creek watershed. Habitat type at the site is oak woodland. The threat to existing infrastructure is runoff and sediment from the burned slope behind the home and adjacent parcel. Homeowner reports occasional ponding from runoff that does not reach the home.

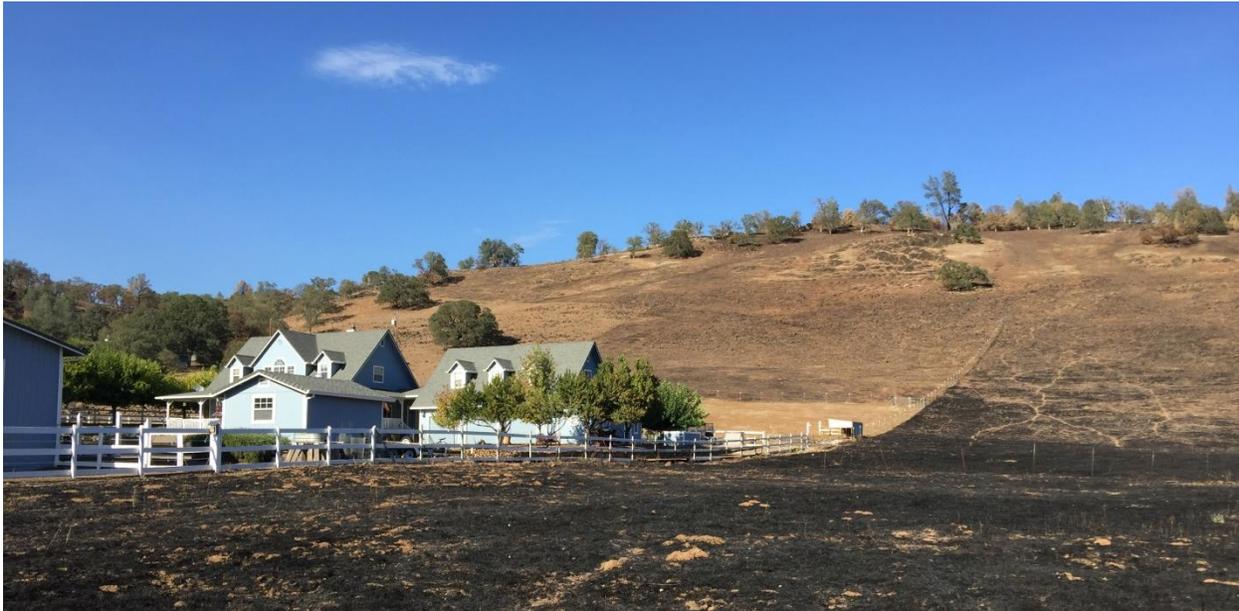
## Site 132

This site is a single family home located on Stinson Road (38.80172' N, 122.54339' W). The home is located adjacent to an unnamed tributary to Gallagher Creek. The tributary is a seasonally dry channel in the Putah Creek watershed. Habitat type at the site is oak woodland. The threat to existing infrastructure is runoff and sediment from the burned slope behind the home and adjacent parcel.

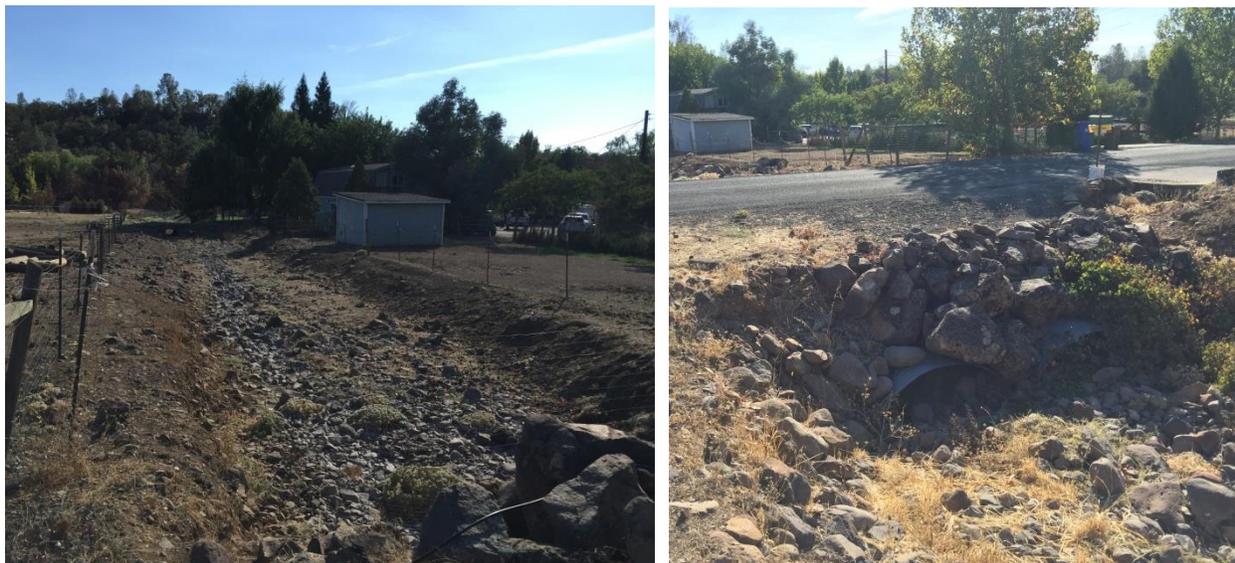
## Site 133

This site is a single family home with outbuildings located on Stinson Road (38.80201' N, 122.54454' W). The property is located along an unnamed tributary of Gallagher Creek. The tributary is a seasonally dry channel in the Putah Creek watershed. The habitat type at this site is oak woodland. There are two arch type culverts with a vertical clearance of 24-inches where the tributary crosses Stinson Road and two 48-inch culverts under a private drive on the property across the creek. The threat is debris-laden flow blocking the culverts causing flooding to the home as well as flooding Stinson Road.

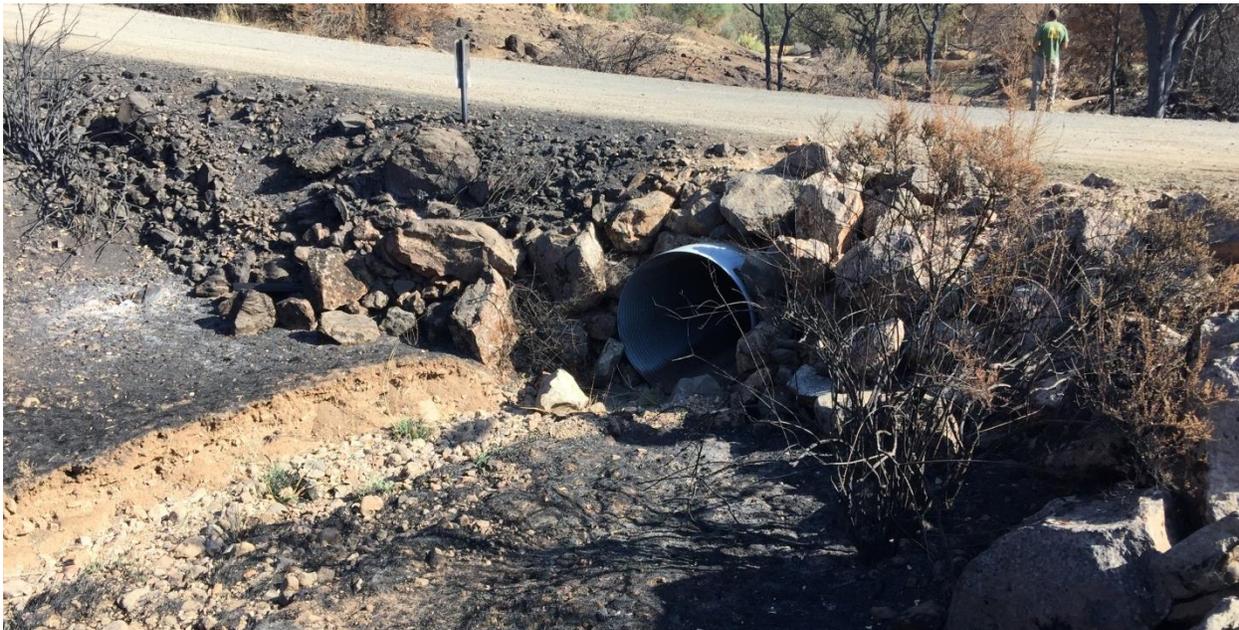
## Site 134

This site is a 48-inch culvert on Sandy Road (38.80605' N, 122.55147' W). The culvert is on an unnamed tributary to Gallagher Creek. The tributary is a seasonally dry channel in the Putah Creek watershed. The habitat type at this site is oak woodland. The threat to existing infrastructure is debris-laden flow down the creek blocking the culvert and causing flooding of the road and nearby area.

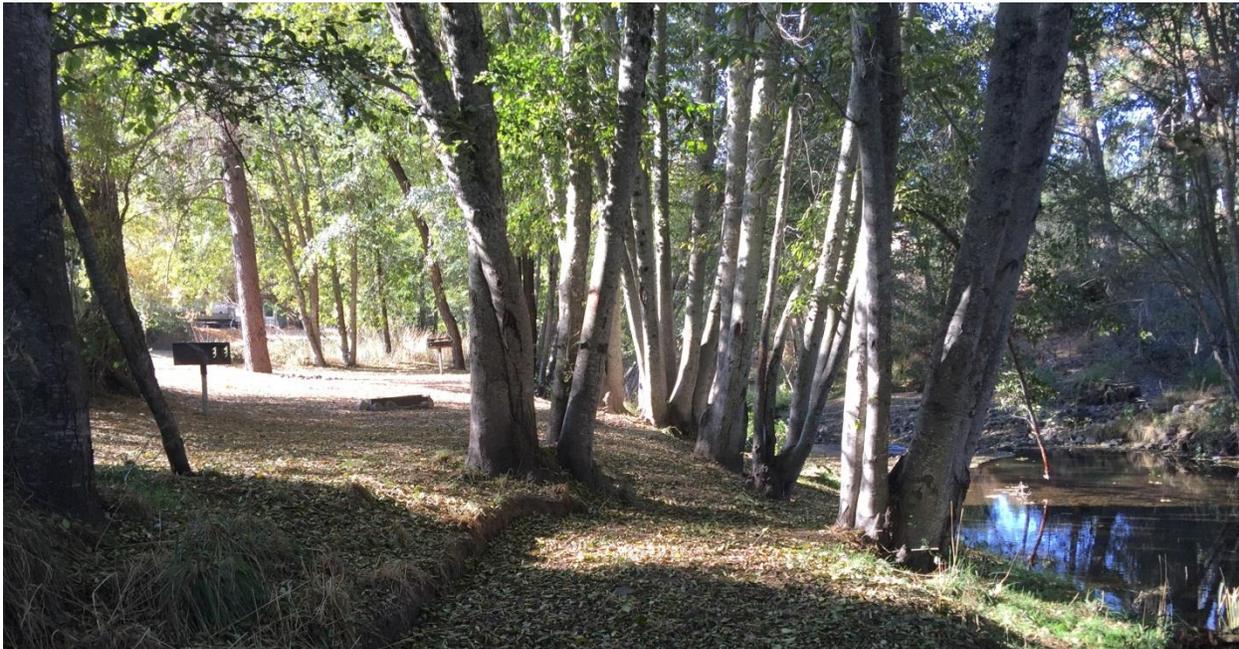
## Site 135

This site includes a campground and private access bridge on Bottle Rock Road (38.85387' N, 122.75888' W). The campground is located on Kelsey Creek. Kelsey Creek is a perennial fish bearing stream. Habitat type at this site is mixed-conifer. The threat to existing infrastructure is debris-laden flow and debris flow down Kelsey Creek piling on bridge and flooding nearby campsites and facilities or damaging bridge.

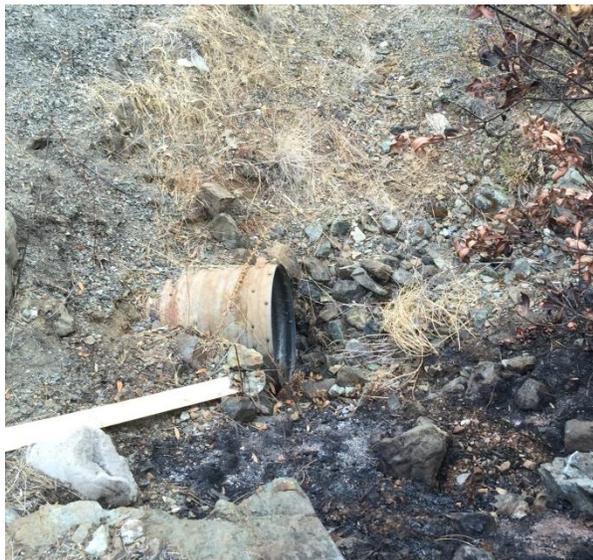
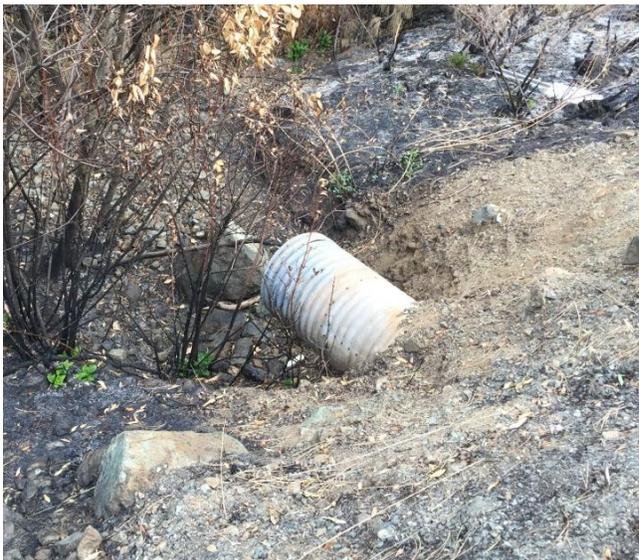
## Site 139

This site is a 24-inch culvert located on Butts Canyon Road (38.70519' N, 122.46407' W). The culvert is located on Butts Creek. Butts Creek is a seasonally dry channel in the Putah Creek watershed. Habitat type at this work site is oak woodland. The threat to existing infrastructure is debris-laden flow down the drainage piling up on the culvert and causing flooding of road and nearby area.

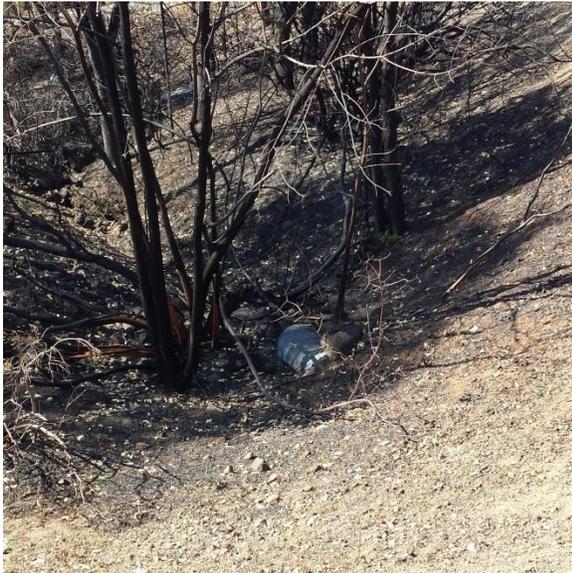
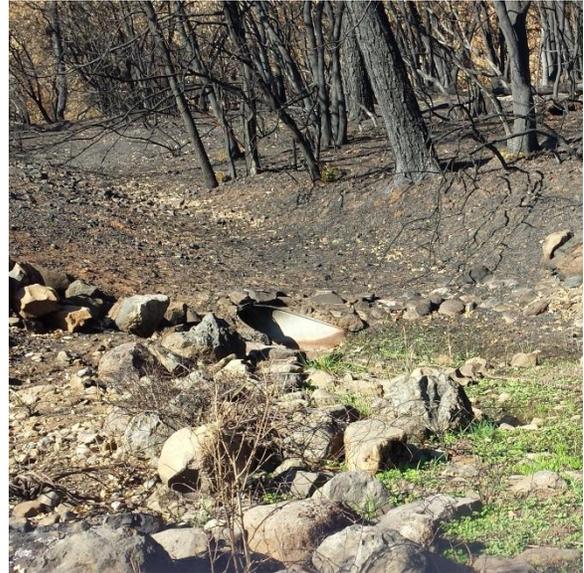
## Site 500

This site is two culverts in series near a home located on Casa Grande Lane (38.78982' N, 122.68872' W). The culverts are conveying flow under the driveway into a confined drainage leading to another single residence (Site 501). The channel is seasonally dry and is located in the Putah Creek watershed. Habitat type at this site is oak woodland. The threat to existing infrastructure is increased flow and debris-laden flow blocking the culverts impacting the home downslope and possibly overtopping Casa Grande Lane.

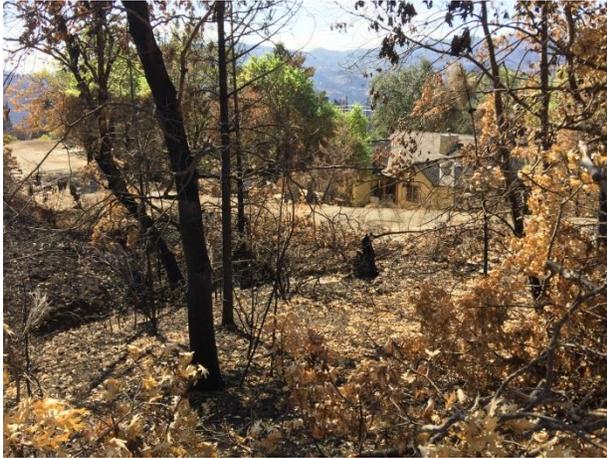
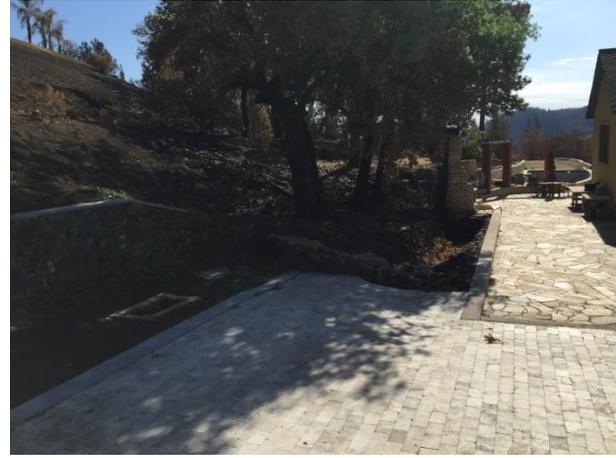
## Site 501

This site includes one house and culvert located on Casa Grande Lane (38.78431' N, 122.68903' W). The culvert drains a swale in the Putah Creek watershed. Habitat type at this site is oak woodland. The culvert discharges above the house, which then flows into a constrained masonry channel that bends around the home. The threat to existing infrastructure is debris-laden flow down the swale piling up on the culvert and causing flooding of road and home.

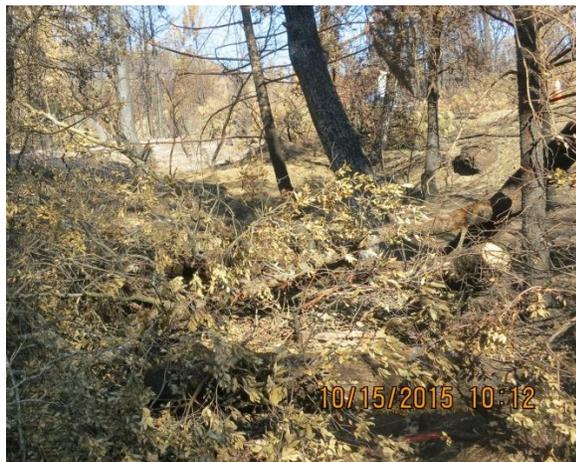
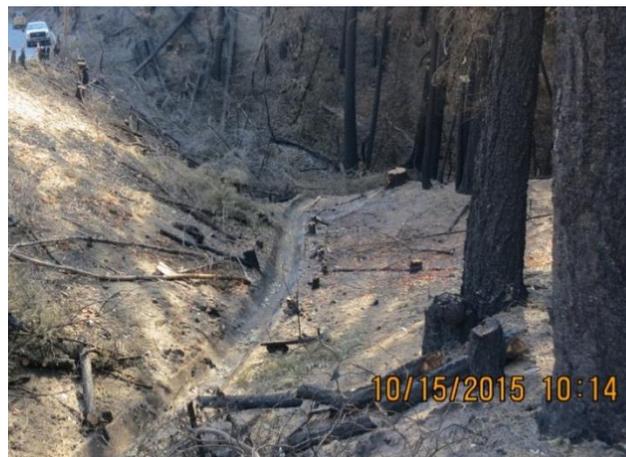
## Site 504

This site is a culvert under a private road providing access to Highway 175 (38.79133' N, 122.70031' W). The culvert is located at an unnamed tributary to Putah Creek. The tributary is a seasonally dry channel. The habitat type at this work site is pine-oak woodland. The channel is laden with dead woody debris. The threat is debris-laden flow piling up at the culvert and flooding onto the private drive as well as Highway 175.

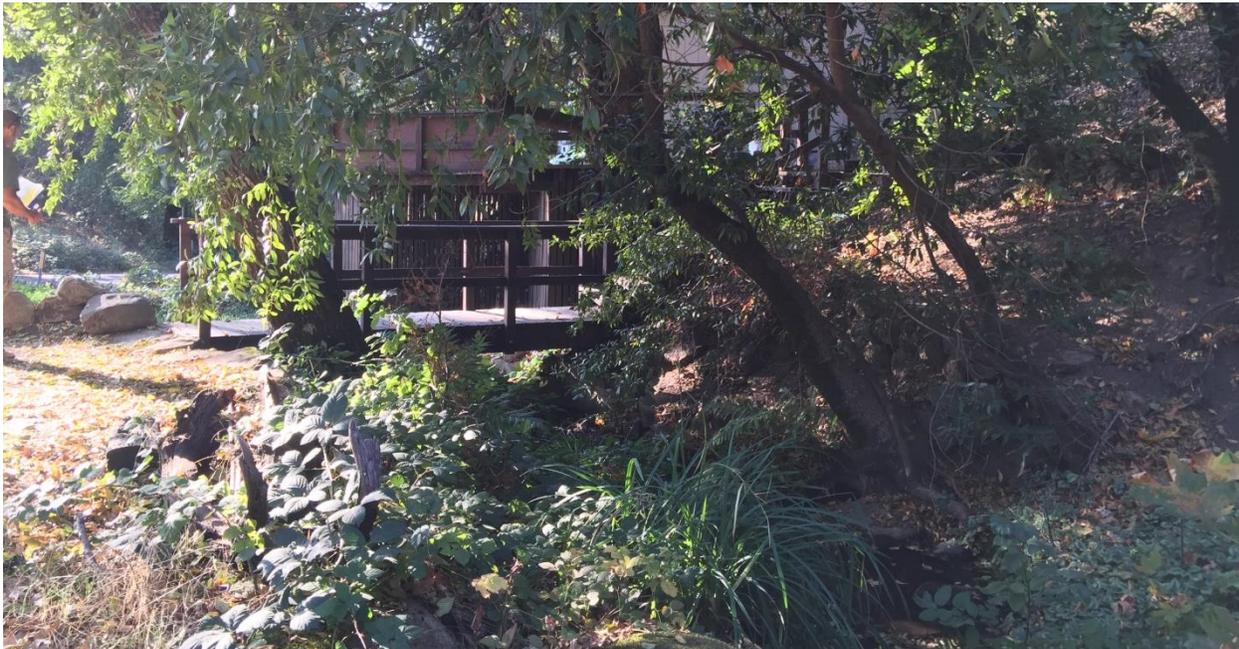
## Site 507

This site is a single family dwelling located on Maple Shadows Drive (38.81086' N, 122.71020' W). The house is located along an unnamed tributary to Putah Creek. The unnamed tributary is a perennial stream. Habitat type at this site is mixed-conifer. The threat to existing infrastructure is debris-laden flooding and debris flow down the unnamed tributary rising to an elevation that will impact the home.

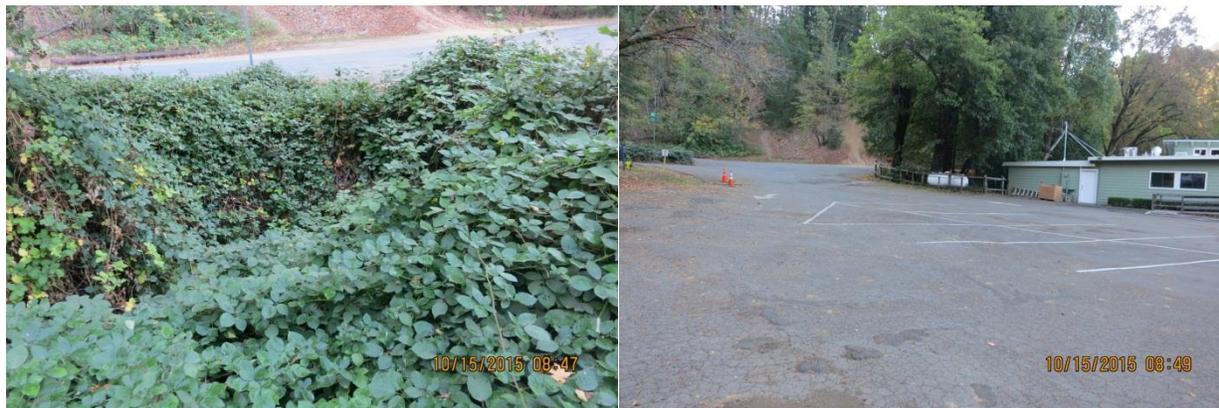
## Site 510

This site is a golf clubhouse and course on Golf Road (38.82201' N, 122.71598' W). The clubhouse and course is located adjacent to Jones Creek. Jones Creek is a perennial fish bearing stream in the Kelsey Creek watershed. The habitat type at this work site is mixed-riparian. Multiple culverts converge into the outfall next to the golf clubhouse. There is dense vegetation and debris in the channel upstream of this site. The threat to existing infrastructure is debris-laden flooding and debris flow down Jones Creek.

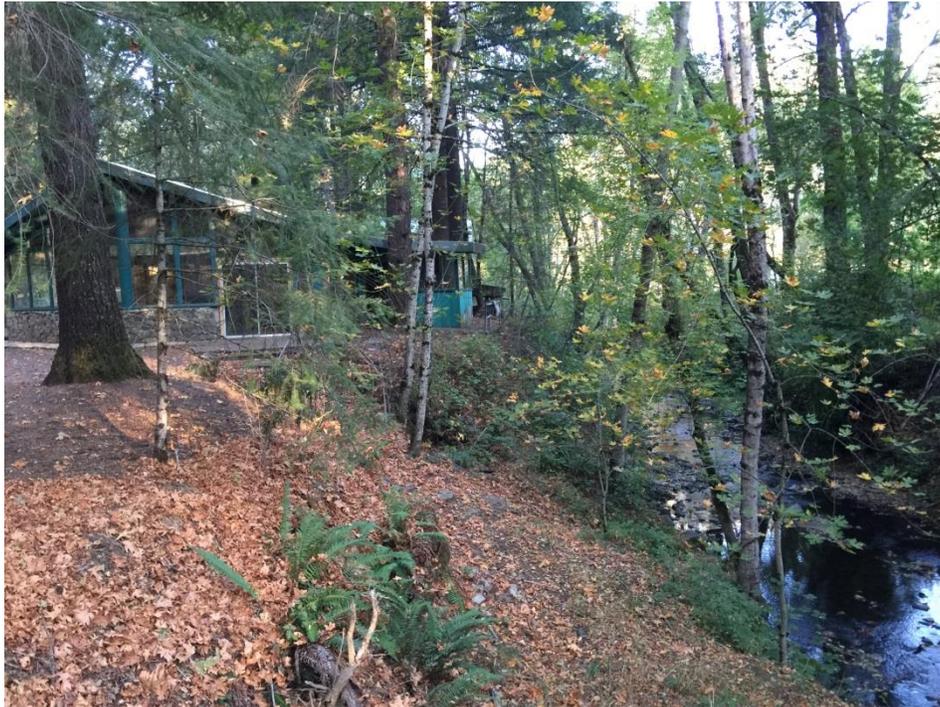
## Site 514

This site is multiple single family residences in the vicinity of Bottle Rock and Highway 175 (38.82421' N, 122.72352' W). The residences are located along Kelsey Creek. Kelsey Creek is a perennial fish bearing stream. The habitat type is mixed-riparian. The threat to existing infrastructure is debris-laden flooding and debris flow down Kelsey Creek rising to an elevation that will impact the homes.

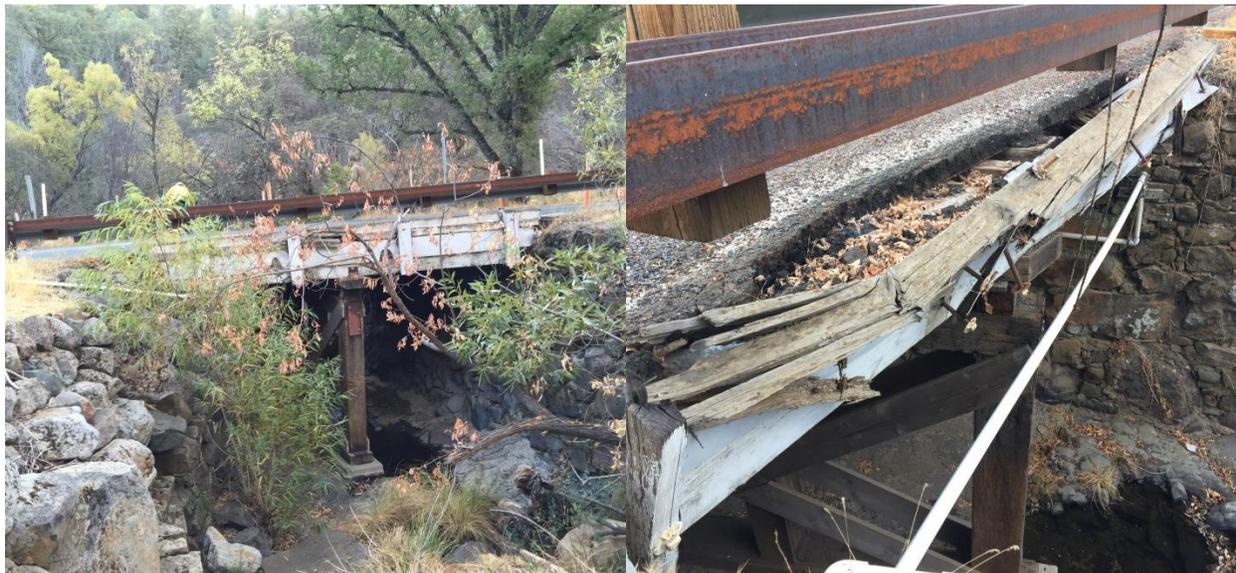
## Site 517

This site is a bridge along Seigler Canyon Road (38.89533' N, 122.65088' W). The bridge is located over Seigler Canyon Creek. Seigler Creek was flowing at time of visit and in the Cache Creek watershed. Habitat at this site is mixed-riparian. The bridge's downstream edge is starting to fail and high debris flows may further damage the bridge. The threat to existing infrastructure is debris-laden flow down the creek piling up on the bridge and causing flooding of road and compromising bridge.

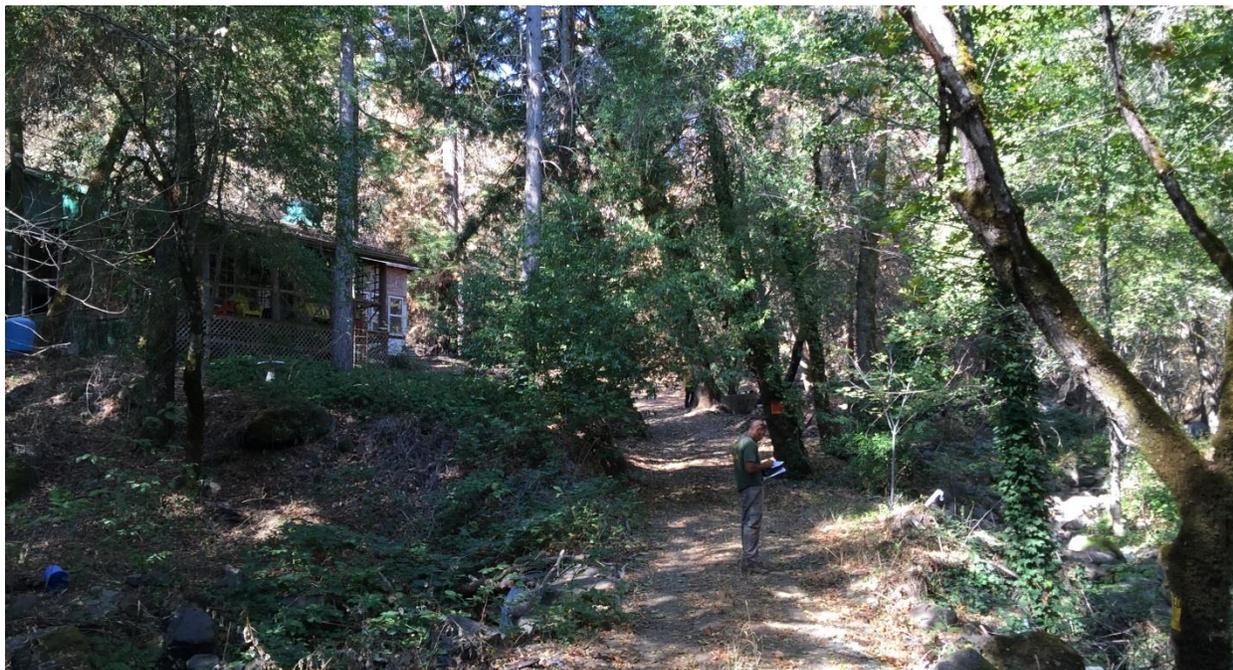
## Site 520

This site is a single family home on Ettawa Springs Road (38.85015' N, 122.69913' W). The home is located above the convergence of Big Canyon Creek and Mill Creek. Big Canyon Creek and Mill Creek are perennial fish bearing streams, in the Putah Creek watershed. The habitat type at this work site is mixed-riparian. The access bridge along Ettawa Springs Road was destroyed by the fire and a temporary footbridge is in place. Several dead trees have fallen in the channel from the upstream burn area. A local landowner reported significant runoff from the hill behind the home during rain events. The threat is debris-laden flow and debris flooding onto home, runoff and erosion, as well as high water at the convergence threatening the building.

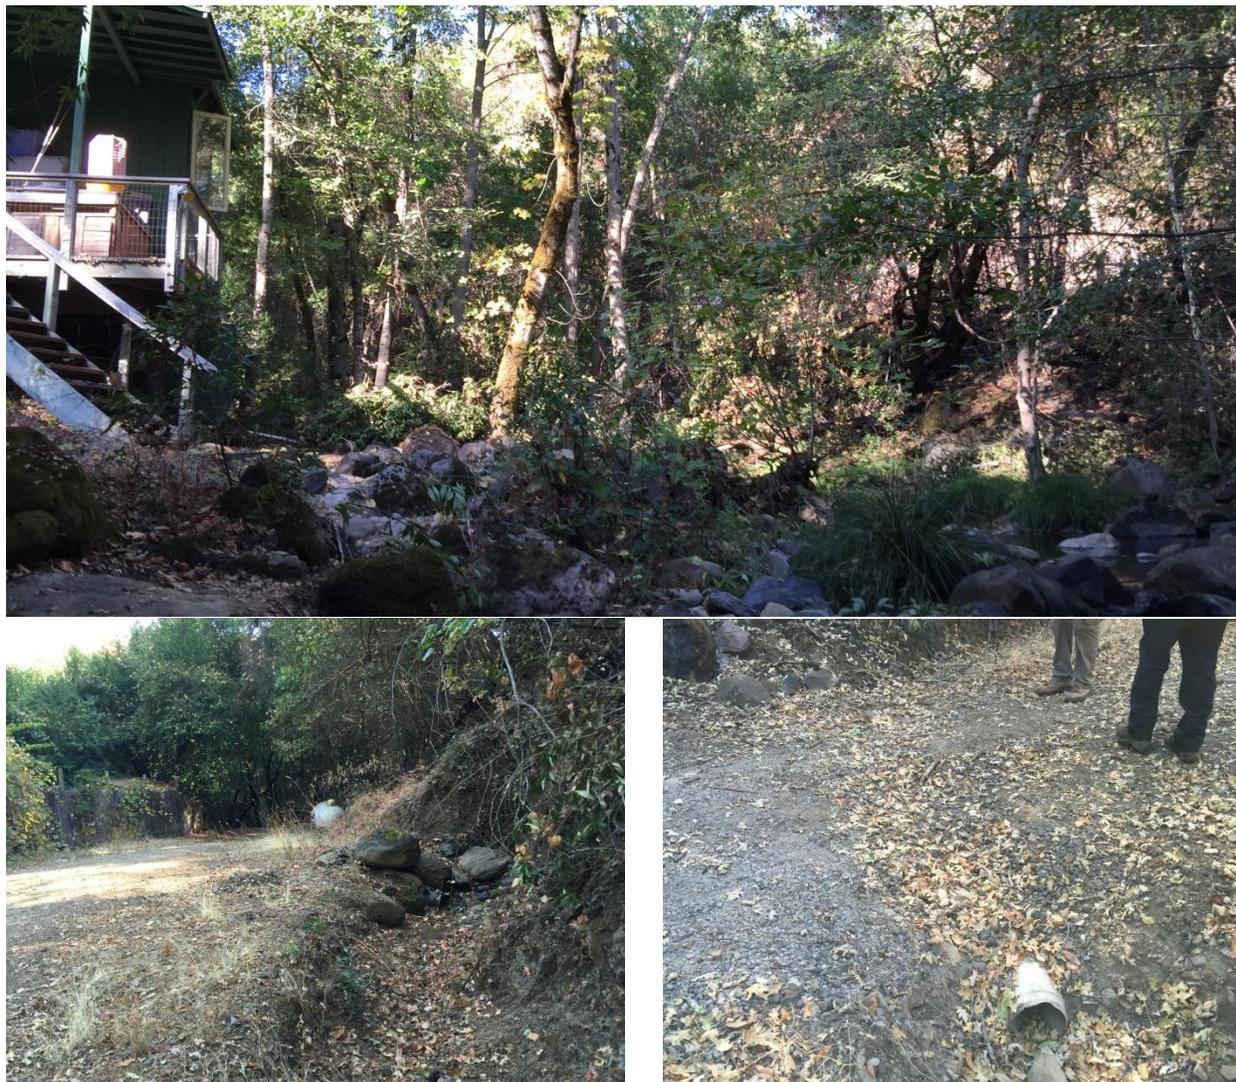
## Site 521

This site is a single family home on Ettawa Springs Road (38.85089' N, 122.69658' W). The home is located along Big Canyon Creek. Big Canyon Creek is a perennial fish bearing stream, in the Putah Creek watershed. The habitat type at this work site is mixed-riparian. The access bridge on Ettawa Springs Road was destroyed; there is a temporary footbridge in place. A roadside ditch collects and conveys water from the hillside and roadway away from the home. The ditch has two culverts that discharge into Big Canyon Creek. The culverts are spaced approximately 300 feet apart.

sediment along a 30-foot segment just below the culvert at the upper end of the property. There are several fallen trees in the stream channel that also pose a debris flooding hazard for the home.

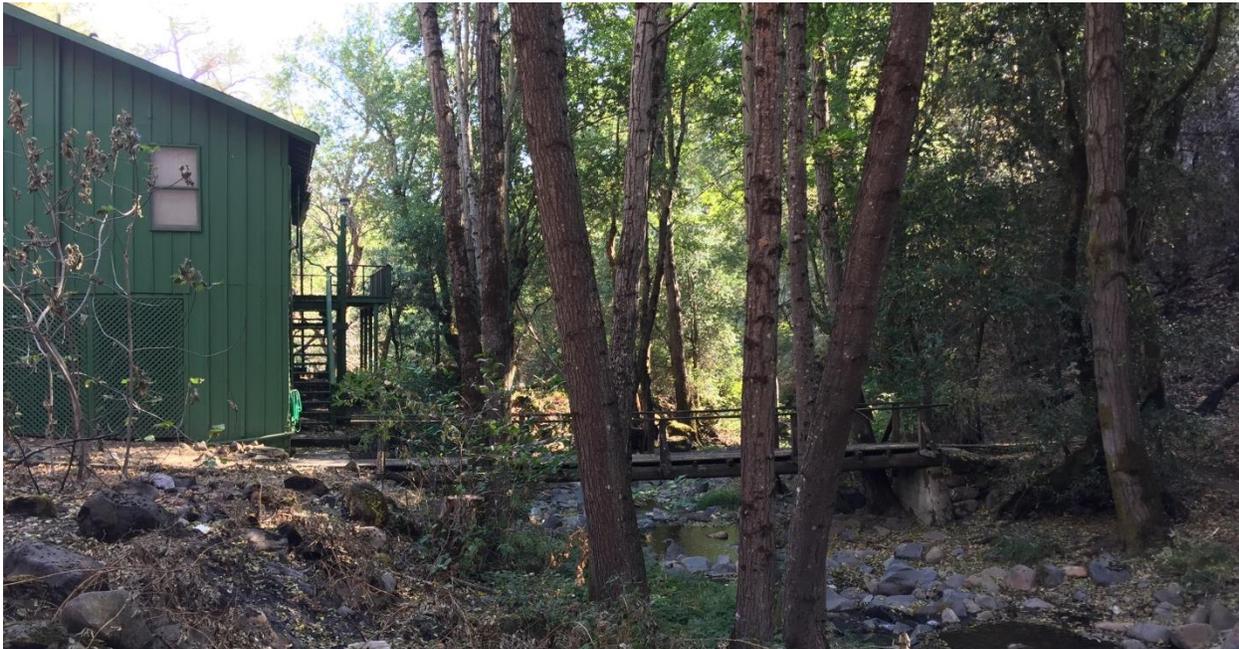
## Site 522

This site is a single family home located on Ettawa Springs Road (38.85122' N, 122.69420' W). The house is located along Big Canyon Creek. Big Canyon Creek is a perennial fish bearing stream in the Putah Creek watershed. Habitat type at this site is mixed-riparian. The threat to existing infrastructure is debris-laden flooding and debris flow down Big Canyon Creek rising to an elevation that will impact the home.

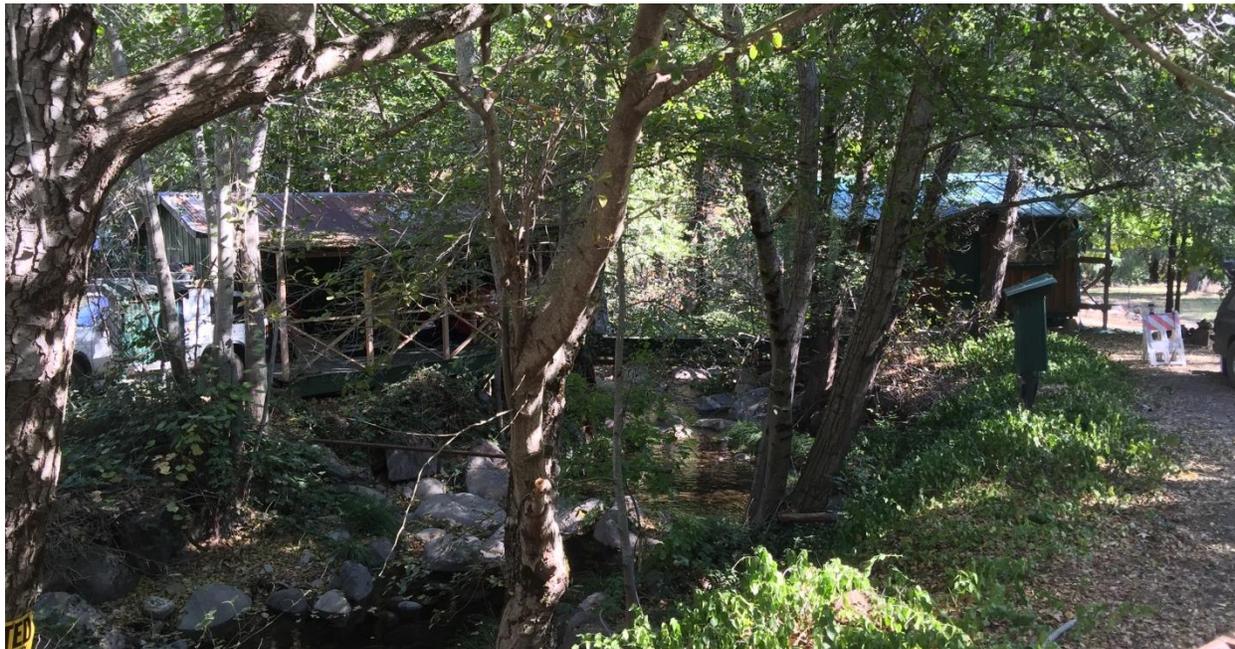
## Site 523

This site is a group of resort cabins, outbuildings and an access bridge on Ettawa Springs Road (38.85142' N, 122.69241' W). The buildings are located along Big Canyon Creek. Big Canyon Creek is perennial fish bearing stream in the Putah Creek watershed. Habitat type at this site is mixed-riparian. The threat to existing infrastructure is debris-laden flooding and debris flow down Big Canyon Creek.

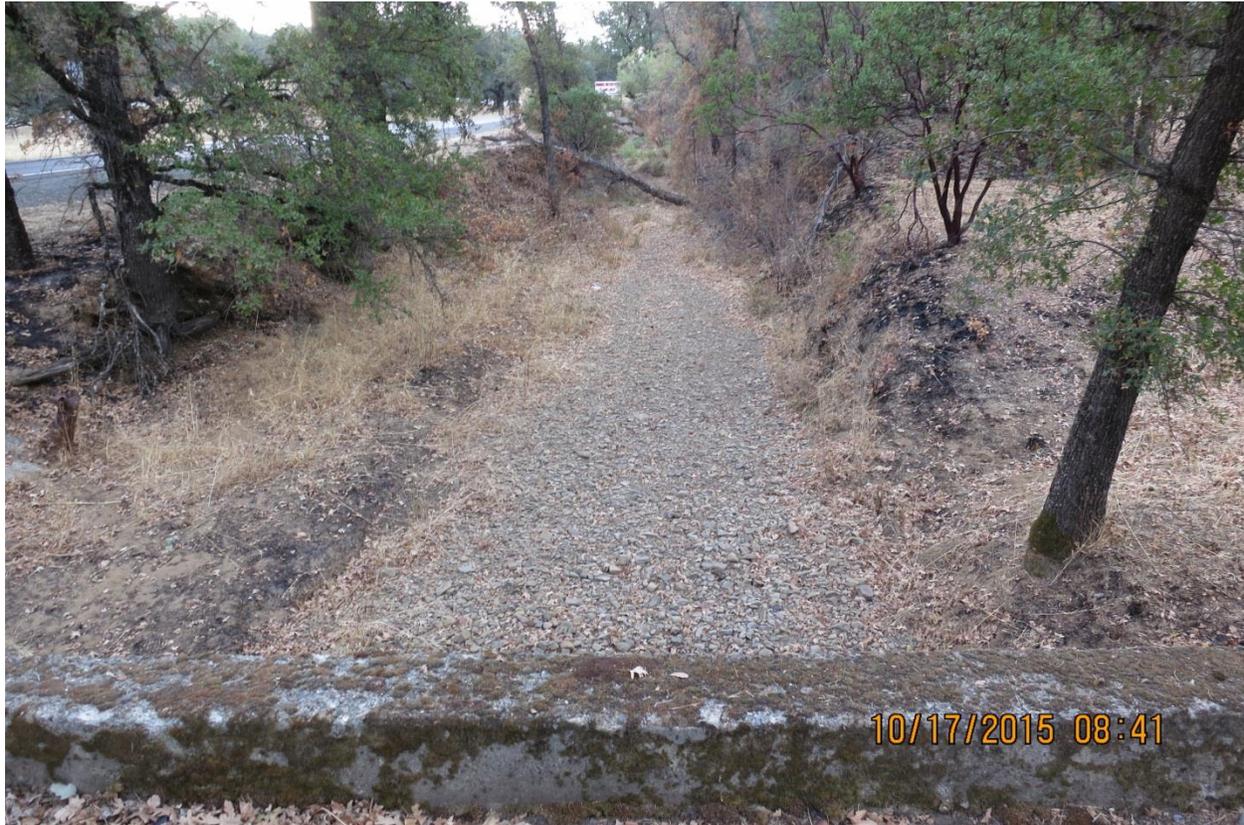
## Site 524

This site is a private bridge located off of Highway 29 (38.84562' N, 122.60915' W). The bridge crosses Harris Creek. Harris Creek is a seasonally dry channel in the Cache Creek watershed. The habitat type at this site is oak woodland. The threat is debris flow piling on the bridge and flooding along Highway 29.
