# Valley Fire

State Post Fire Watershed Emergency Response Team  
Addendum I

Hazard Site Evaluation

October 2015

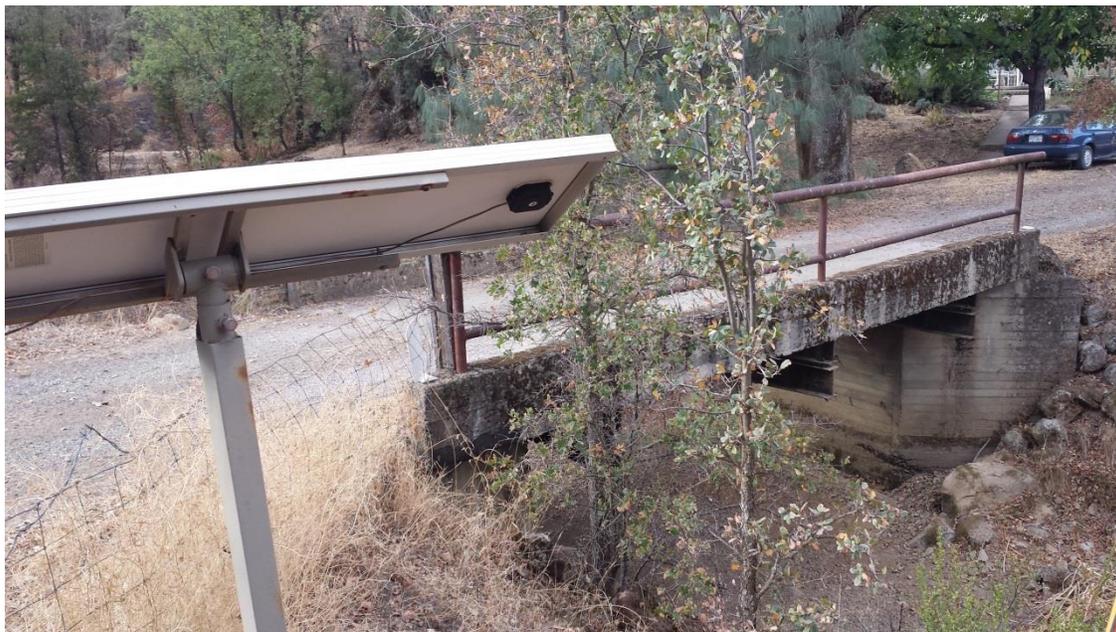
## Site 525

This site is a private bridge located off of Highway 29 (38.84745' N, 122.61152' W). The bridge crosses Harris Creek. Harris Creek is a seasonally dry channel in the Cache Creek watershed. The habitat type is oak woodland. The threat is debris-laden flow piling on bridge and flooding along Highway 29.

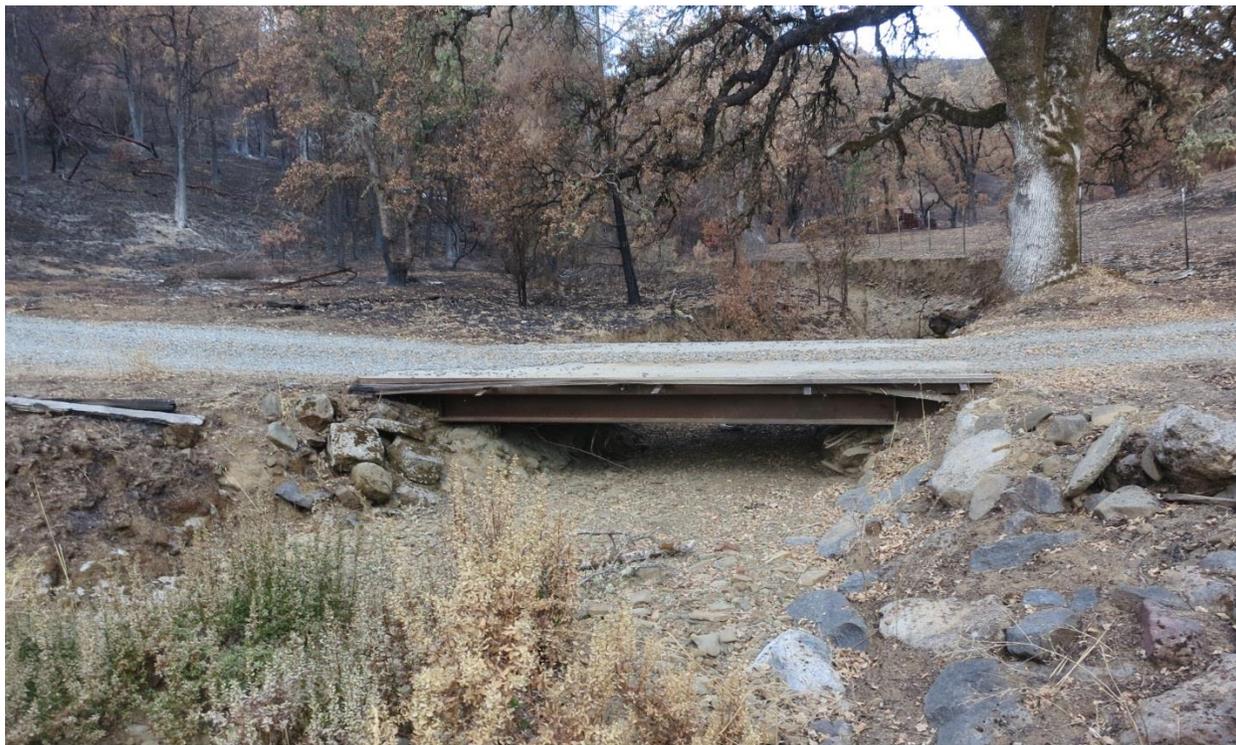
## Site 526

This site is bridge located on a private road west of Highway 29 (38.84131' N, 122.61196' W). The bridge is located at Harris Creek. Harris Creek is a seasonally dry creek in the Cache Creek watershed. Habitat type at this site is oak woodland. The threat to existing infrastructure is debris-laden flooding and debris flow piling up on the bridge, flooding the surrounding area and/or damaging the bridge.

Prior to rain events upstream of the bridge should be inspected and loose debris removed. This site should be monitored during rainfall events for debris and flooding. Early warning of flood events and storm patrol.

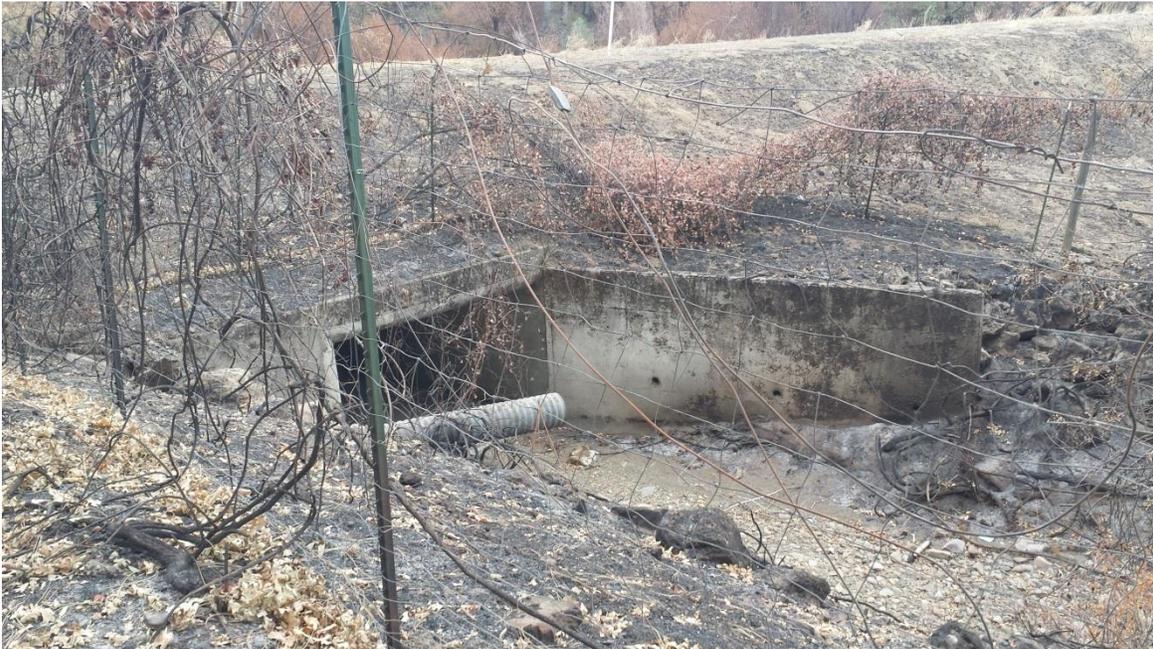
## Site 527

This site is two single family dwellings located near the corner of Big Canyon Road and Aqua Dulce Drive (38.85837' N, 122.62817' W). The two homes are near Copsy Creek. Copsy Creek is a seasonally dry channel in the Cache Creek watershed. The habitat type at this site is oak woodland. The threat is flooding and debris-laden flow to the homes.

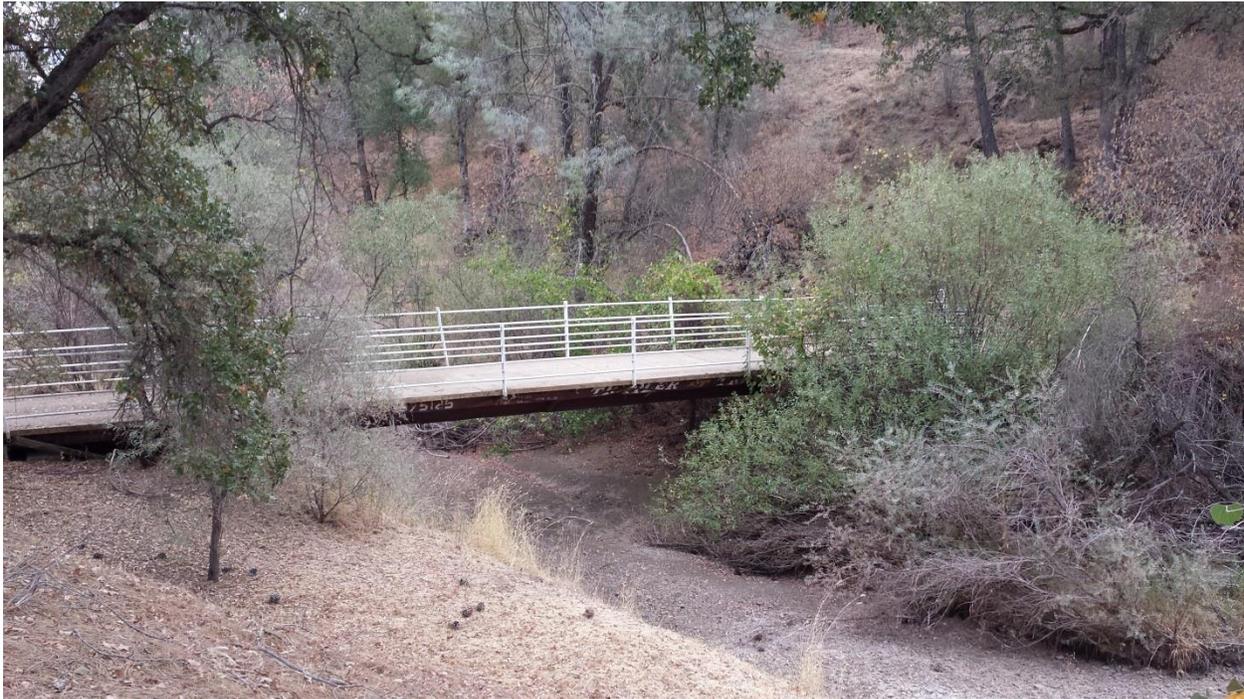
## Site 528

This site is a single family home and business on Highway 29 (38.86505' N, 122.62446' W). The house is located on the west side of Copsey Creek. Copsey Creek is a seasonally dry channel in the Cache Creek watershed. Habitat type at this site is mixed-riparian. The threat to existing infrastructure is debris-laden flooding and debris flow down Copsey Creek rising to an elevation that will impact the home and business.

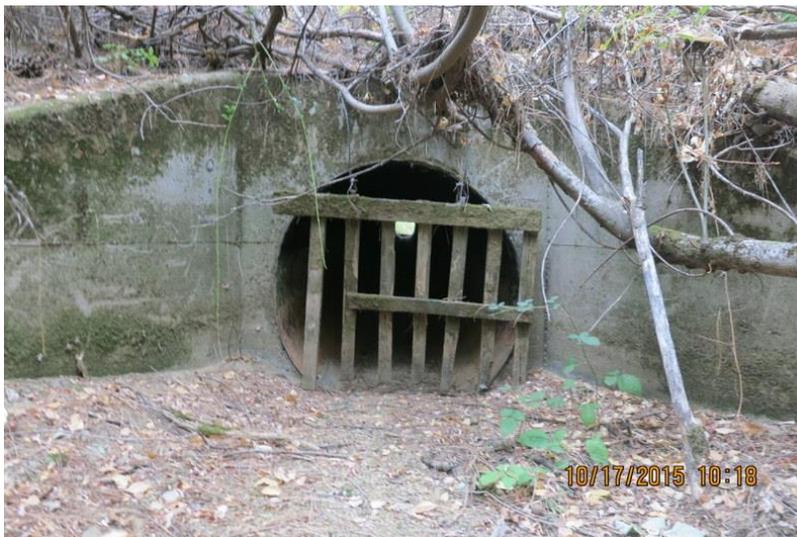
## Site 529

This site is a culvert located off of Highway 29 (38.88235' N, 122.60846' W). The culvert is located along an unnamed tributary to Copsey Creek near the confluence of both streams. The unnamed tributary and Copsey Creek are seasonally dry channels in the Cache Creek watershed. The habitat type at this site is oak woodland. The threat is debris-laden flow clogging in the culvert and flooding the Highway 29 and nearby homes.

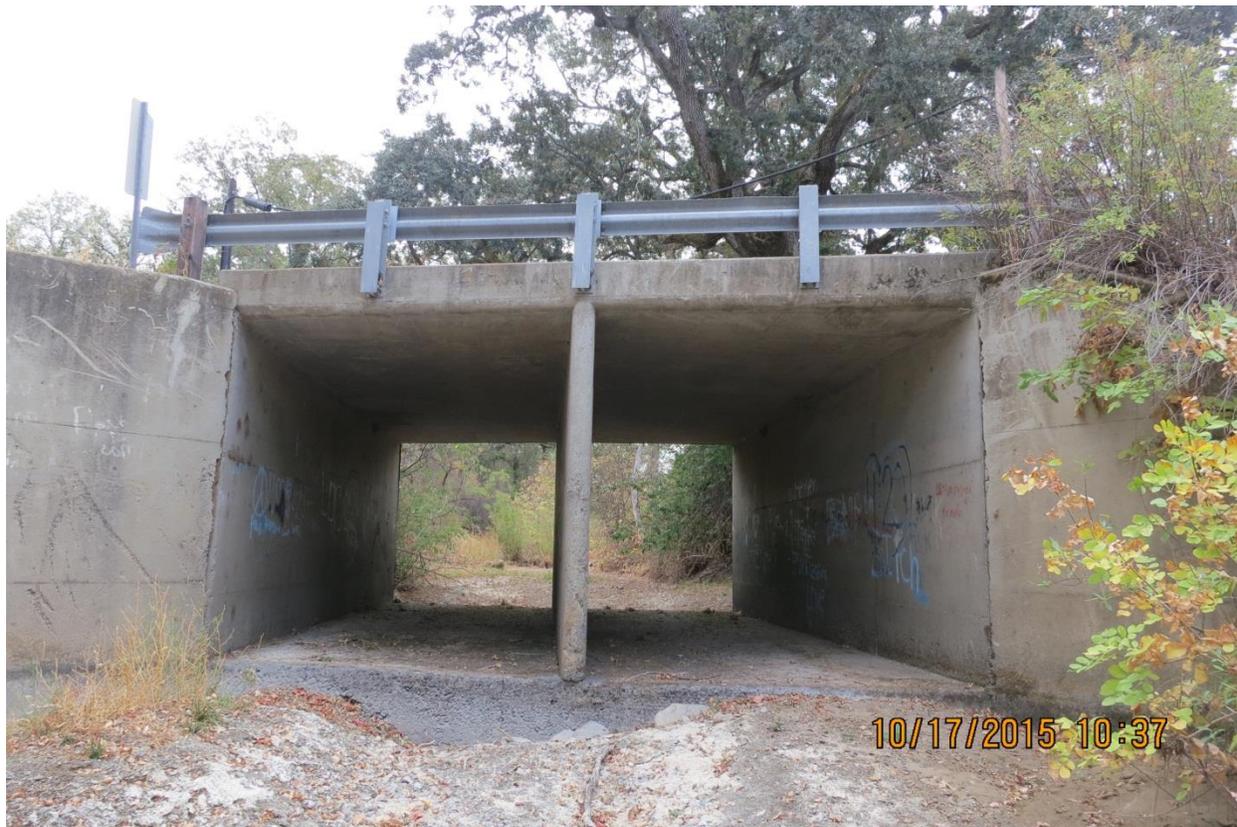
**Site 530**

This site is a bridge located on Riata Road (38.8828' N, 122.60618' W). The house is located on Copsey Creek. Copsey Creek is a seasonally dry creek in the Cache Creek watershed. Habitat type at this site is mixed-riparian. The bridge has a center piling that can catch debris. The threat to existing infrastructure is debris-laden flooding and debris flow down Copsey Creek piling up on the bridge, impacting Riata Road, the surrounding area, and nearby homes.

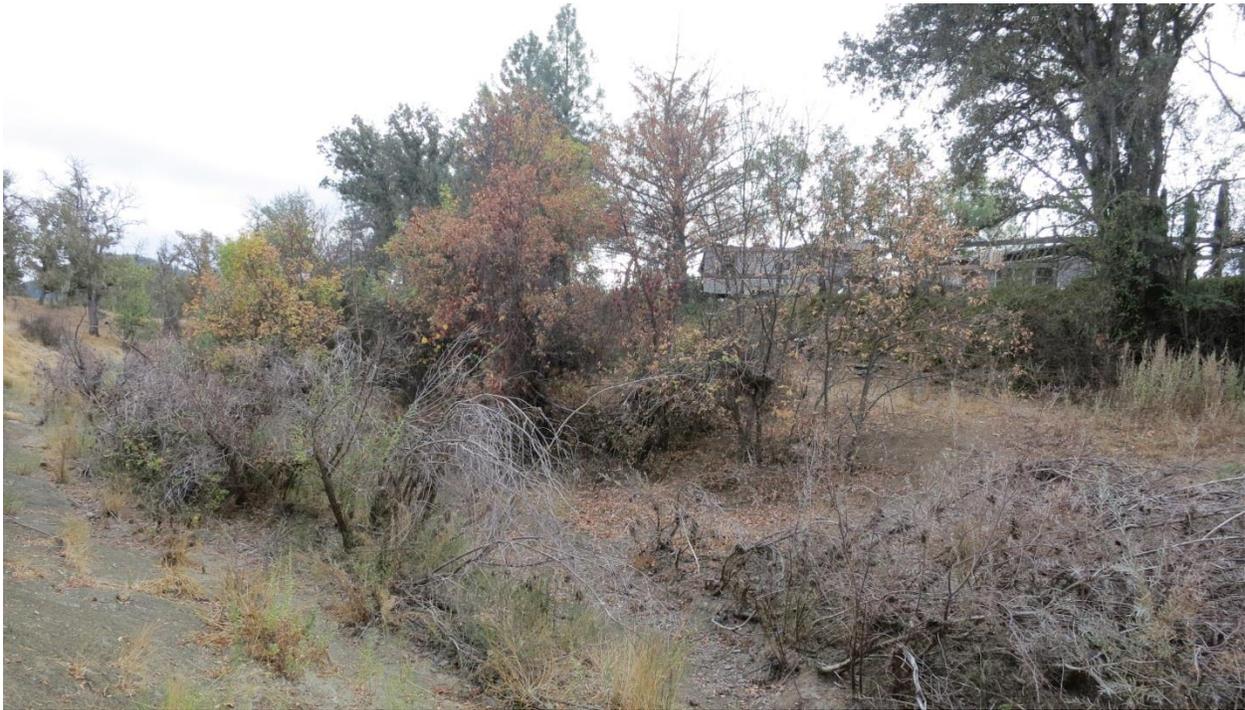
## Site 531

This site is a single family home located on Ellen Springs Court (38.8943' N, 122.59821' W). The house is located along the west side of Copsey Creek. Copsey Creek is a seasonally dry channel in the Cache Creek watershed. Habitat type at this site is oak woodland. The threat to existing infrastructure is debris-laden flooding and debris flow down Copsey Creek, rising to an elevation that will impact the home.

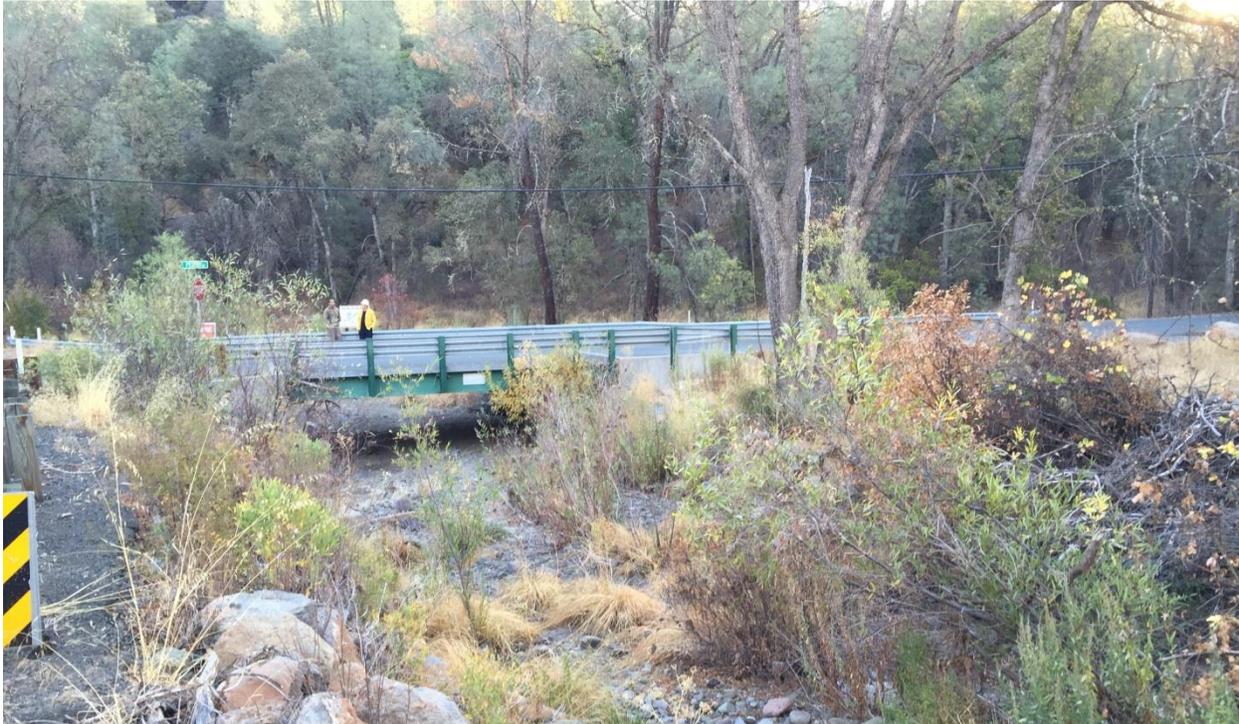
## Site 532

This site is a bridge on Perini Road (38.90324' N, 122.63936' W). The bridge is located over Seigler Canyon Creek. Seigler Canyon Creek is a seasonally dry channel, in the Cache Creek watershed. Habitat type at this site is mixed-riparian. There is moderate in-channel vegetation present. The threat to existing infrastructure is debris-laden flow down the creek piling up on the bridge and causing flooding of road and nearby area.

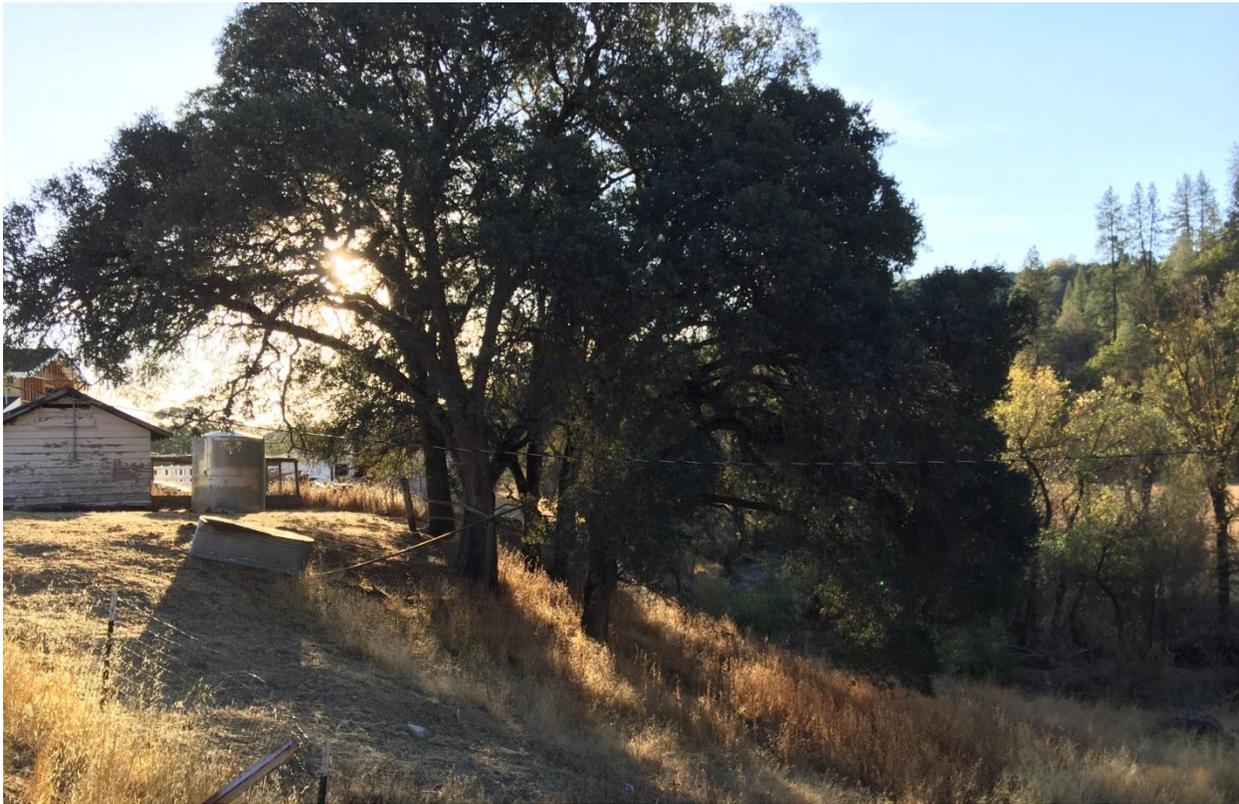
## Site 533

This site includes outbuildings and other unknown structures located on Seigler Canyon Road (38.90731' N, 122.63621' W). The structures are located along Seigler Canyon Creek. Seigler Canyon Creek is a seasonally dry creek, in the Cache Creek watershed. Habitat type at this site is oak woodland. Seigler Canyon Creek is a seasonally dry channel. The threat to existing infrastructure is debris-laden flooding and debris flow down Seigler Canyon Creek rising to an elevation that will impact the structures.

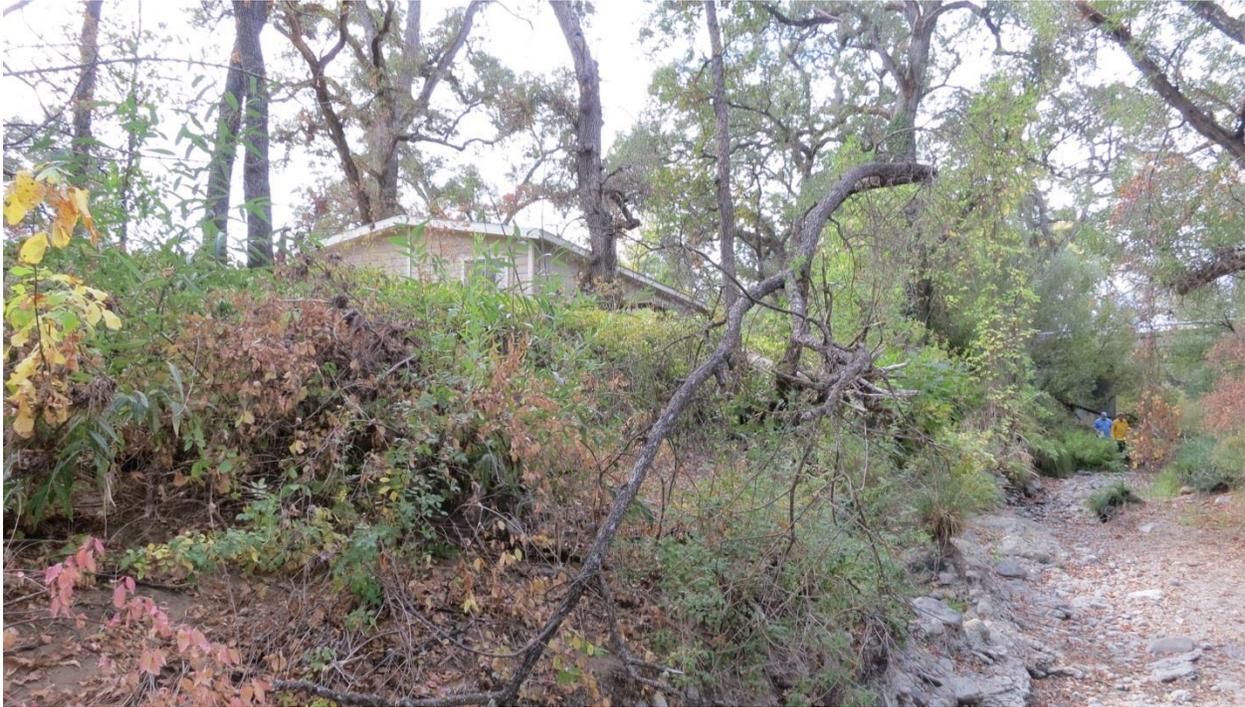
## Site 534

This site is a mobile home located on Bell Avenue (38.90919' N, 122.61626' W). The home is located adjacent to Seigler Canyon Creek. Seigler Canyon Creek is a seasonally dry creek, in the Cache Creek watershed. The habitat type at this work site is mixed-riparian. This reach of Seigler Canyon Creek is restricted by Bell Park Bridge and Highways 29 and 53. This work site is northeast of the burn area. The threat is inundation due to increased flow volume and debris-laden flow.

Clear loose debris, Himalayan blackberry (*Rubus armeniacus*), and small, woody vegetation from Bell Bridge to Highway 29.

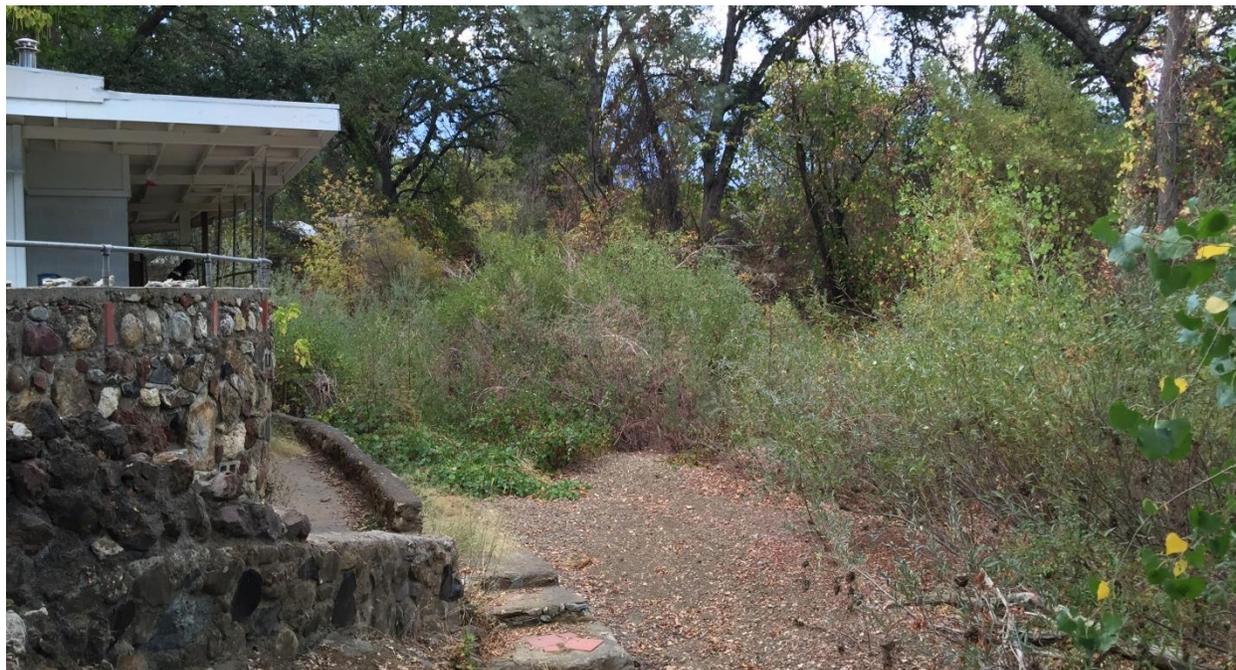
## Site 535

This site is two single family homes on Morgan Valley Road (38.90805' N, 122.595' W). The homes are located along Copsey Creek downstream from a large arch culvert (25 feet high). Copsey Creek is a seasonally dry channel in the Cache Creek watershed, however multiple landowners report significant fish presence and spawning when water is present. The habitat type at this work site is oak woodland. There is a significant amount of woody vegetation present in the channel. Strong storm runoff last year brought the high water line within a foot of overtopping the retaining wall along the homes. The threat is debris-laden flooding and debris flows damaging the home and property.

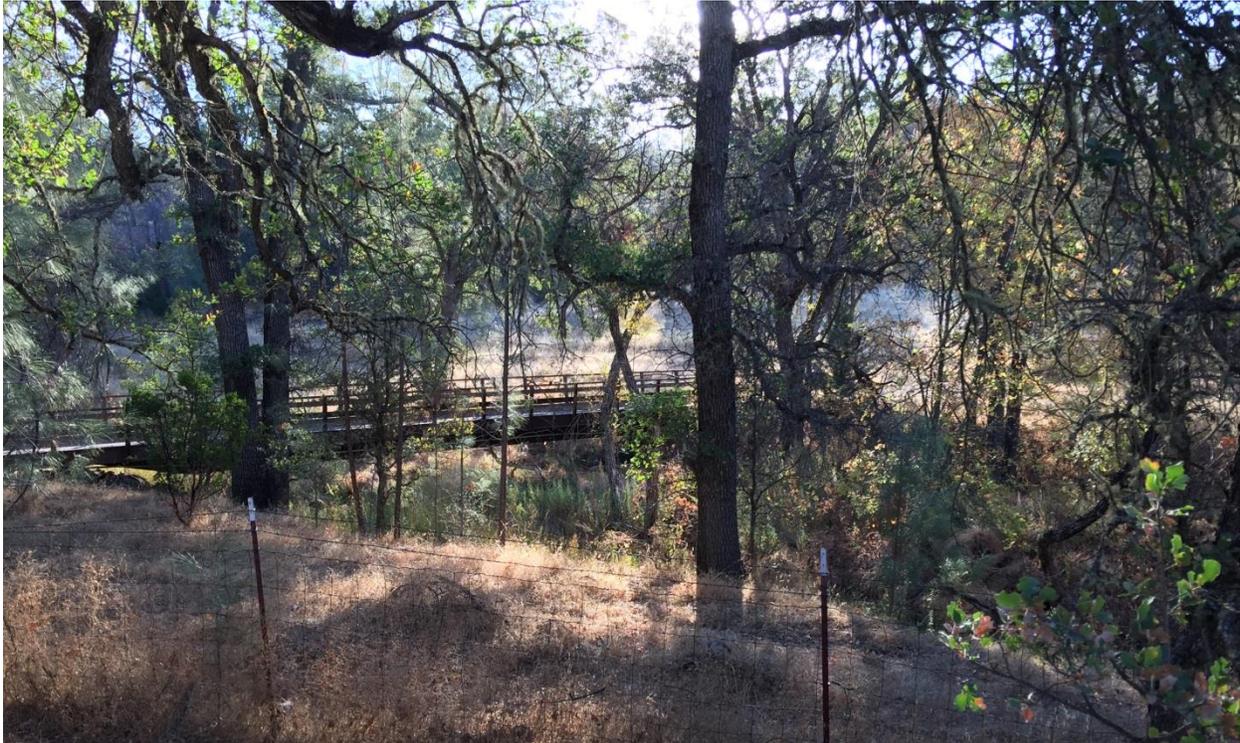
## Site 536

This site is a bridge on a private road along Seigler Canyon Road (38.89875' N, 122.64356' W). The bridge is located over Seigler Canyon Creek. Seigler Canyon Creek is a seasonally dry channel, in the Cache Creek watershed. Habitat type at this site is oak woodland. The threat to existing infrastructure is debris-laden flow down the creek piling up on the bridge and causing flooding of road and nearby area.

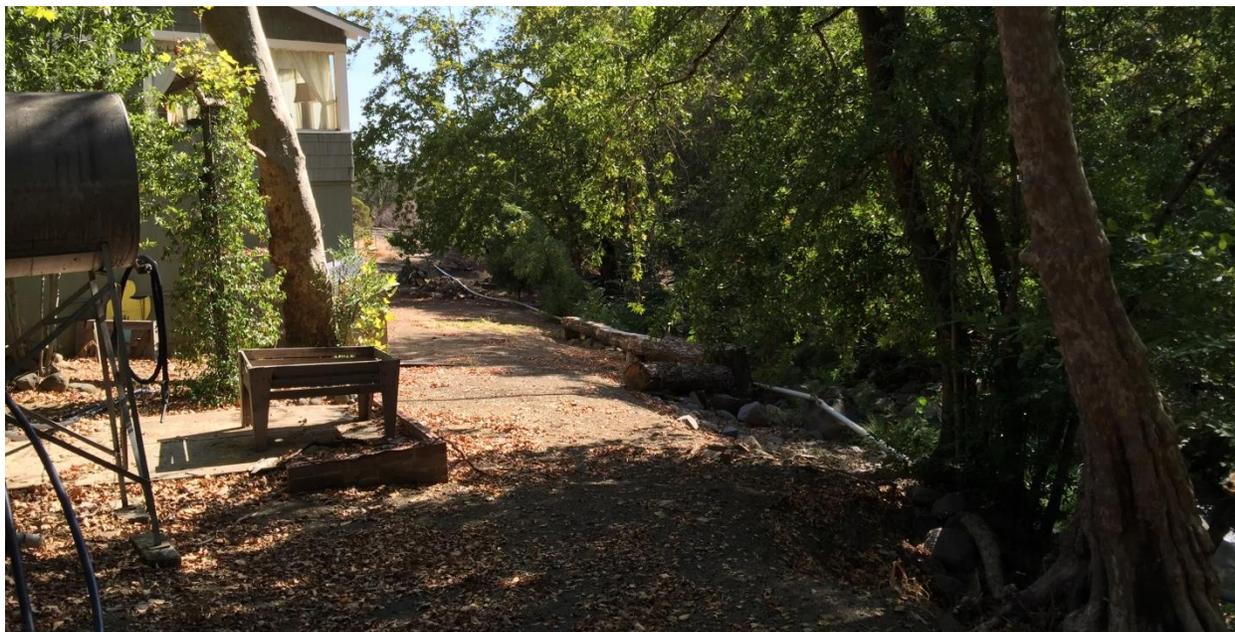
## Site 537

This site is a single family home with outbuilding, including a bridge on Big Canyon Road (38.8521' N, 122.68395' W). The home is located downstream of the Big Canyon Road bridge over Big Canyon Creek, near the junction of Ettawa Springs Road. Big Canyon Creek is a perennial fish bearing channel in the Putah Creek watershed. The habitat type at this work site is mixed-riparian. Two dead trees are located in the center of the creek directly upstream of the bridge. The threat is debris-laden flow piling up at the bridge and catching on the trees causing flooding, impacting the home, buildings and, bridge.

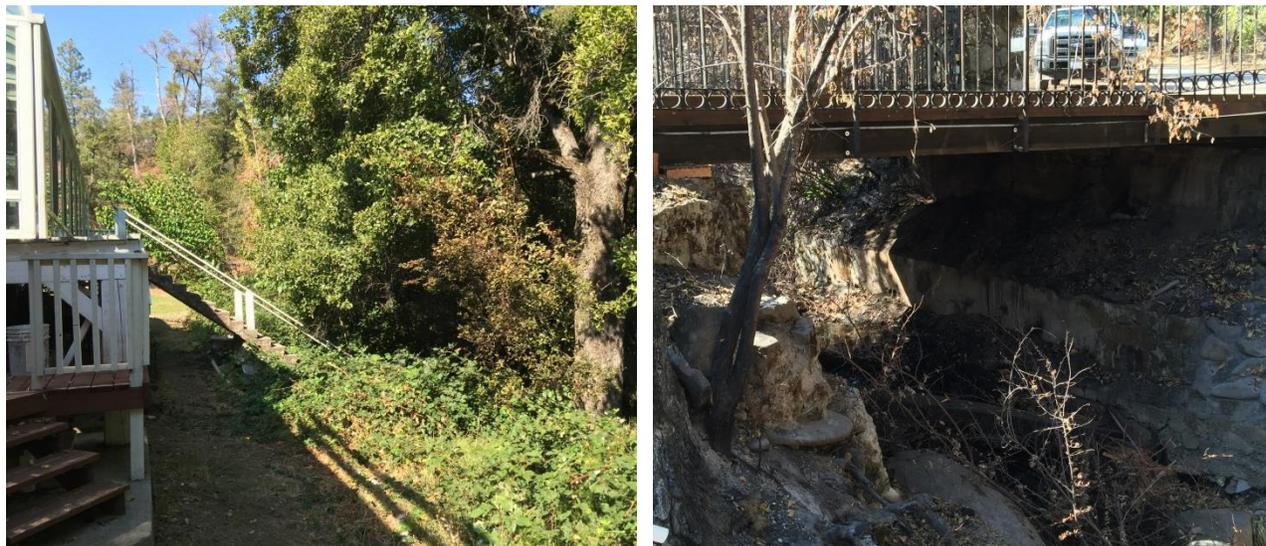
## Site 538

This site is a single family home with outbuildings on Big Canyon Road (38.8491' N, 122.67421' W). The home is located along Spikenard Creek 300 feet upstream of the convergence with Big Canyon Creek. At the time of the site review, flow was present in Spikenard but no fish were observed. Big Canyon Creek is a perennial fish bearing stream in the Putah Creek watershed. The habitat type at this work site is mixed-riparian. There is a private access bridge across Spikenard Creek. Several dead trees are in the channel under the bridge and upstream. The threat is debris-laden flow piling up at the bridges causing flooding to the home as well as flood water rising at the convergence of the creeks threatening buildings.

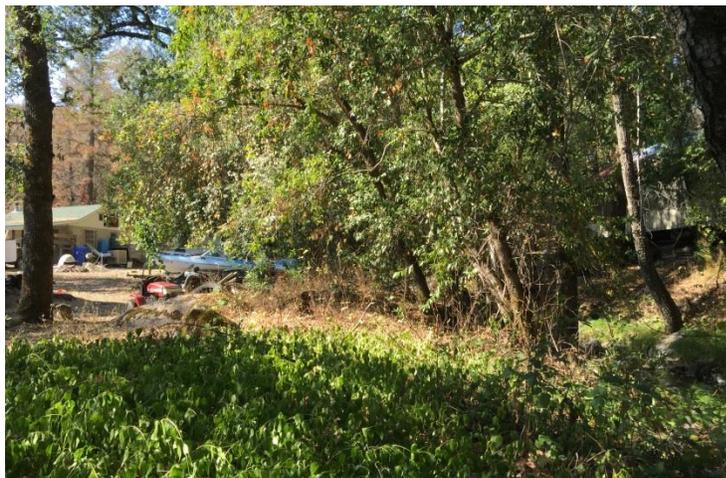
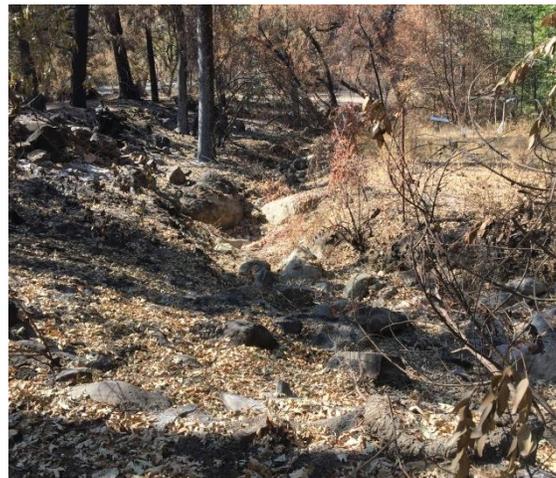
## Site 539

This site is two homes with outbuildings located on Big Canyon Road (38.84953' N, 122.67482' W). The property is located on both sides of Big Canyon Creek, above the confluence of Big Canyon Creek and Spikenard Creek. Big Canyon Creek is a perennial fish bearing stream in the Putah Creek watershed. Habitat type at this site is mixed-riparian. A side channel to Big Canyon Creek that runs during higher flows comes very close to the home and is a hazard during high water events. The threat to existing infrastructure is debris-laden flooding and debris flow down Big Canyon Creek rising to an elevation that will impact the home.

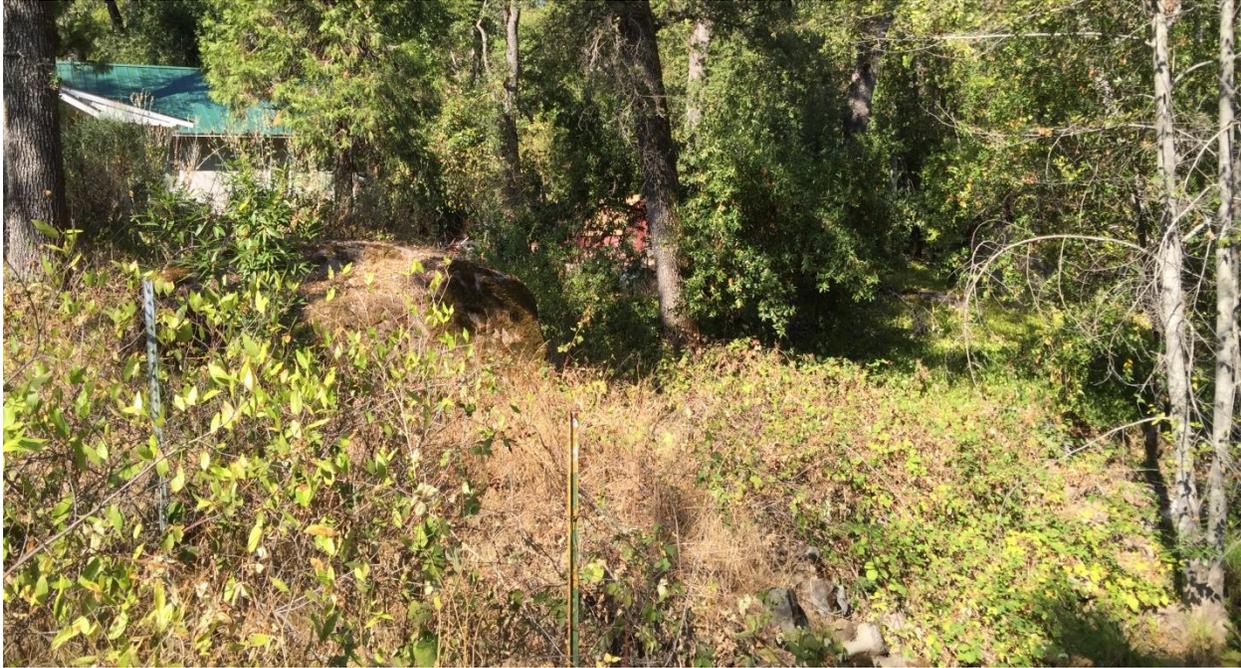
## Site 540

This site is a bridge on Big Canyon Road over Big Canyon Creek (38.84961' N, 122.67442' W). The bridge is located just upstream of the convergence of Big Canyon Creek and Spikenard Creek. Big Canyon Creek is a perennial fish bearing stream in the Putah Creek watershed. The habitat type at this work site is mixed-riparian. There are several dead trees in the channel. The threat is debris-laden flow piling up at the bridge and flooding the home as well as flood water rising at the convergence threatening buildings.

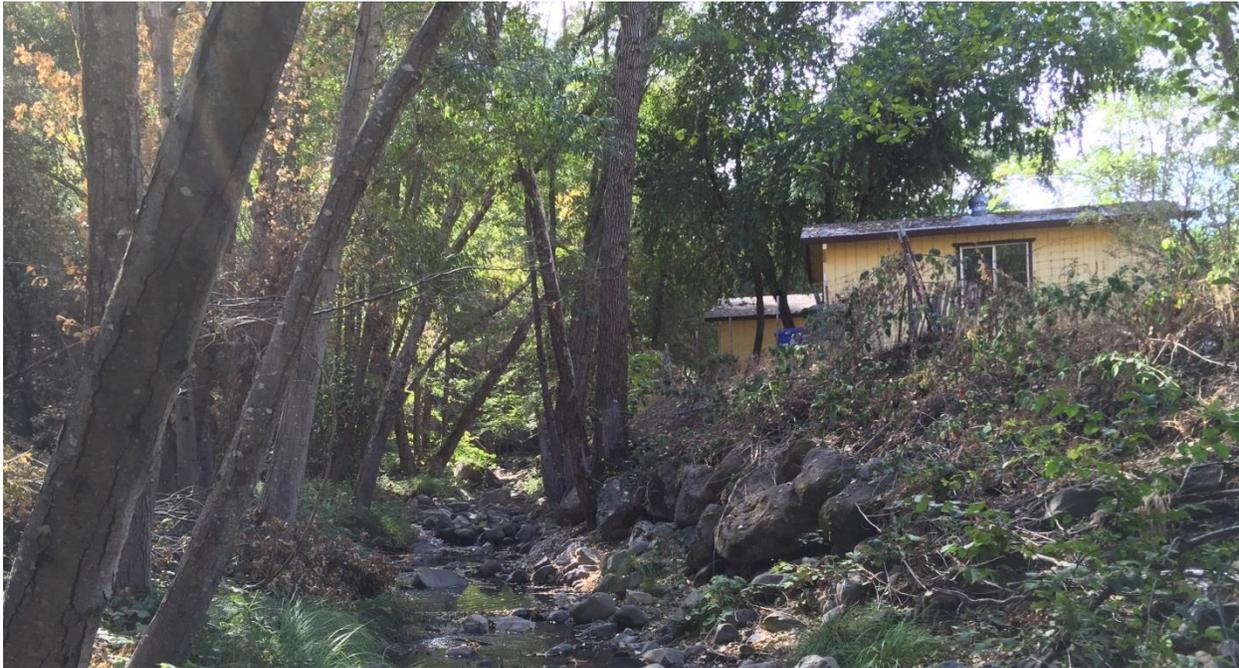
## Site 541

This site is two single family homes located on Big Canyon Road (38.84871' N, 122.66909' W). These houses are located along Big Canyon Creek. Big Canyon Creek is a perennial fish bearing stream in the Putah Creek watershed. Habitat type at this work site is mixed-riparian. The threat to existing infrastructure is debris-laden flooding and debris flow down Big Canyon Creek rising to an elevation that will impact the homes.

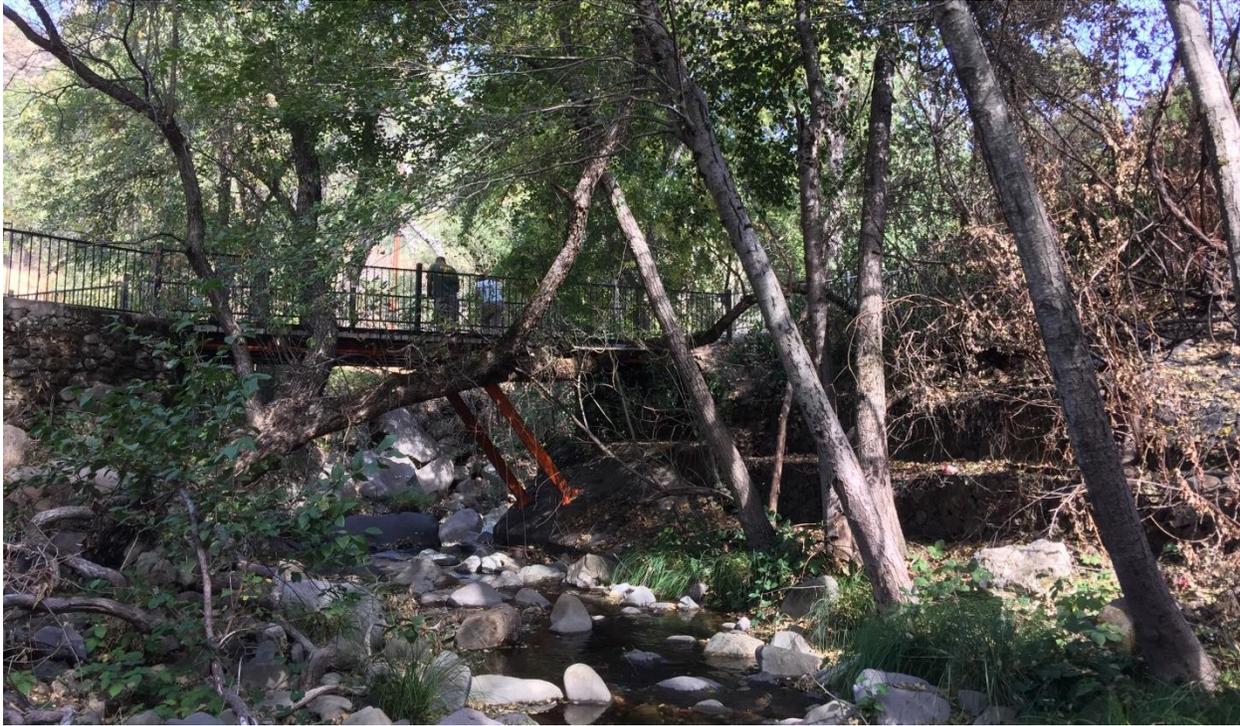
## Site 542

This site is a private access bridge located off of Big Canyon Road (38.84895' N, 122.66862' W). The bridge is located over the Big Canyon Creek channel. Big Canyon Creek is a perennial fish bearing stream in the Putah Creek watershed. The habitat type is mixed-riparian. There is a 45-degree reinforcing support that is in the flow path, potentially a debris-catching hazard. There is also a large tree growing across the channel in front of the bridge that could snag debris if water levels rise. Several dead trees have fallen upstream of the bridge that pose a hazard. The threat is debris-laden flow down Big Canyon Creek piling up on the bridge support or tree and causing damage to the bridge or flooding of local homes.

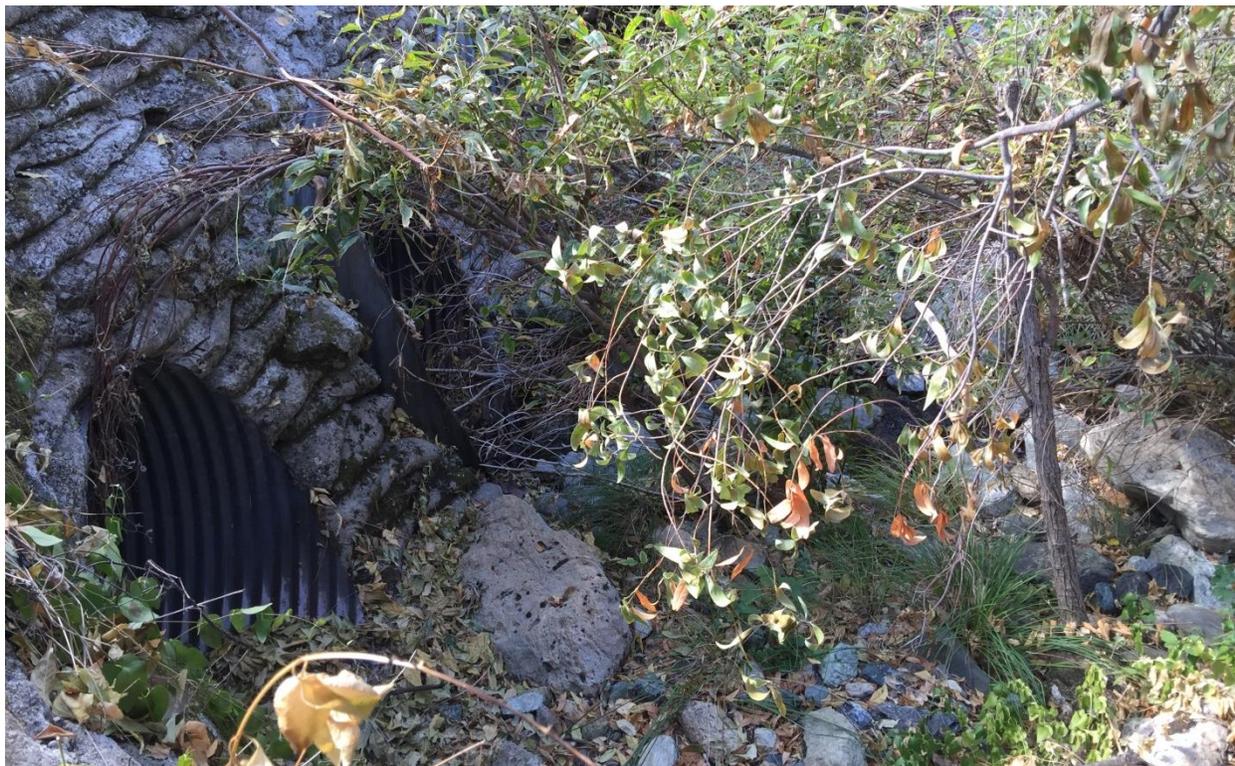
## Site 543

This site is three 48-inch culverts located where Bad Creek crosses under Big Canyon Road (38.84885' N, 122.66627' W). Bad Creek is a seasonally dry channel in the Putah Creek watershed. The habitat type at this site is mixed-riparian. There is a significant amount of woody vegetation upstream. Woody debris is partially clogging one of the culverts. The threat is debris-laden flow down Bad Creek piling up on the culverts and causing flooding of Big Canyon Road and surrounding area.

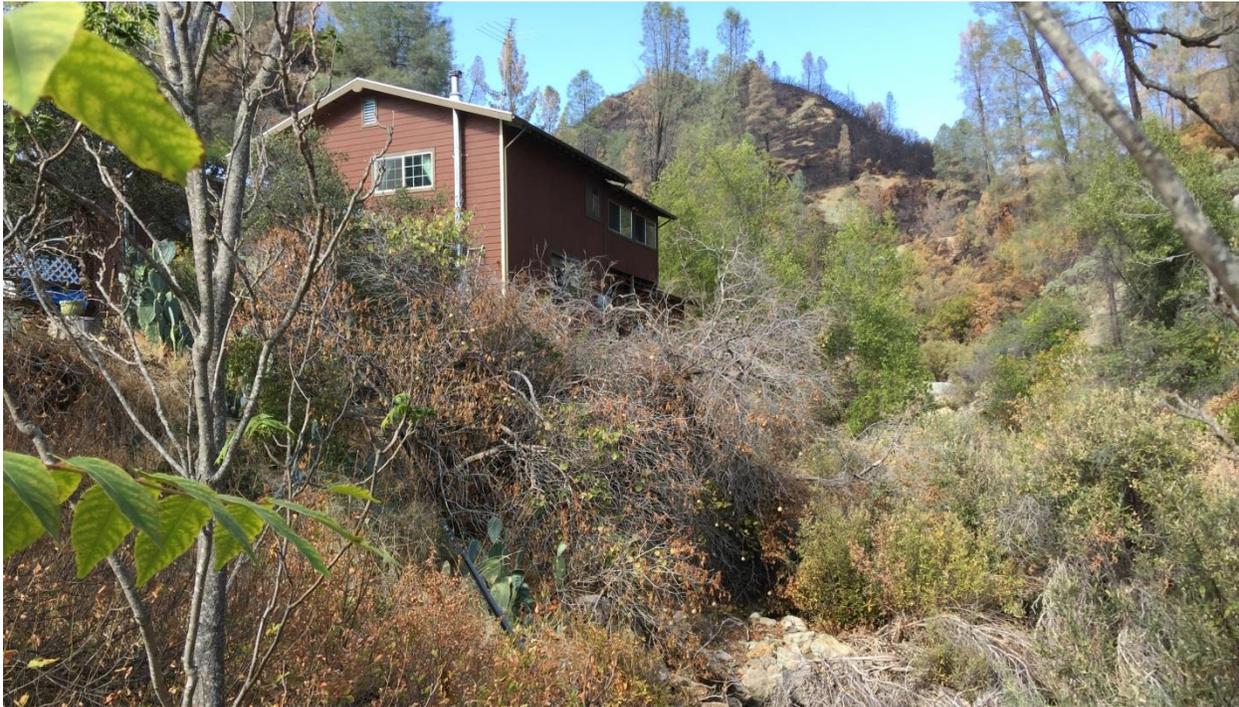
## Site 544

This site is a single family home located on Big Canyon Road (38.84929' N, 122.66646' W). The house is located along Bad Creek, near the confluence with Big Canyon Creek. Bad creek is a seasonally dry channel in the Putah Creek watershed. Habitat type is at this site is mixed-riparian. The threat to existing infrastructure is debris-laden flooding and debris flow down Bad Creek rising to an elevation that will impact the home.

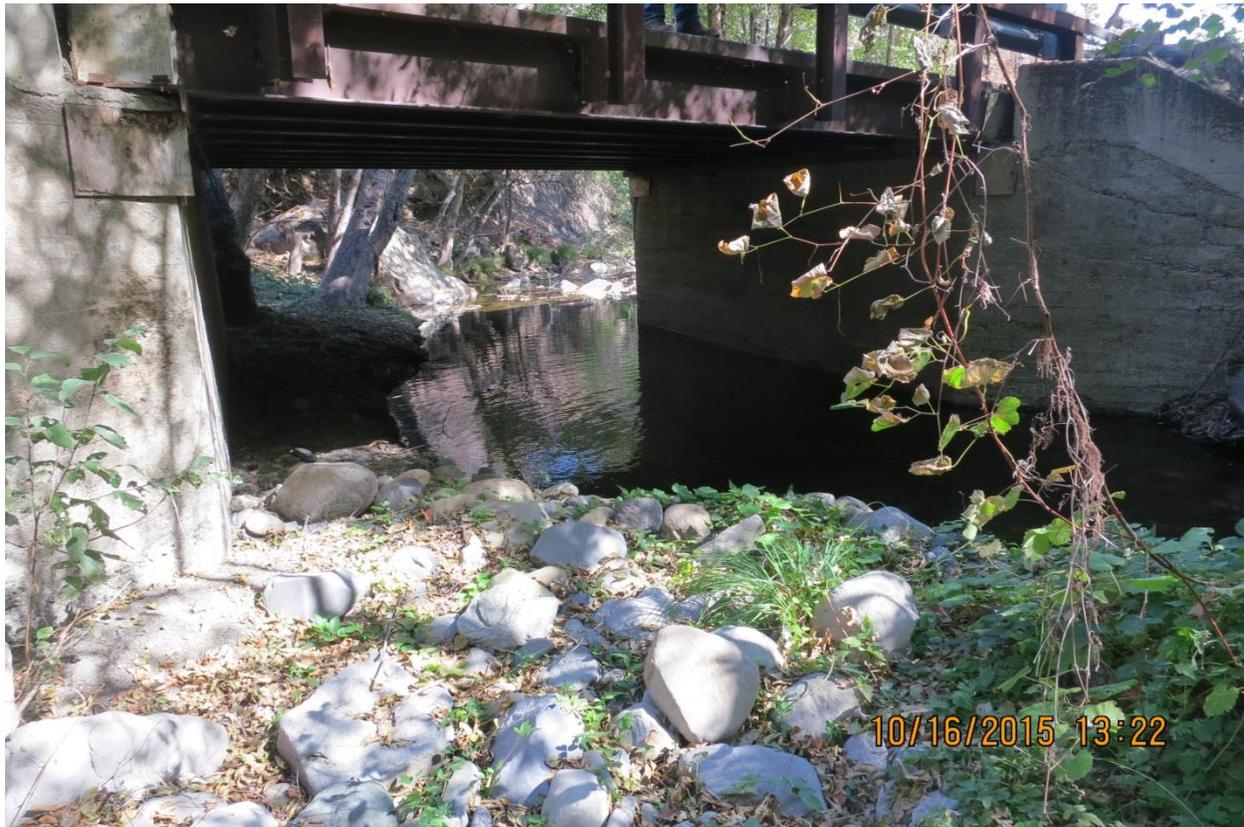
## Site 545

This site is a bridge located on Big Canyon Road (38.84619' N, 122.66416' W). The bridge is across Big Canyon Creek. Big Canyon Creek is a perennial fish bearing stream in the Putah Creek watershed. The habitat type at this site is oak woodland. The threat is flooding and debris-laden flow from a tributary leading to the bridge inlet.

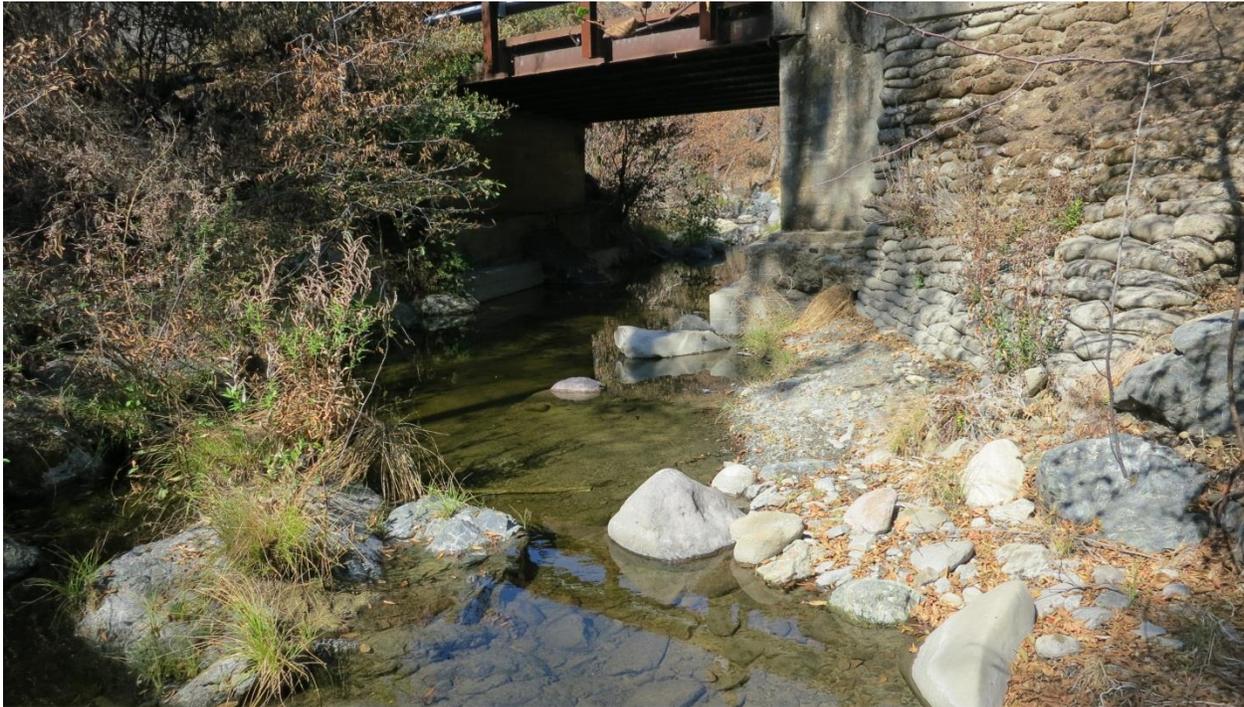
## Site 546

This site is a bridge located on Big Canyon Road (38.84511' N, 122.65937' W). The bridge is located at Big Canyon Creek. Big Canyon Creek is a perennial fish bearing stream in the Putah Creek watershed. Habitat type at this site is mixed-riparian. The threat to existing infrastructure is debris-laden flooding and debris flow piling up on the bridge flooding the surrounding area or damaging the bridge.

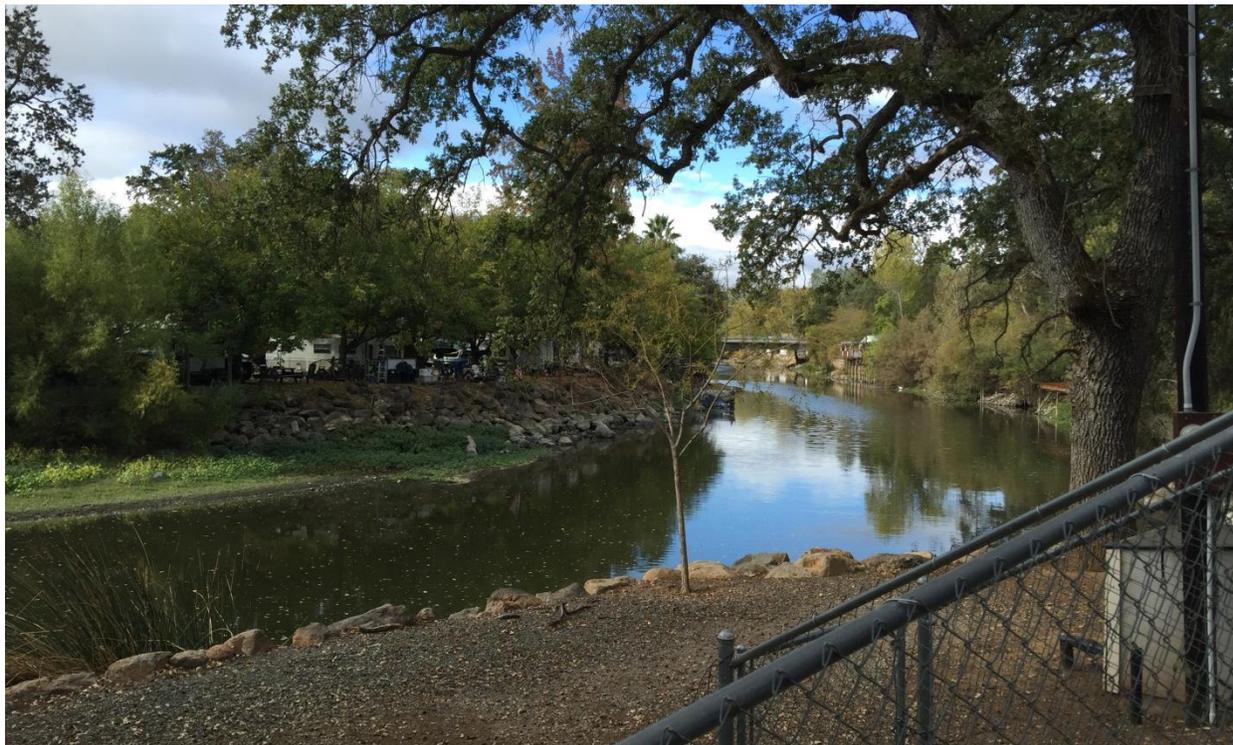
## Site 547

This site includes multiple single-family dwellings, mobile homes and a recreational vehicle (RV) park located along Dam Road and Tish-a-Tang Road (38.92499' N, 122.6089' W). The dwellings are located along Cache Creek. Cache Creek is a perennial fish bearing stream. Cache Creek at this location is above the outlet dam for Clear Lake, so the water is slow moving. Habitat type at this site is oak woodland. The threat to existing infrastructure is debris-laden flooding and debris flow down Cache Creek rising to an elevation that will impact the homes and RV Park.
