# Valley Fire

State Post Fire Watershed Emergency Response Team  
Addendum I

Hazard Site Evaluation

October 2015

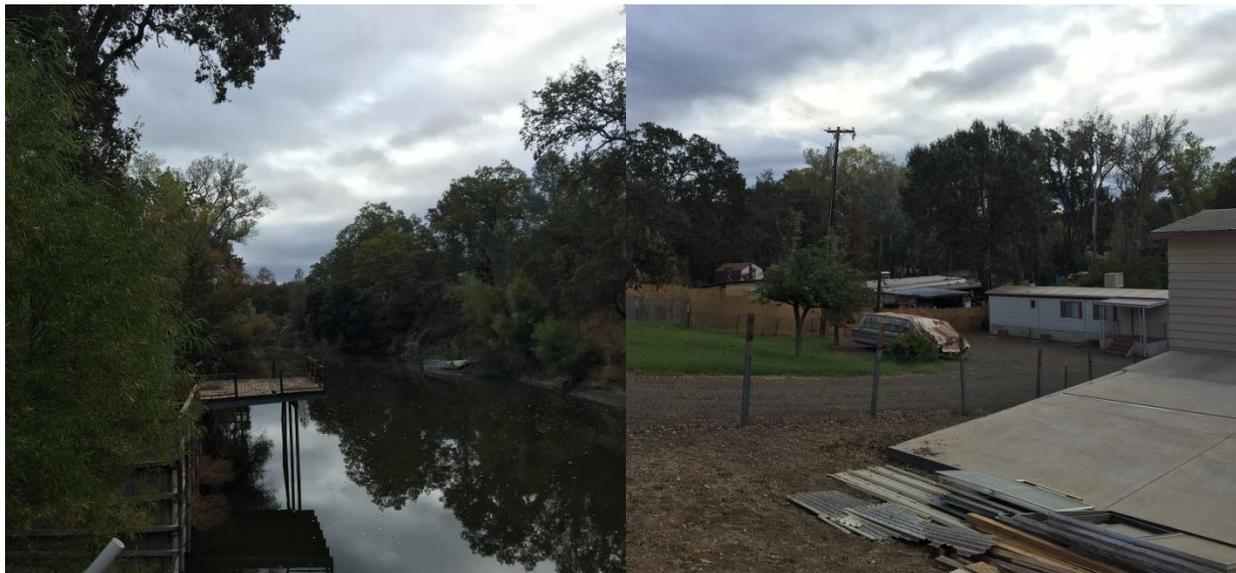
## Site 548

This site includes multiple single-family homes and structures located off Cache Creek Lane (38.92044' N, 122.59792' W). The homes and structures are located along Cache Creek. Cache Creek is a perennial fish bearing stream in the Cache Creek watershed. Habitat type at this site is oak woodland. The threat to existing infrastructure is debris-laden flooding and debris flow down Cache Creek rising to an elevation that will impact the homes and structures.

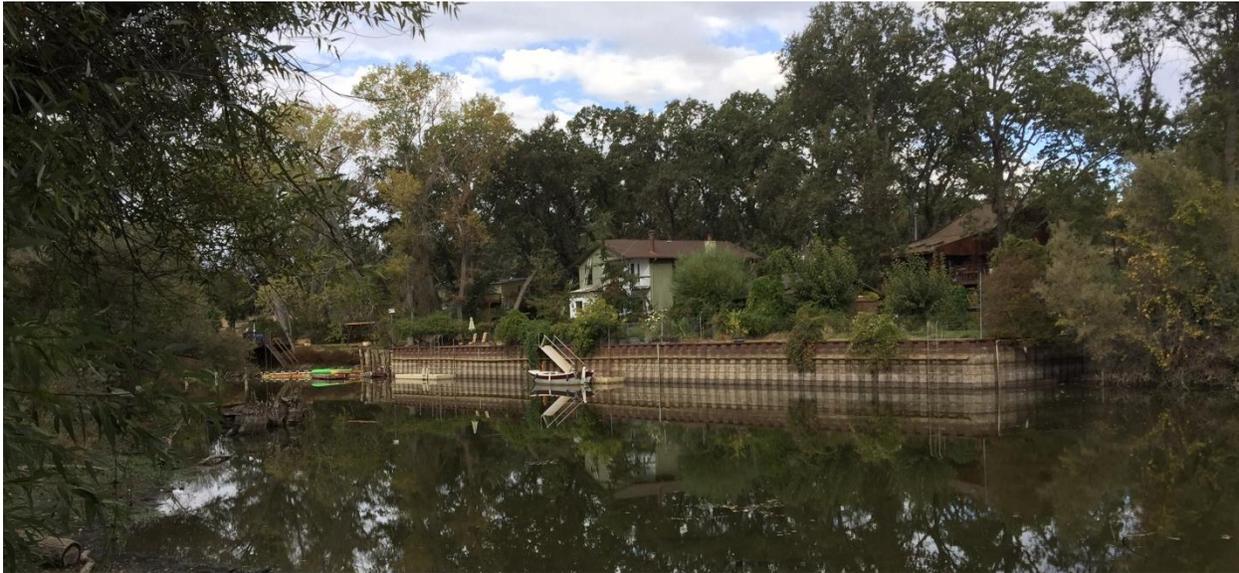
## Site 549

This site is a group of single family homes located at the end of Dam Road South (38.9226' N, 122.5953' W). The homes are located along Cache Creek near the confluence of Copsey Creek. Cache Creek is a perennial fish bearing stream. Habitat type at this site is oak woodland. The threat to existing infrastructure is debris-laden flooding and debris flow down Cache Creek rising to an elevation that will impact the homes.

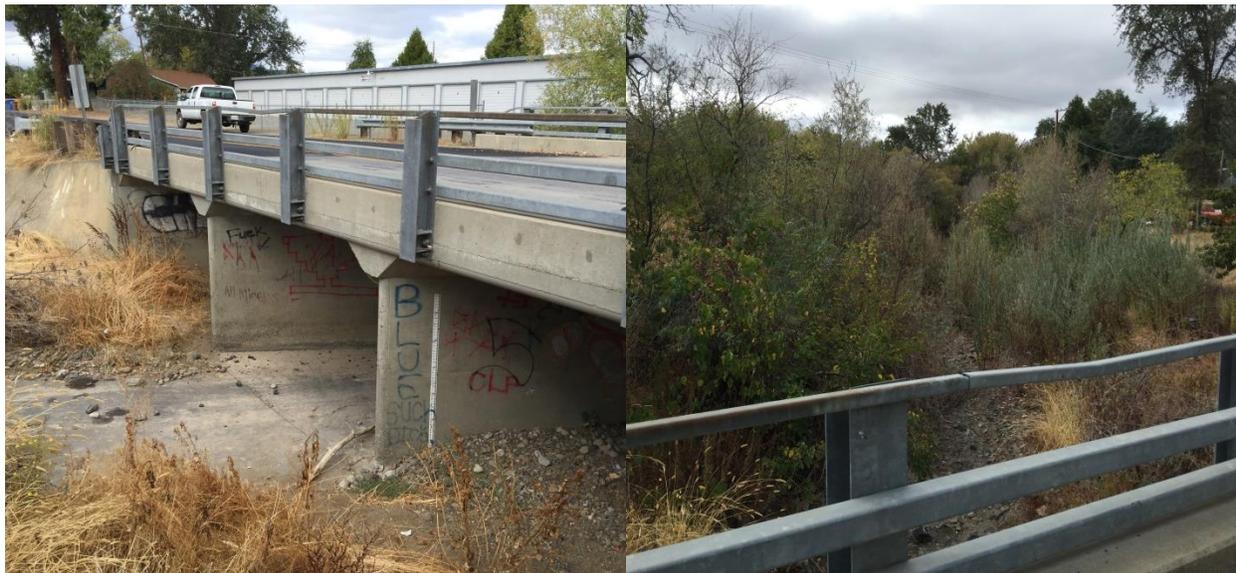
## Site 550

This site is a bridge on Jessie Street (38.91372' N, 122.61006' W). The bridge is located over Seigler Canyon Creek. Seigler Canyon Creek is a seasonally dry channel, in the Cache Creek watershed. Habitat type at this site is oak woodland. The bridge has two concrete wall supports in the channel. There is significant debris and woody vegetation present in the channel. The threat to existing infrastructure is debris-laden flow down the creek piling up on the bridge and causing flooding of road and nearby area.

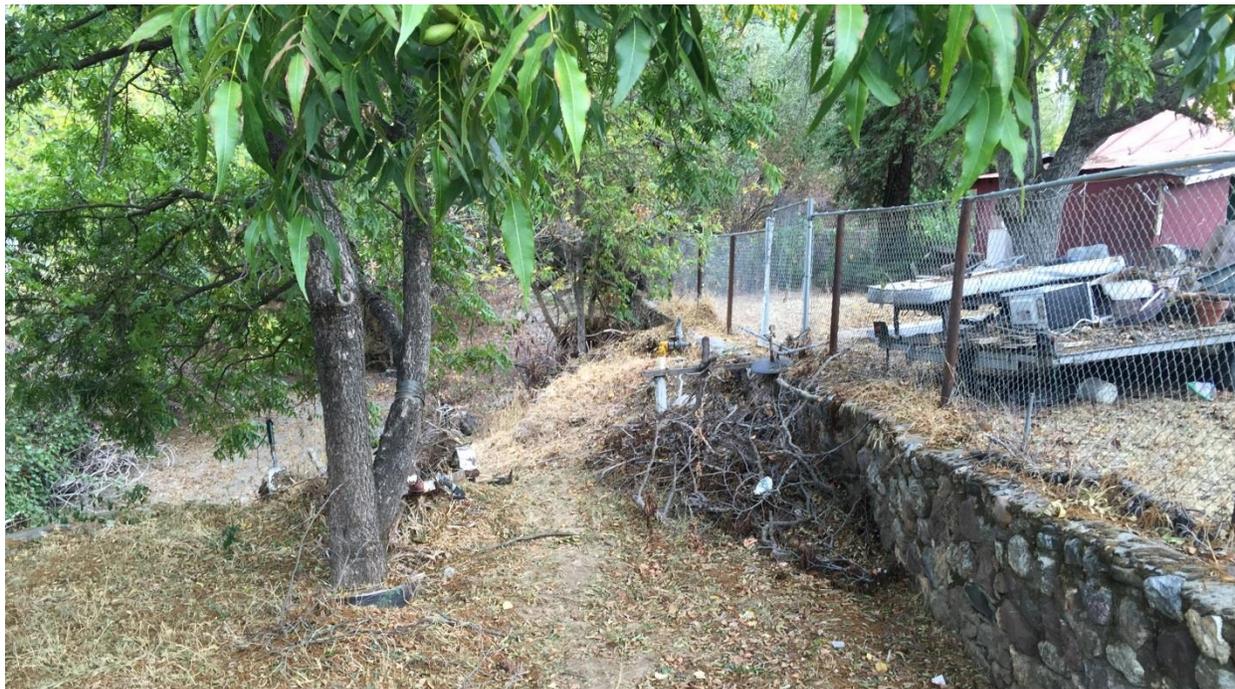
## Site 551

This site includes an area of single-family dwellings bordered to the west by Highway 53, east by Lake Street, north by Cache Creek, and south by Main Street (38.91735' N, 122.6111' W). The dwellings are located along Seigler Canyon Creek. Seigler Canyon Creek is a seasonally dry channel in the Cache Creek watershed. Habitat type at this site is oak woodland. The threat to existing infrastructure is debris-laden flooding and debris flow down Seigler Canyon Creek rising to an elevation that will impact the homes in the area.

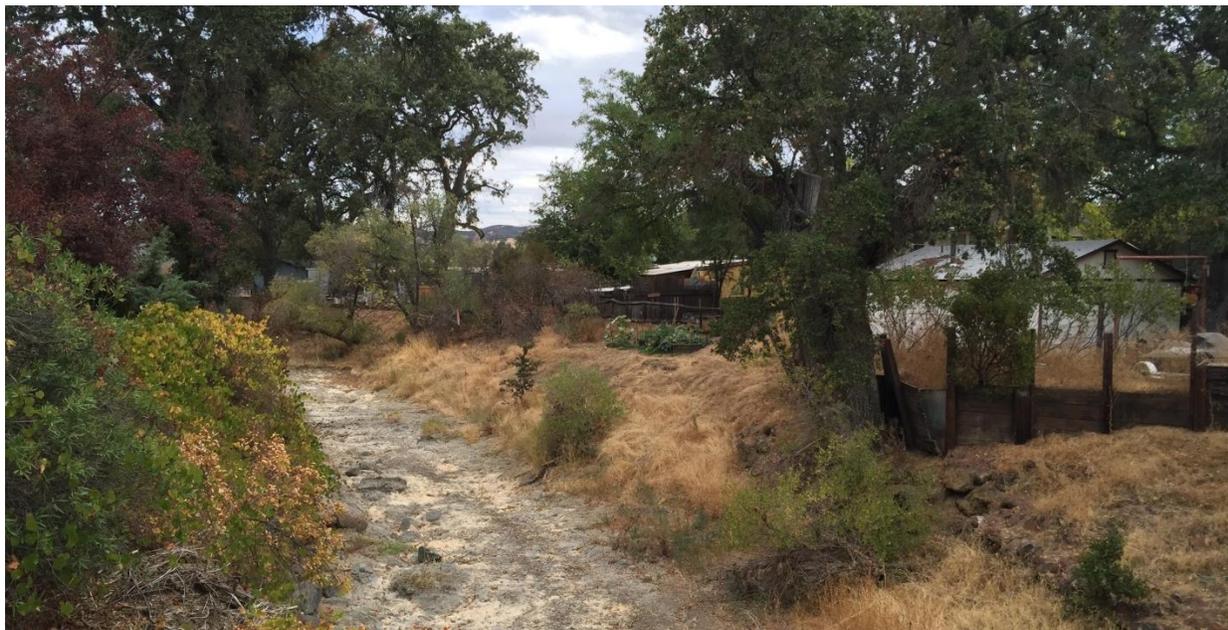
## Site 552

This site is a community of single family homes that border Copsey Creek along Pinto Place, Bronco Lane, and Quarterhorse Lane to the east and Stagecoach Lane to the west (38.91648' N, 122.59528' W). Copsey Creek is a seasonally dry channel in the Cache Creek watershed; however it has significant fish activity when flowing. The habitat type at this site is oak woodland. The threat to existing infrastructure is debris-laden flooding and debris flow down Copsey Creek rising to an elevation that will impact the homes.

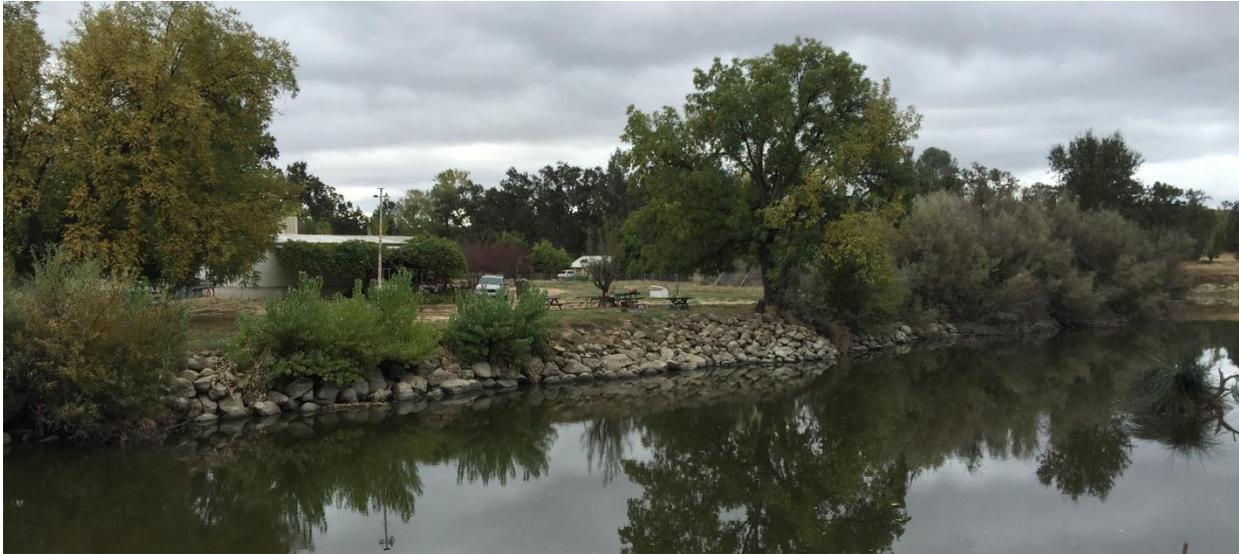
## Site 553

This site is a group of single family homes located at the end of Quarterhorse Lane (38.92161' N, 122.59393' W). The homes are located along Cache Creek just downstream of Copsey Creek. Cache Creek is perennial fish bearing stream. Habitat type at this site is oak woodland. The threat to existing infrastructure is debris-laden flooding and debris flow down Cache Creek rising to an elevation that will impact the homes.

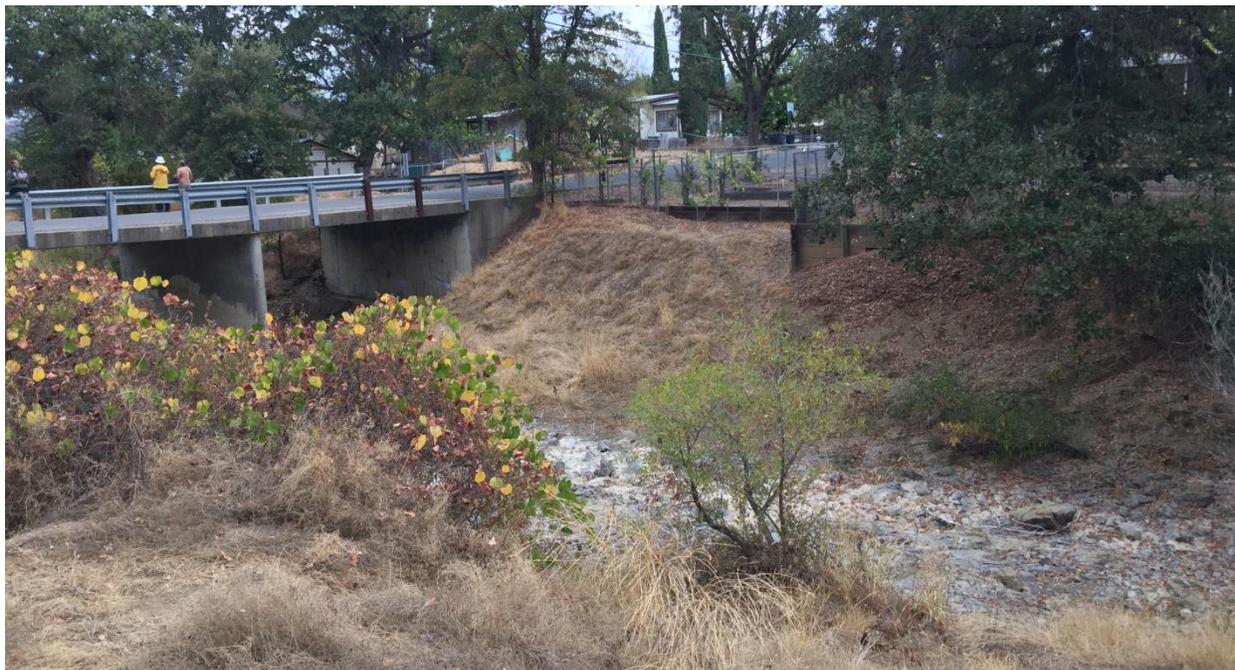
## Site 554

This site is a bridge over Copsey Creek on Copsey Creek Way (38.91424' N, 122.59355' W). Copsey Creek is a seasonally dry channel, in the Cache Creek watershed; however residents report significant fish activity in creek when flowing. The habitat type at this work site is oak woodland. There are two concrete wall supports in the channel as well as some vegetation in the channel. The threat is debris-laden flow piling up at the bridge supports and flooding onto nearby homes.

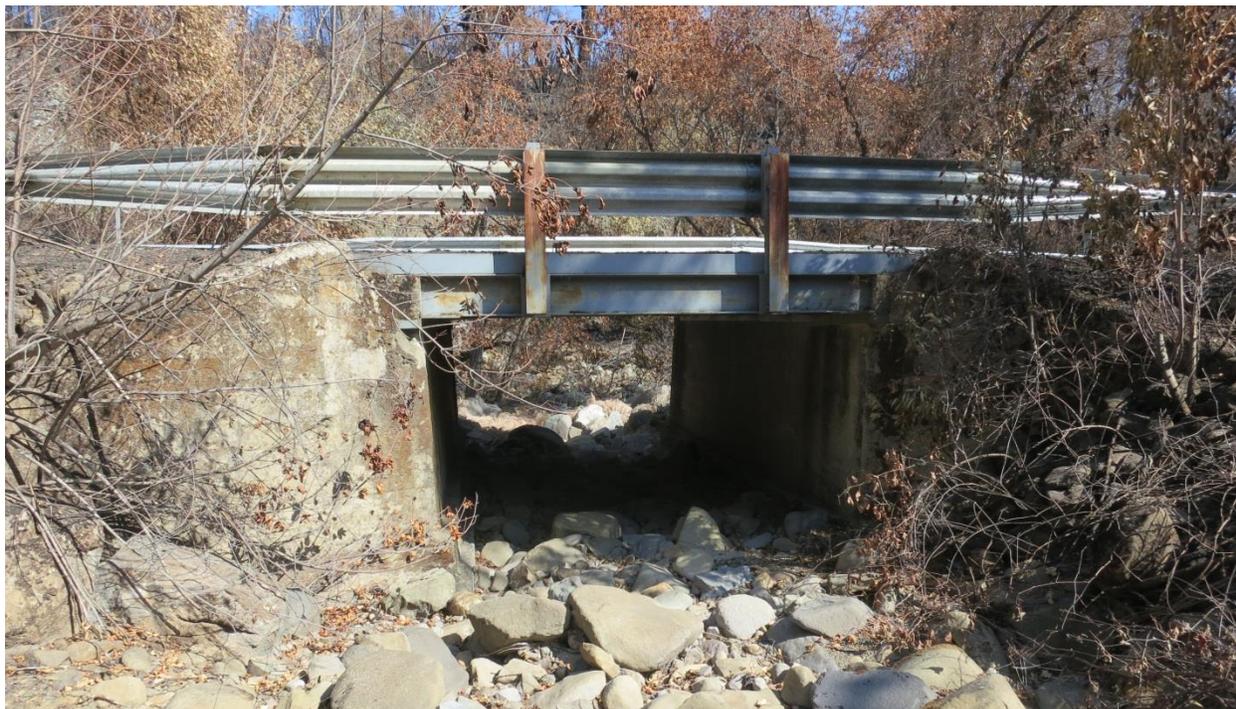
## Site 555

This site is a bridge located on Big Canyon Road (38.83173' N, 122.64526' W). The bridge is located over Malo Creek at the confluence to Big Canyon Creek. . Malo Creek is a seasonally dry creek while Big Canyon Creek is a perennial fish bearing stream, in the Putah Creek watershed. Habitat type at this site is mixed-riparian. The threat to existing infrastructure is debris-laden flooding and debris flow piling up at the bridge impacting the surrounding area and/or damaging the bridge.

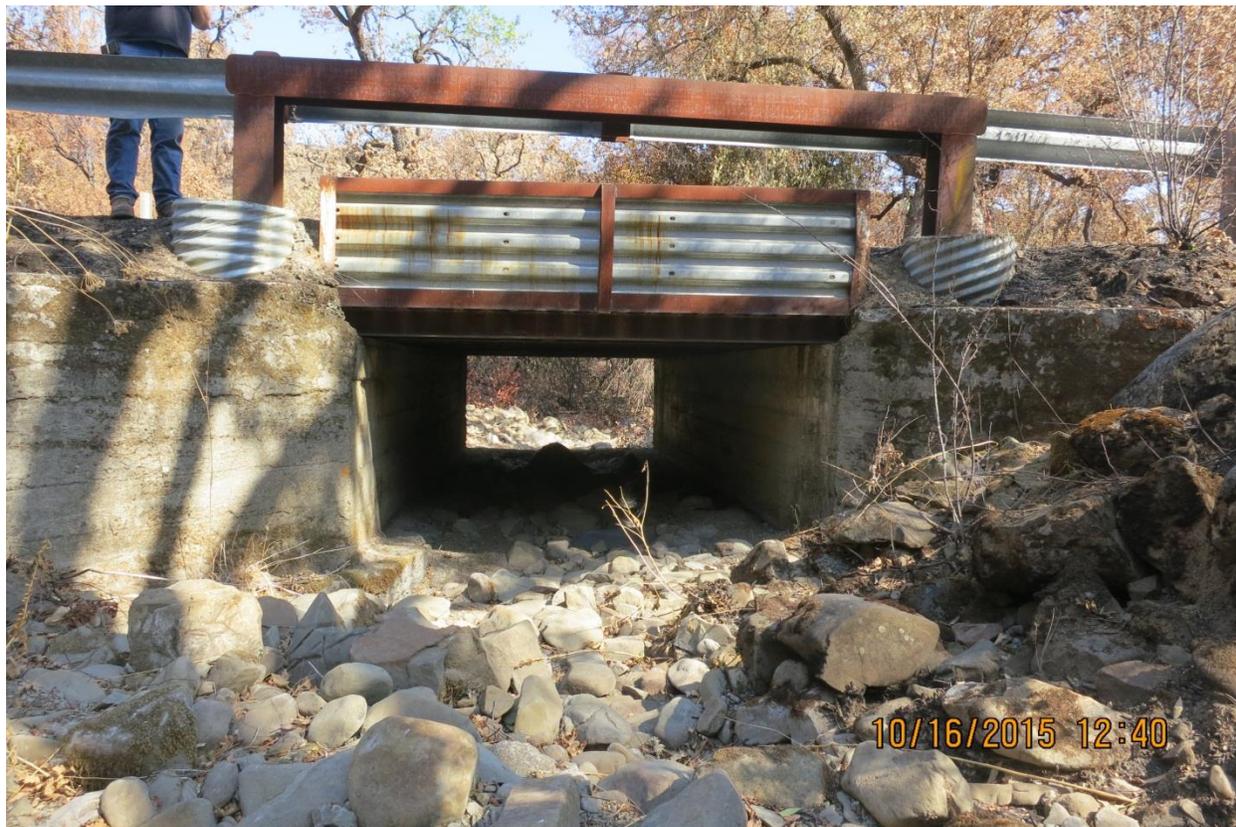
## Site 556

This site is a bridge located on Big Canyon Road (38.82377' N, 122.63148' W). The bridge is on an unnamed tributary of Big Canyon Creek just west of Big Canyon Creek. The tributary is seasonally dry while Big Canyon Creek is a perennial fish bearing stream, in the Putah Creek watershed. The habitat type at this site is oak woodland. The threat is debris-laden flow piling on the bridge and flooding the road.

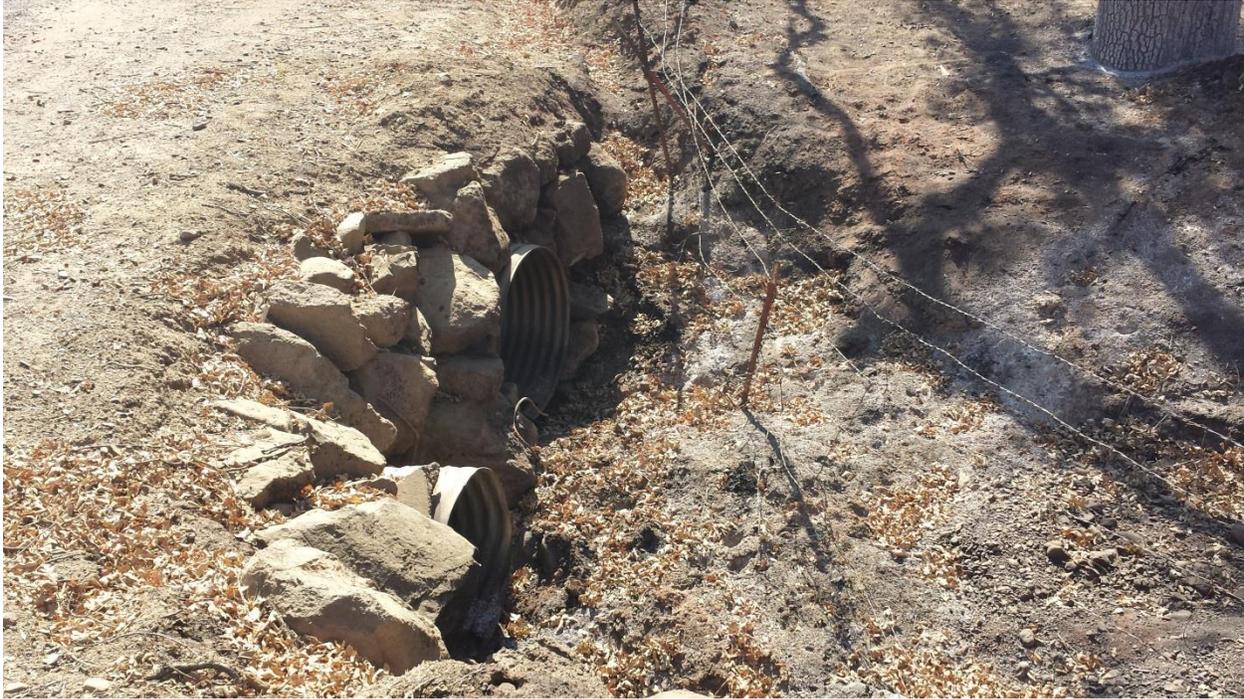
## Site 557

This site is two culverts (approximately 30-inch and 24-inch) crossing under Big Canyon Road (38.80665' N, 122.61617' W). The culverts are located at an unnamed tributary to Big Canyon Creek near the convergence of Big Canyon Creek and Putah Creek. The unnamed tributary is a seasonally dry channel while Big Canyon Creek and Putah Creek are perennial fish bearing streams. The habitat type at this work site is oak woodland. There is barbed wire fencing across the channel on both sides of Big Canyon Road. There is evidence of previous overtopping. The threat is debris-laden flow piling up at the culverts and fencing as well as flood water rising and overtopping Big Canyon Road.

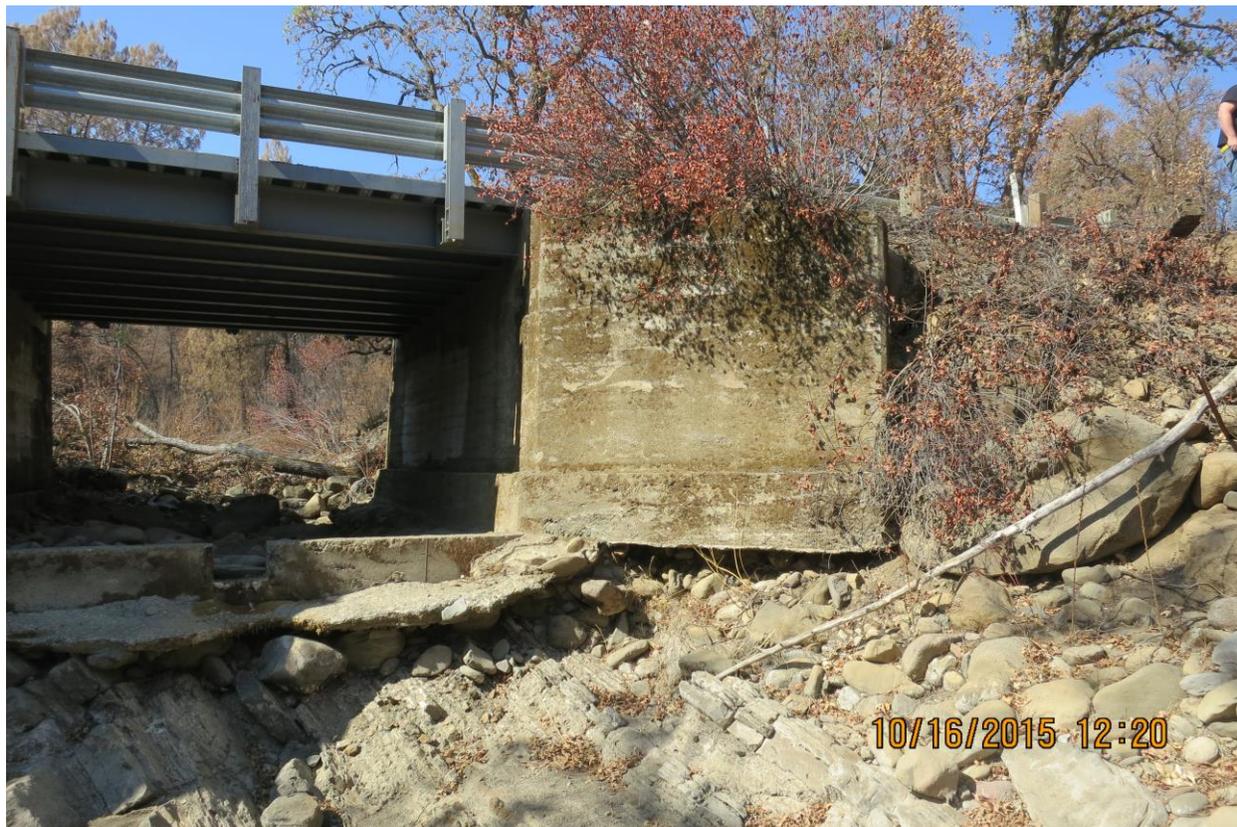
## Site 558

This site is a bridge located on Big Canyon Road (38.80252' N, 122.61459' W). The bridge is on the Cockerell Canyon Creek near the confluence of Putah Creek. Cockerell Canyon Creek is a seasonally dry channel in the Putah Creek watershed. The habitat type at this site is oak woodland. Downstream concrete footings are undermined and not founded on concrete. Additionally, there is a large oak branch in the stream channel. The threat to existing infrastructure is debris-laden flow piling on bridge, flooding the road and compromising the bridge.

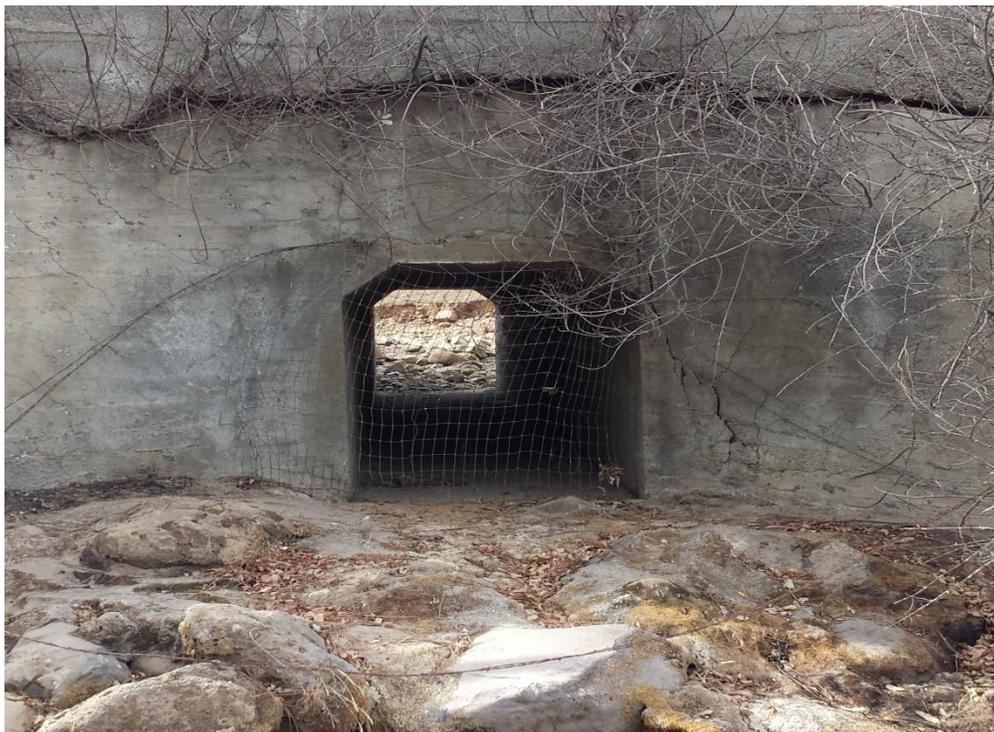
## Site 559

This site is a box culvert located on Big Canyon Road (38.78092' N, 122.61427' W). The box culvert is over an unnamed tributary of Harbin Creek. The unnamed tributary is a seasonally dry channel, in the Putah Creek watershed. The habitat type at this site is oak woodland. The unnamed tributary is a seasonally dry channel, in the Putah Creek watershed. There is a fence in the culvert outlet that obstructs water flow. The threat to existing infrastructure is debris-laden flow piling in the culvert and flooding local area.

Fish found downstream of the recommended work would see a net benefit if fencing was cleared of debris and removed from tunnel.

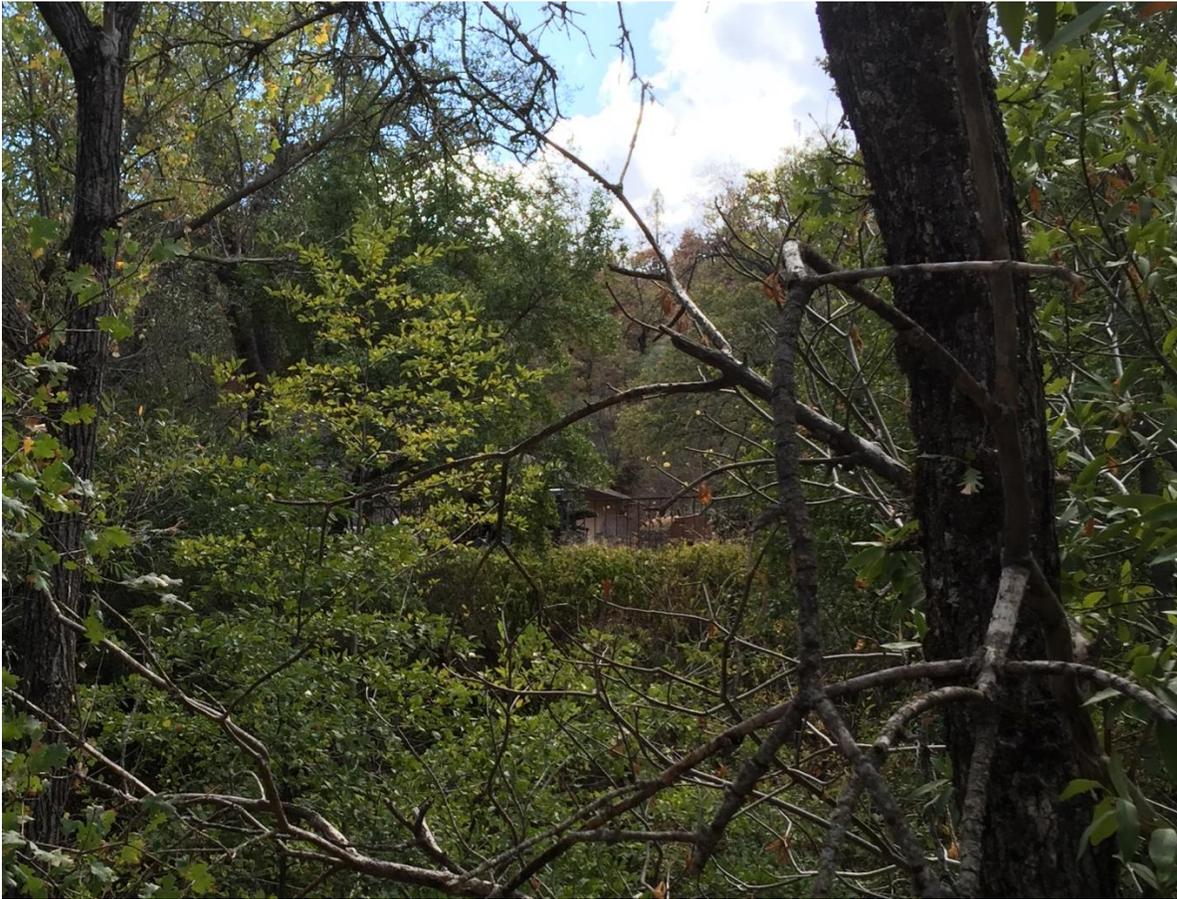
## Site 560

This site is two homes with outbuildings located on Big Canyon Road (38.84851' N, 122.66692' W). The property is located at the confluence of Bad Creek and Big Canyon Creek. Big Canyon Creek is a perennial fish bearing stream in the Putah Creek watershed. Habitat type at this site is oak woodland. The buildings back up to a steep hill that has been burned. The threat to existing infrastructure is debris-laden runoff and erosion down the hill onto the structures.

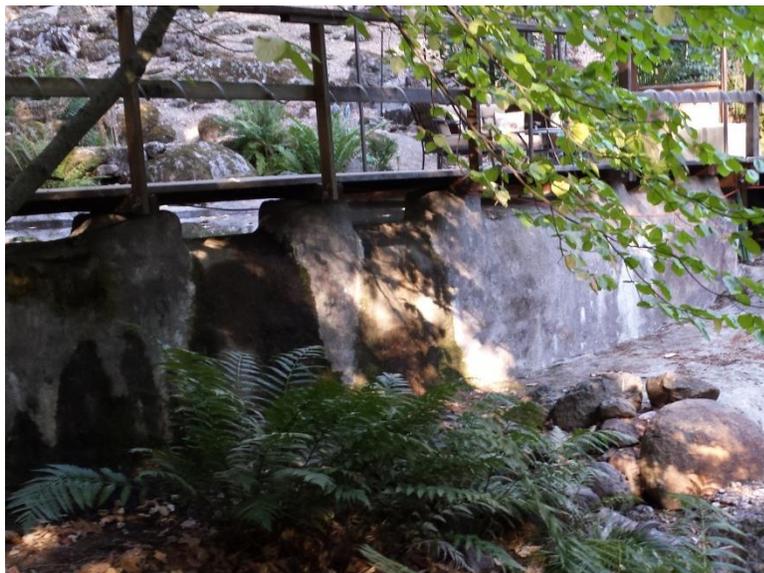
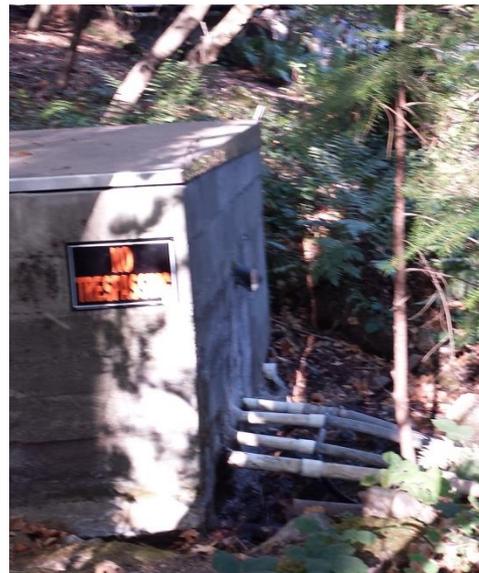
## Site 562

This site is a single family home located on Maple Shadows Drive (38.81114' N, 122.7137' W). The house is located at an unnamed tributary to Putah Creek. Putah Creek is a perennial fish bearing stream. Habitat type at this site is mixed-riparian. There are several obstructions in the channel that can block natural flow. The threat to existing infrastructure is debris-laden flooding and debris flow down the tributary.

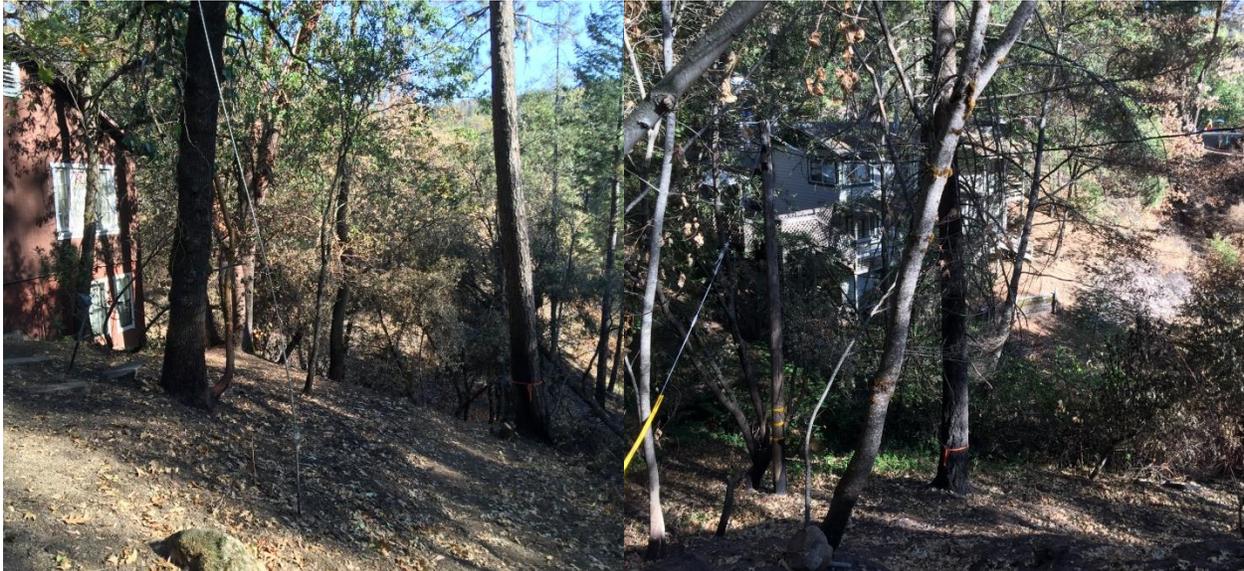
## Site 563

This site includes two houses located on Maple Shadows Drive (38.81025' N, 122.71142' W). The homes are located between an unnamed tributary and swale runoff in the Putah Creek watershed. Habitat type at this site is mixed-conifer. The threat to existing infrastructure is debris-laden flooding and debris flow down the creek or swale rising to a level impacting the homes.

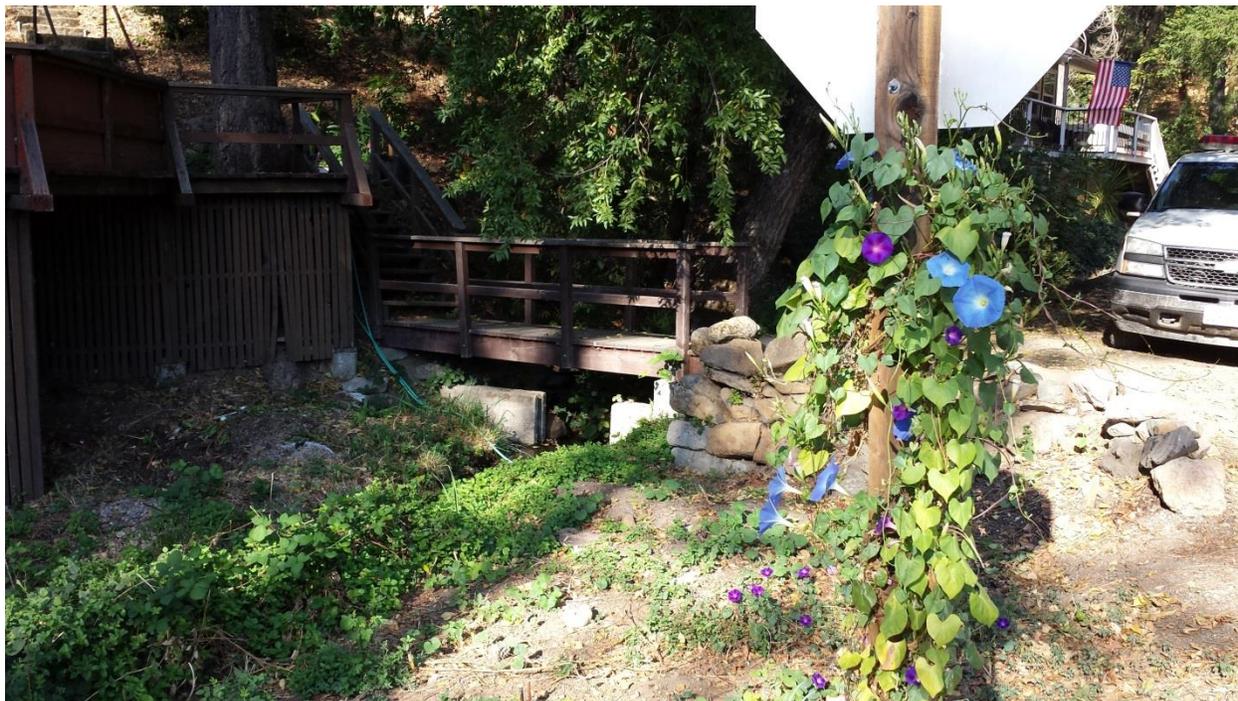
## Site 564

This site is a single family home located on Highway 175 (38.81023' N, 122.71013' W). The house is located at an unnamed tributary to Putah Creek. Putah Creek is a perennial fish bearing stream. Habitat type at this site is mixed-riparian. There is a small foot bridge with concrete pilings located in the channel as well as a culvert at Highway 175. The threat to existing infrastructure is debris-laden flooding and debris flow down the tributary, catching on the small foot bridge and culvert at Highway 175, and water rising to an elevation that will impact the home.
