DEPARTMENT OF FORESTRY
AND FIRE PROTECTION

INVESTIGATION REPORT

Case Number: 07-3522-075

Case Name: MARTIN

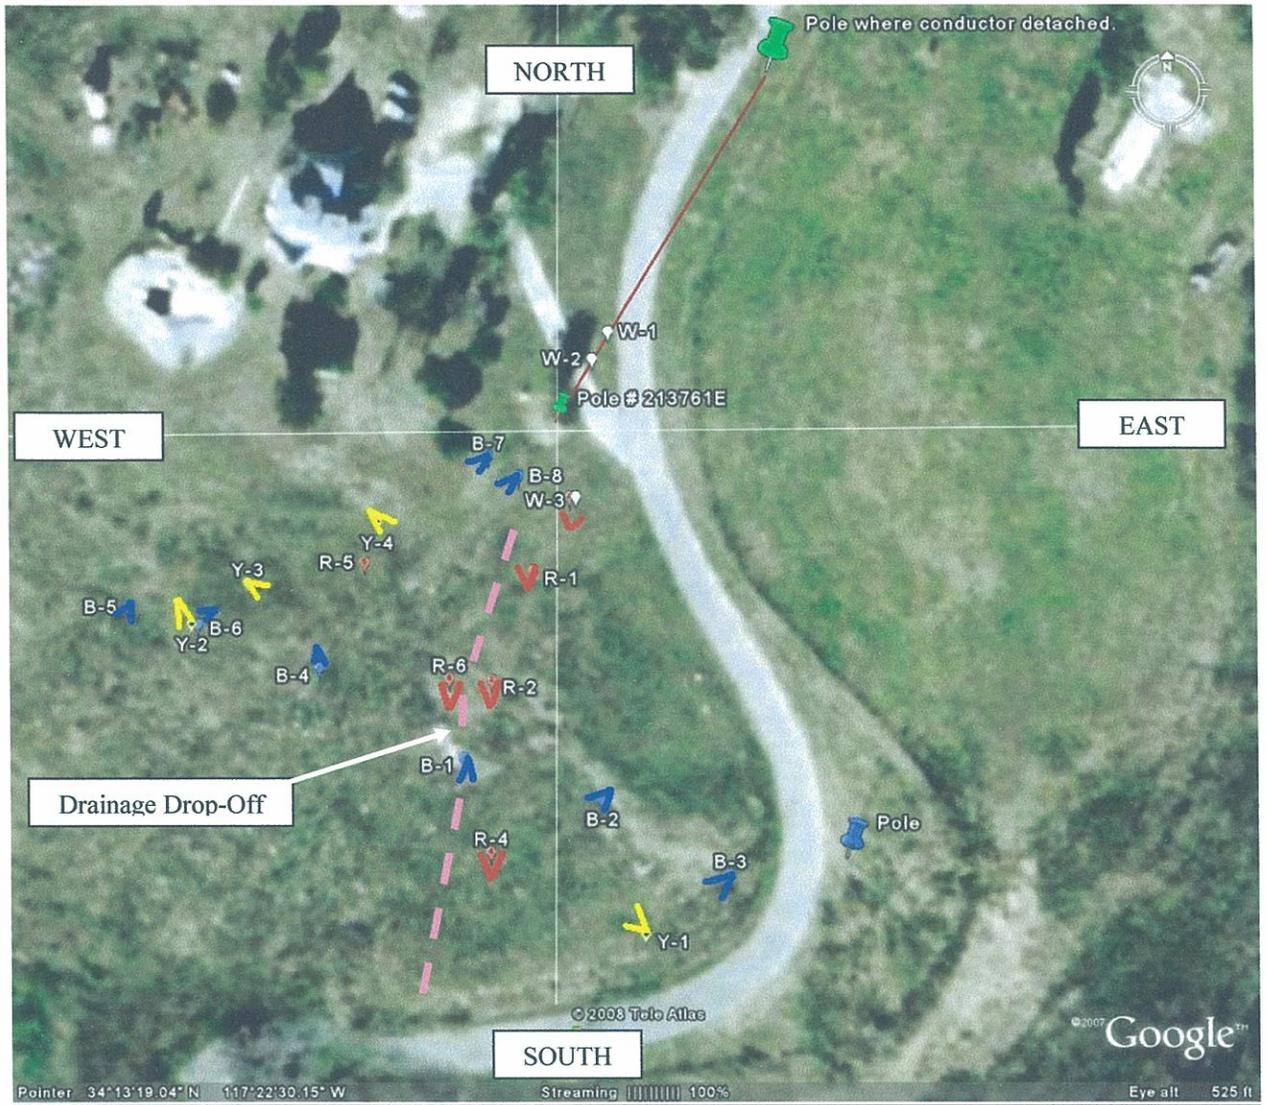
10- ATTACHMENT: Fire Spread & Burn Indicator Locations Diagram

Location Descriptions: Refer to Photographic Log, Item number 5-4 through 5-41

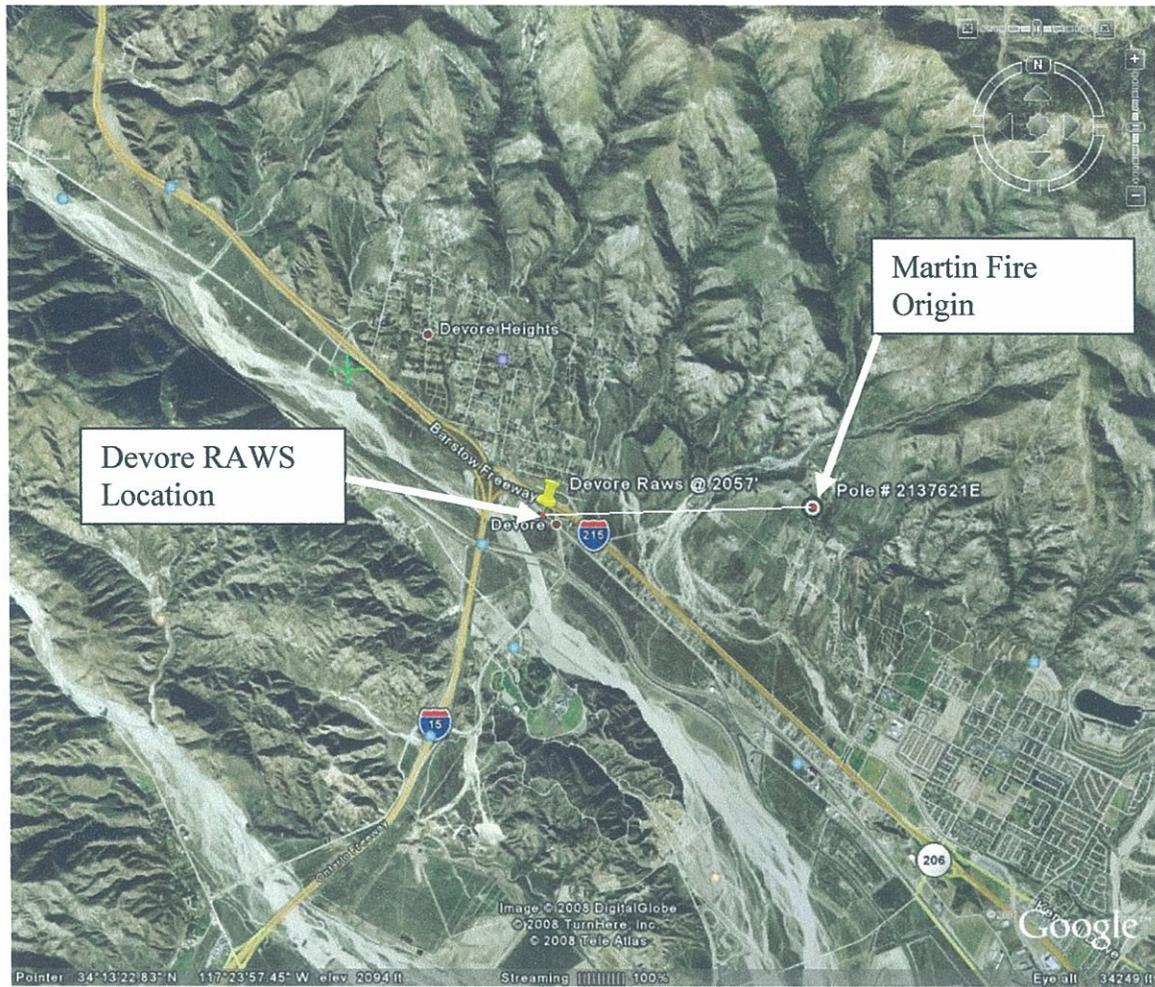
10- ATTACHMENT: Devore RAWS Location Map

The Devore RAWS (Remote Automated Weather Station) is located approximately 1.65 miles west of the Martin Fire point of origin.

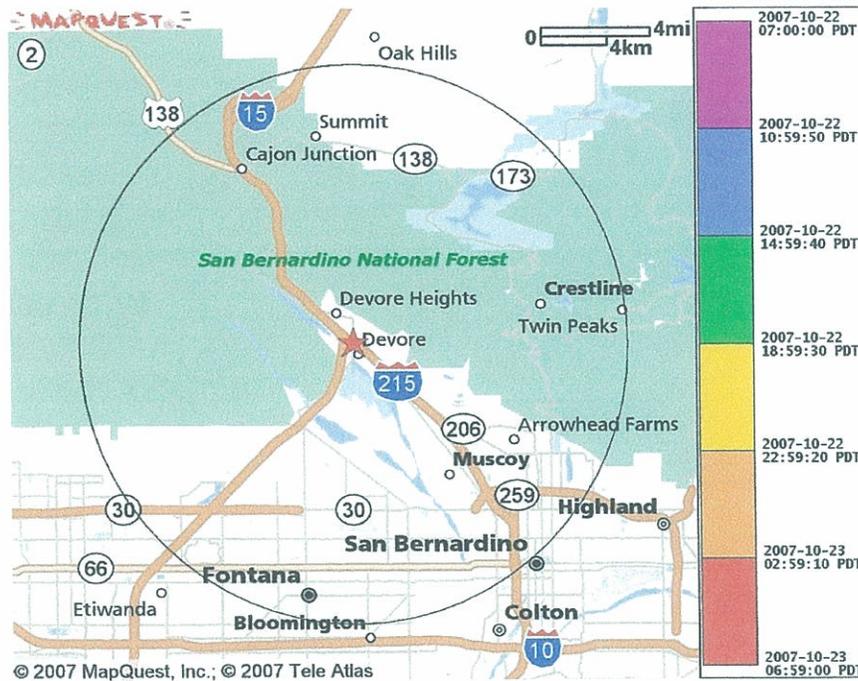
Location Points For Lightning Strokes

Report Title: 24 Hour Lightning RPT
 Total Lightning Strokes Detected: 0
 Lightning Strokes Detected within 10 mi/16 km radius: 0
 Lightning Strokes Detected beyond 10 mi/16 km whose confidence ellipse overlaps the radius: 0
 Search Radius: 10 mi/16 km
 Time Span: Oct 22, 2007 07:00:00 AM US/Pacific to Oct 23, 2007 06:59:00 AM US/Pacific

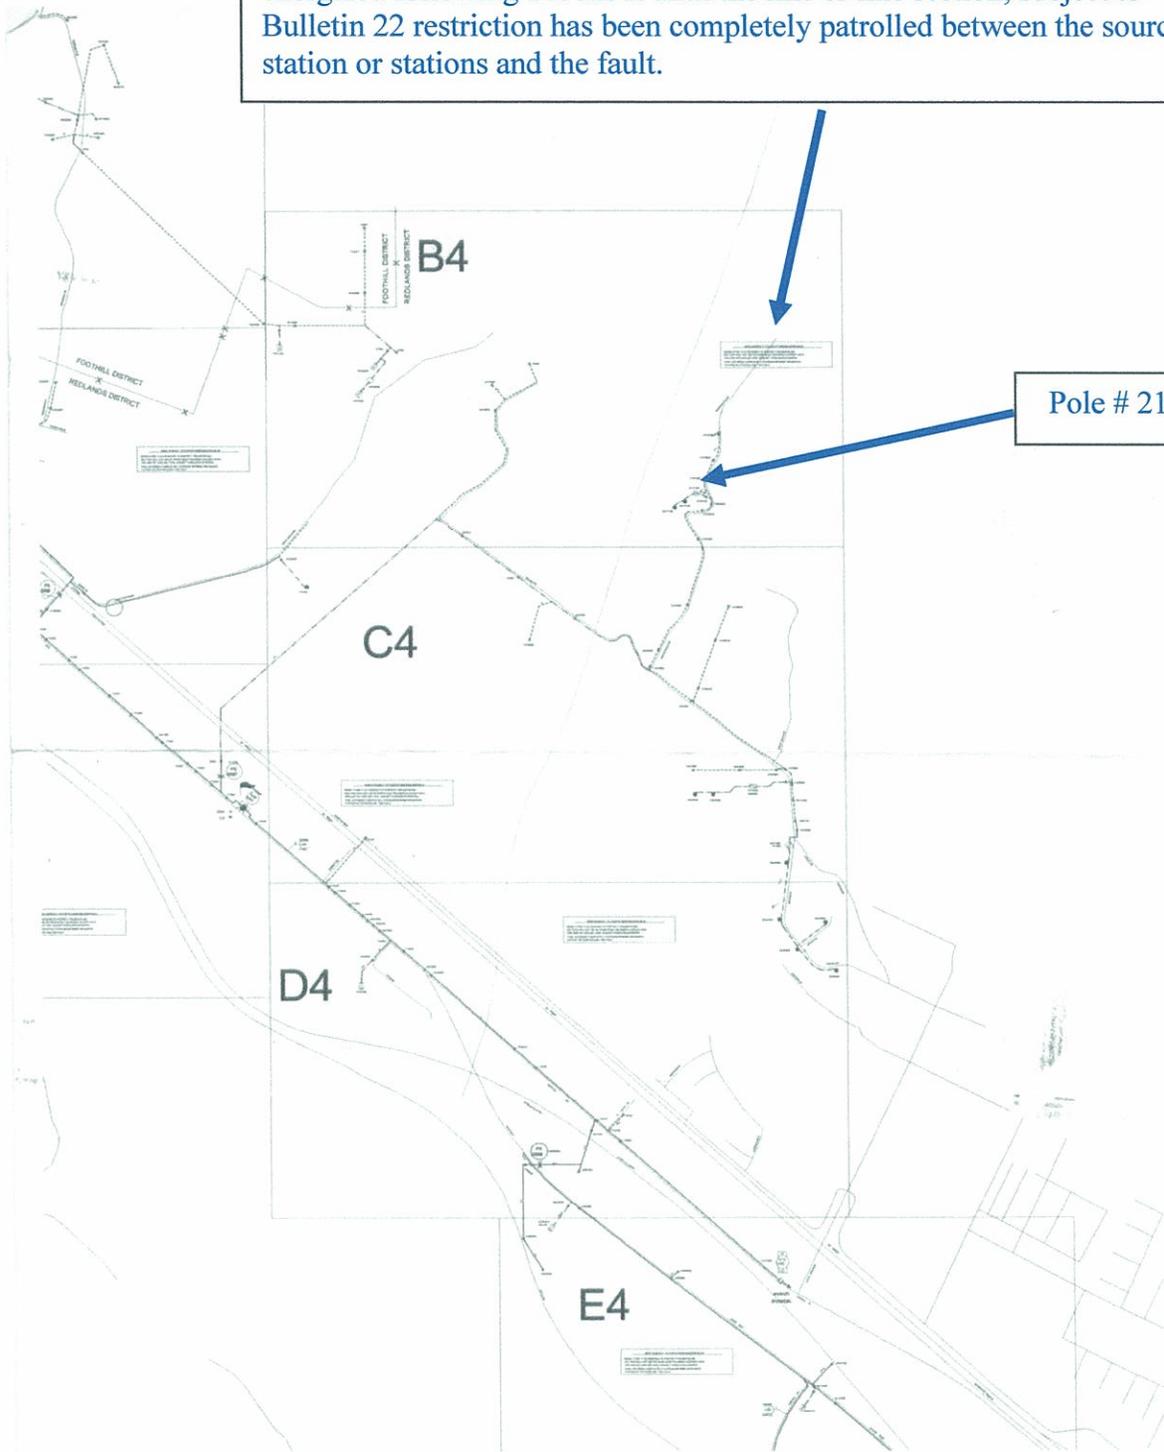
10- ATTACHMENT: Circuit Map

AREA SUBJECT TO DISPATCHERS BULLETIN NO 22
When a Red Flag Warning is in effect the line or line section will not be re-energized following a lockout until the line or line section, subject to Bulletin 22 restriction has been completely patrolled between the source station or stations and the fault.
