10- ATTACHMENT: Photographs
Picture # 1 (Photograph I.D. # 1-13)

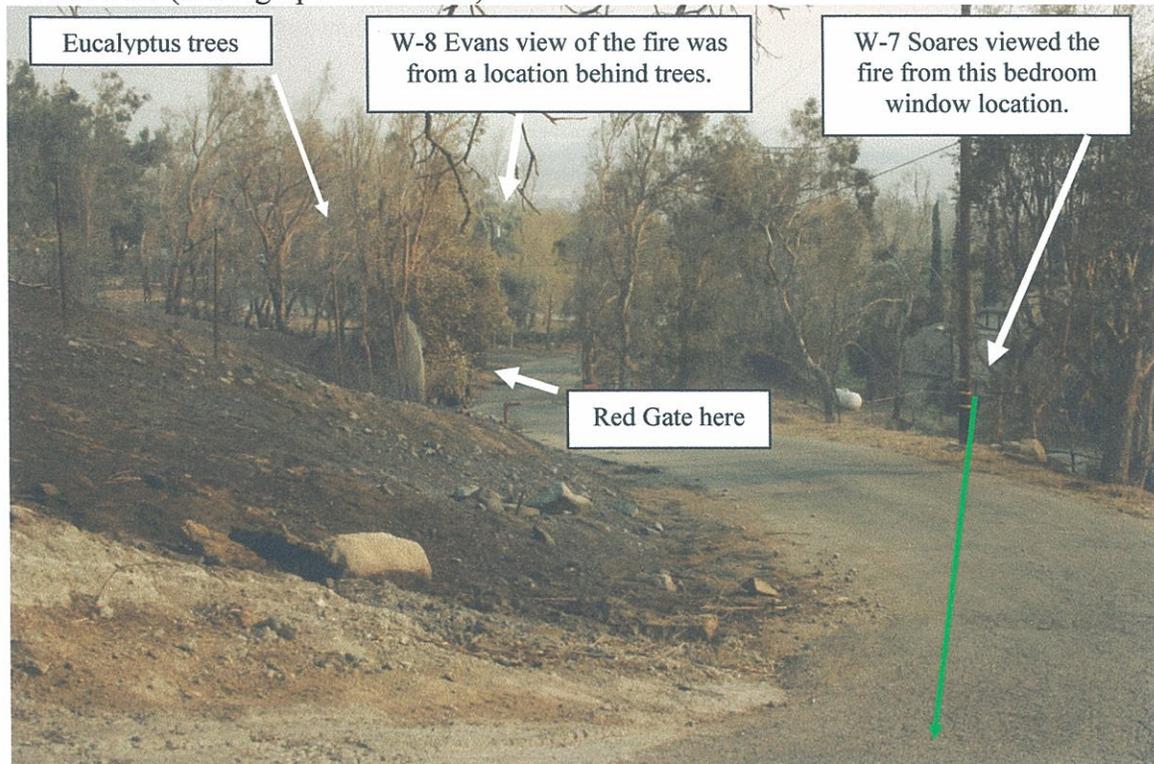
Picture # 30 (Photograph I.D. # 5-42)

Photographer location: Martin Ranch Road in the S-curve where the natural drainage meets the road (looking southeast). W-7 SOARES' residence is on the right side adjacent to the propane tank, and the direction where she first saw the fire is indicated with the green arrow. W-8 EVANS stated she first saw the fire where the car had turned around by the red gate twenty minutes earlier. The eucalyptus trees lining the road showed intense burning all the way down to ground level occurred through the vegetation, and the fire was well established when it burned in and around the area of the red gate.
